Rapid Lesson Sharing

Event Type: Skidgine Rollover

Date: August 7, 2020

Location: Neals Hill Fire, Burns Interagency
Fire Zone, Burns District, BLM
Oregon

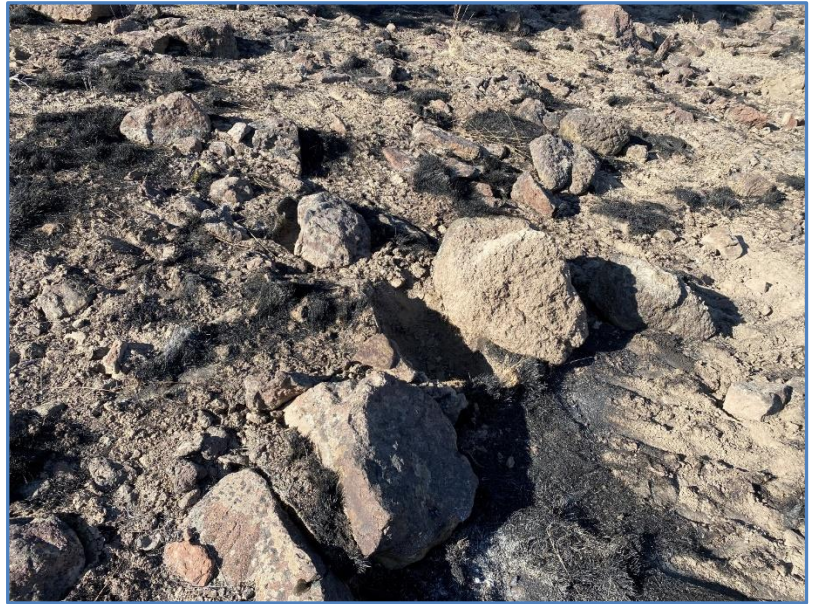
As he made the turn and headed downhill, the Skidgine A operator felt the machine shift sideways as his rear right tire rolled off a half-buried two-foot boulder that rolled to the surface. Slopes were estimated at approximately 20 percent.

Observations from NW Team 9 Safety Officer: *"Upon my initial review of the scene, the skidgine was not operating on excessive slopes or overly rugged terrain. There was no glaring cause evident other than the shifting rock under the rear passenger tire. Additionally, the operator was wearing his seat belt and the roll cage performed as designed, which led to the positive outcome of no injuries."*

View of boulder that shifted from beneath the skidgine's rear tire resulting in the imbalance that led to the rollover.

- ❖ You may be operating within the slope capabilities of the equipment. However, big, loose rocks change the slope percentage each time you go over one, making the slope much steeper within a two-foot area.

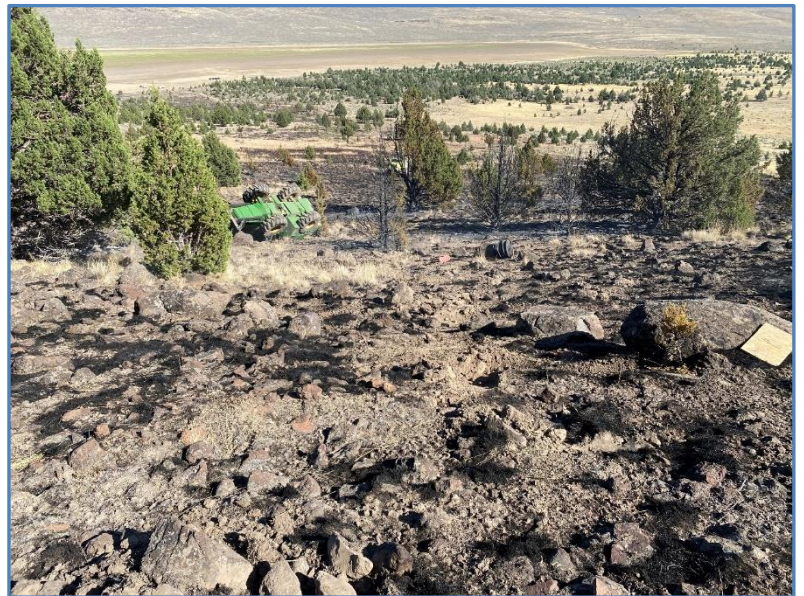
The operator recalls that it felt as if the machine was going to tip over. He therefore made the decision to drop the blade in an attempt to stabilize the machine. In doing so, according to witnesses, the machine proceeded to roll over three to five times.

Photo taken from the location of the initial rollover site looking down at the skidgine's final resting place.

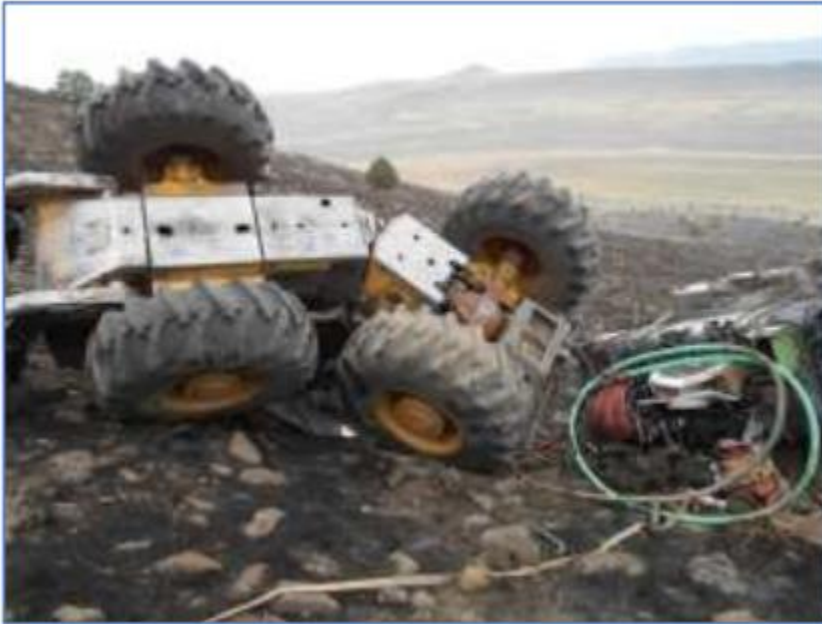
Skid #2 started to adjust the back end of the skidgine to be fully pointed downhill when several rocks kicked loose and rolled out from under the rear tires. This action changed the ordination and angle of Skid #2, jarring it toward the front right tire (the downhill side)—causing Skid #2 to rollover.

Skid #2 rolled five times before coming to rest on its right side, approximately 200 feet down slope. When Skid #2 stopped rolling, the operator immediately jumped out of the skidgine, under his own power, and ran clear of the machine—thinking it might roll again.

- Always remember: Skidgines are NOT dozers.
- You may be operating within the slope capabilities of the equipment but big, loose rocks change the slope percentage each time you go over one, making the slope much steeper within a two-foot area.

- HEQBs and Equipment Operators need to keep in mind the effects that rocks and uneven terrain have on the stability of the equipment. If this had been the exact same slope but without all the loose rocks, the skidgine would likely not have rolled over. (The rocks kicking loose from under the back tires caused Skid #2 to rollover.)
