Alkali Rim Prescribed Fire (TA-76)
Worland Field Office Wyoming
September 20, 2001 Incident Review

Alkali Rim Prescribed Fire Photos

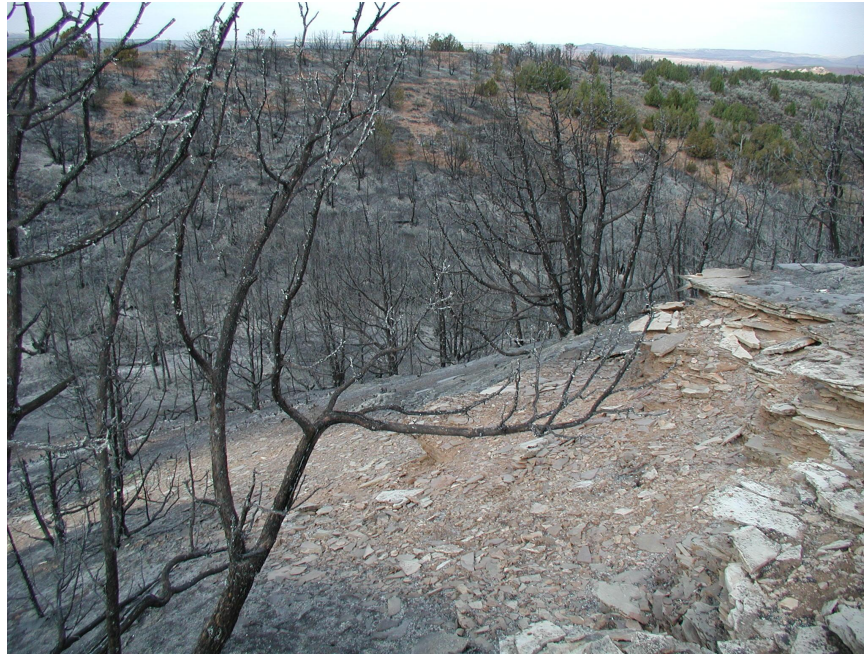
Photo 1: Route four personnel took out of drainage in foreground. Rock outcrop on right is where drip torches were placed. Safety zone is 100 feet to the right in cold black.

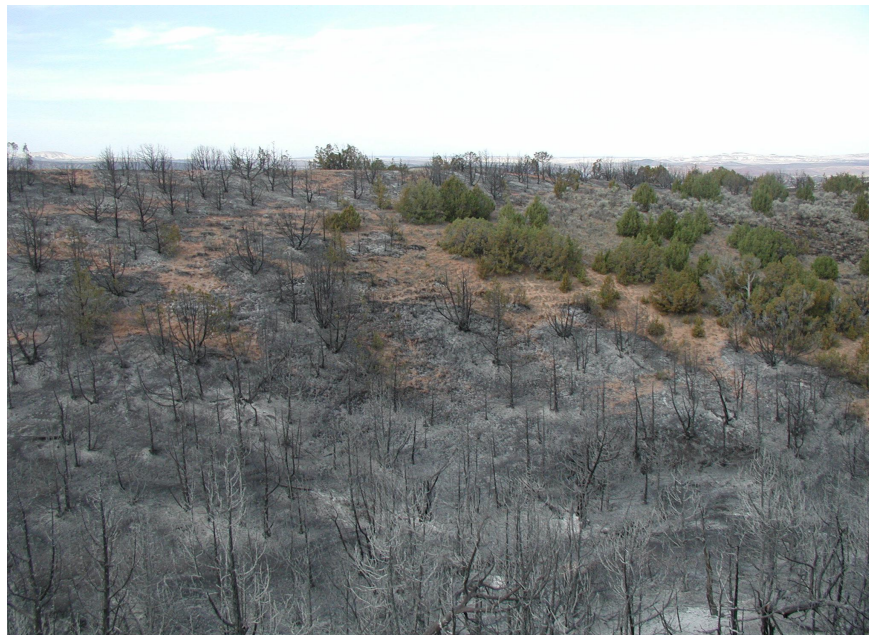
Photo 2: Route 5th person took out of drainage on west slope to road on ridgeline. Route was next to the unburned area.

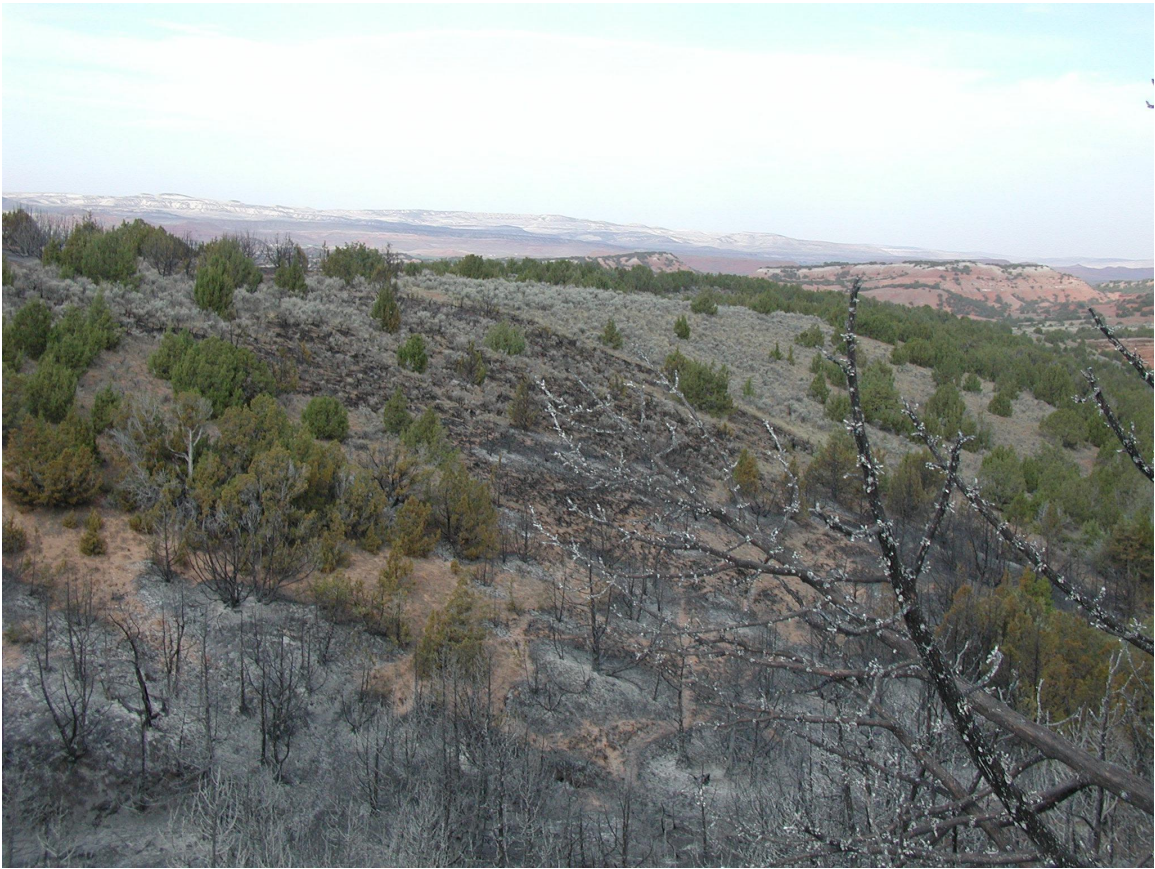
Photo 3: Overview of the prescribed burn block. Ignition started in bottom of drainage lower right.
