MULTIPLE
FATALITY ACCIDENT
ANDERSON CREEK FIRE

BOISE NATIONAL FOREST
INTERMOUNTAIN REGION

Accident: Multiple Fatality
Vehicle Accident
Jemez Pueblo Firefighting Crew

Location: Region 4, Boise National Forest, Anderson Creek Fire

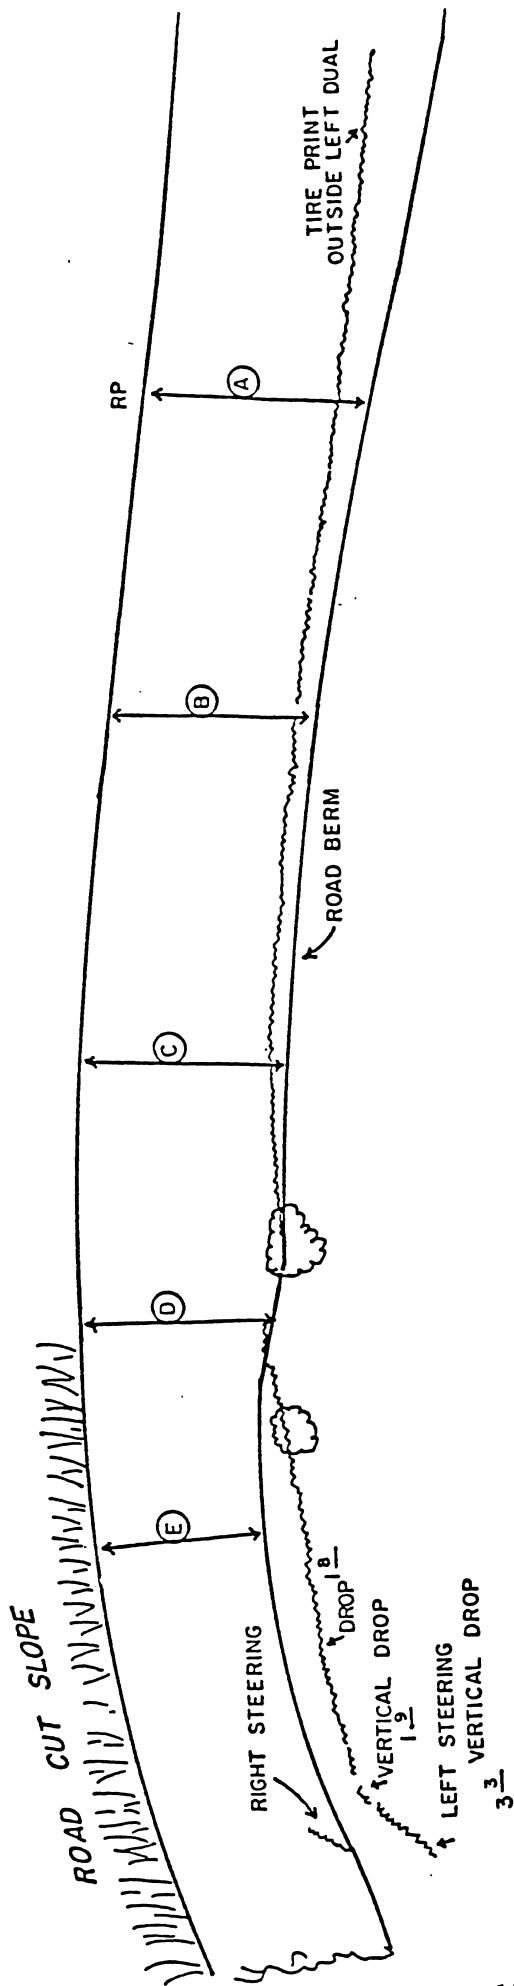
SITE DIAGRAM

- (A) Width of Rd. at RP 16 ft. and 93 ft. 10 in. from end of vehicle track South.
- (B) 20 ft. S of RP Width is 13 ft.
- (C) 40 ft S of RP Width is 12 1/2 ft
- (D) 56 ft. S of RP Width is 11 ft. 4 in.
- (E) 70 ft S of RP Width is 10 ft. 3 in.

The road at the accident site narrows from approximately 16 feet with a berm to 10 feet 3 inches without a berm. The road (when viewed from the direction of travel for the accident vehicle) curves gently to the left. From the intersection with FDR 649, the road is generally straight with a gentle uphill grade of 4 percent. The grade through the accident site is nearly level. The narrowing in the gentle left curve created a "kink" in the road. There also is a bush approximately 4 feet in diameter and height located at the point that the berm ends as one approaches the accident site. A second bush, a few feet further south and just below the edge of the road on the fill slope (slough slope) gave a visual clue that the berm and the road edge continued as it probably had before the sloughing occurred. The masking effect of the first bush and the false reassurance that the second bush offered when combined with the darkness and the headlights shining straight ahead as the road curved gently left and the residual dust from the previous vehicle, may have obscured the significant narrowing at the accident site.

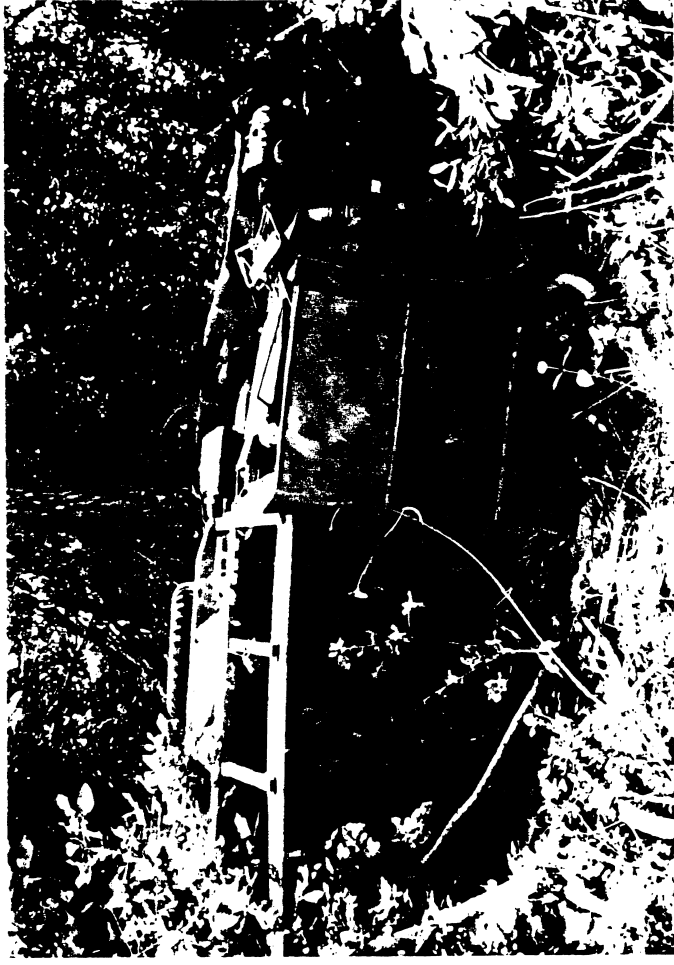
Vehicle in creek bottom.
