**Bald Mountain Wildland Fire  
Firefighter Injury and Engine Burnover Incidents  
Lessons Learned Review**

**July 11, 2019**

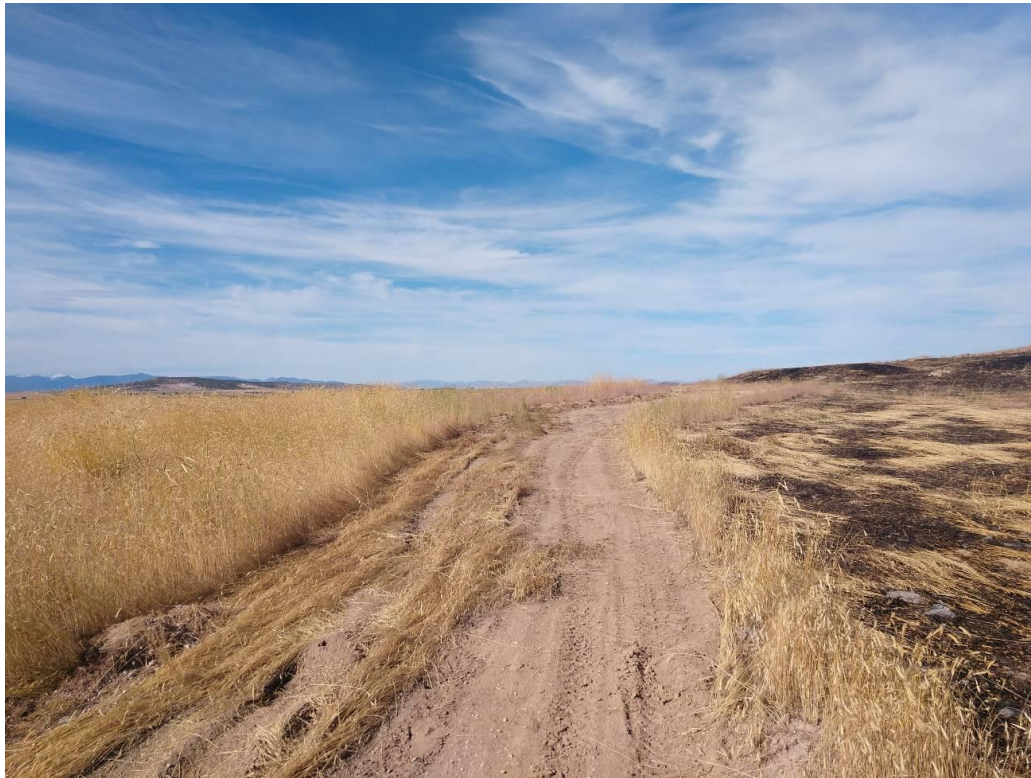
**Post-fire view of section of fire, showing burned area and fine fuel loading.**

**Discussion:** The 2019 fire season has gotten off to a slow start due to the significant moisture and cooler temperatures that occurred throughout the winter and spring. However, this has led to a higher fine fuel load across the west, which was on its way to being available to burn. On this incident, the weather, specifically gusty, erratic winds, played a significant role in influencing fire behavior and the availability of fuels to burn. On both incidents, crews had to change tactics and switch hose types due to booster reels not providing adequate water volume to attack the fire.

**Recommendations:** When fire conditions do not represent what was anticipated based on current predictive forecasts, take time to gather accurate information on fire behavior and weather, and provide that information to all on-scene and incoming resources. Ensure that on-site weather and fire behavior observations are taken and recorded to inform decision making and tactics. Consider providing on-site weather observations to meteorologists at the National Weather Service and the Geographic Area Coordination Center to help build a data pool in areas where RAWS coverage is poor.

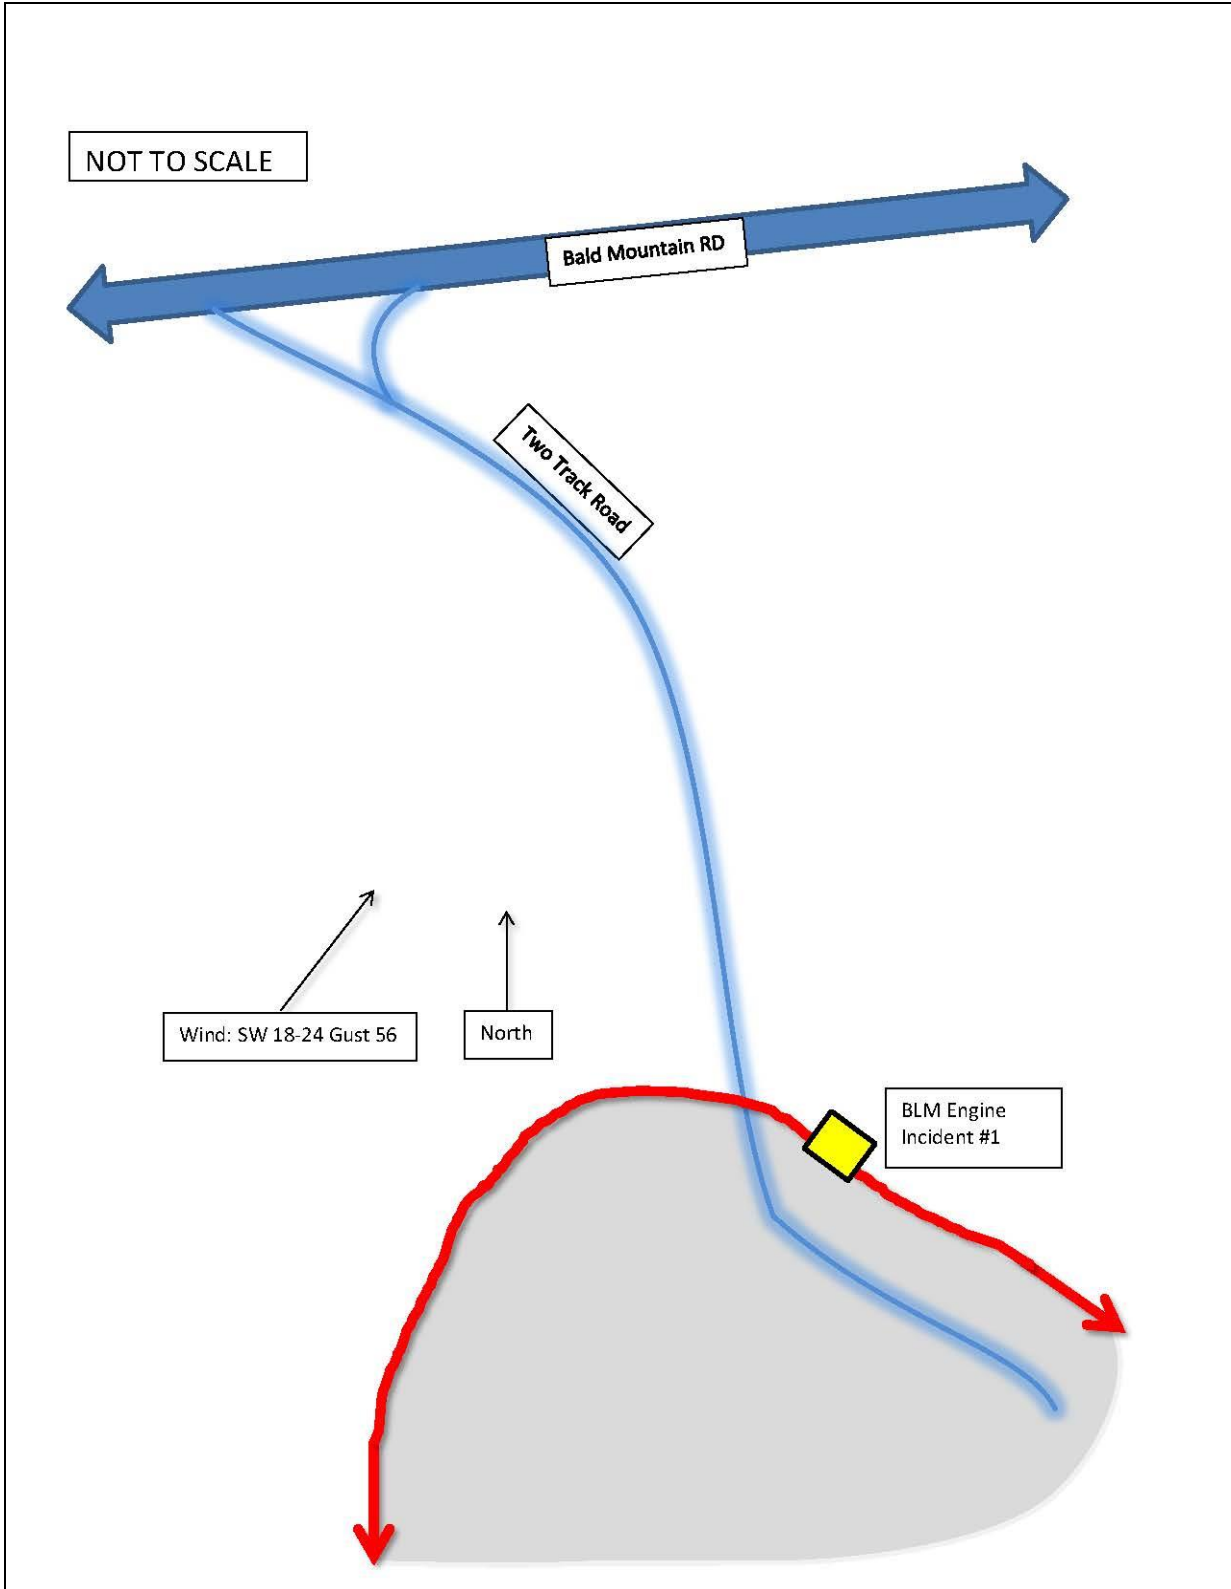
In **Incident 1**, while conducting mobile attack, a BLM firefighter was struck by the tire of a moving engine, impacting his foot and lower leg and pulling him to the ground, with the engine continuing to roll over his lower left leg. The resulting injury was non-life threatening, but resulted in a bone contusion and soft tissue damage, which lead to a medical recommendation of no-duty for two weeks.

Approximate sketch of Incident #1 (BLM Firefighter Injury).

**Discussion:** During mobile attack operations, due to the impacts of smoke on visibility, the BLM Crewmember 1 operated the hose too close to the BLM Engine. The BLM Captain did not maintain full view of BLM Crewmember 1 while he was operating the hose and the BLM Engine was in motion.

**Recommendations:** Firefighters, while engaged in mobile attack, should ensure that the engine operator can maintain full view (from top of the head to bottom of the boots) of personnel operating hoses/nozzles. Based on published BLM risk assessments, which state that a spotter should be used during mobile attack, when adequate staffing levels allow, a spotter should be utilized. Engine danger zones stickers (see below) should be made available to firefighters operating on engine to inform and remind them of danger areas where engine operator visibility of ground personnel is reduced. An image of this sticker can be found of the [National Interagency Fire Center website](https://www.nifc.gov/training/EquipmentProgram/FireVehicleTraining/BL300/dangerzone_2014.jpg)<sup>2</sup>.

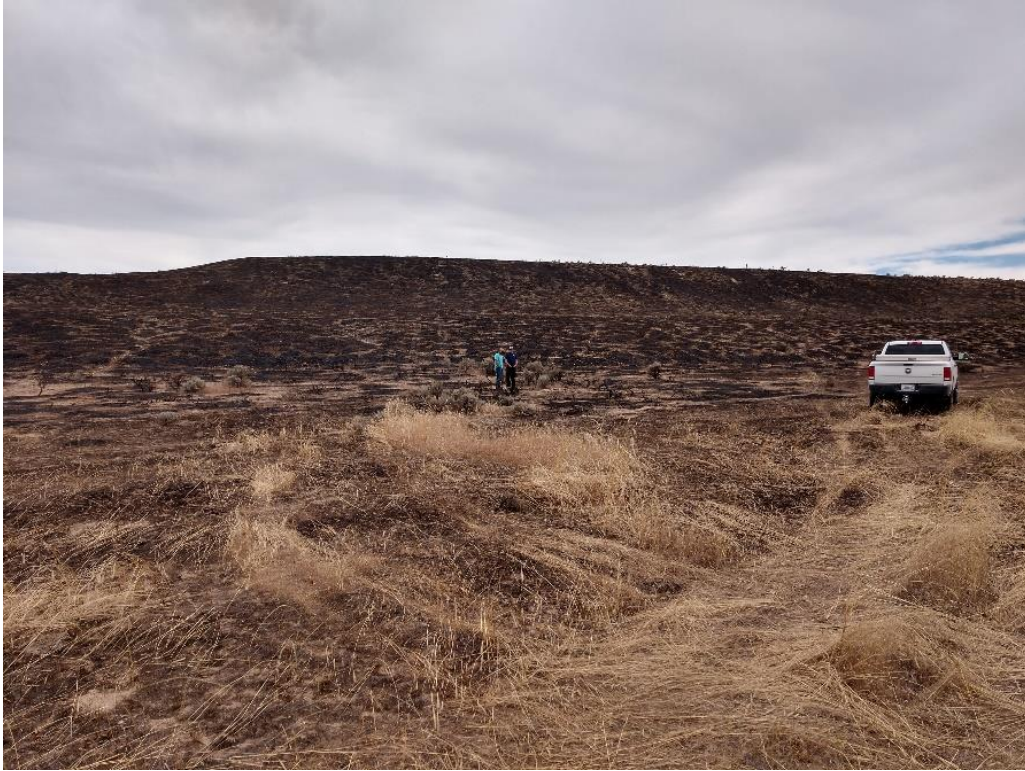
**Post-fire view of area where Incident #1 occurred.**

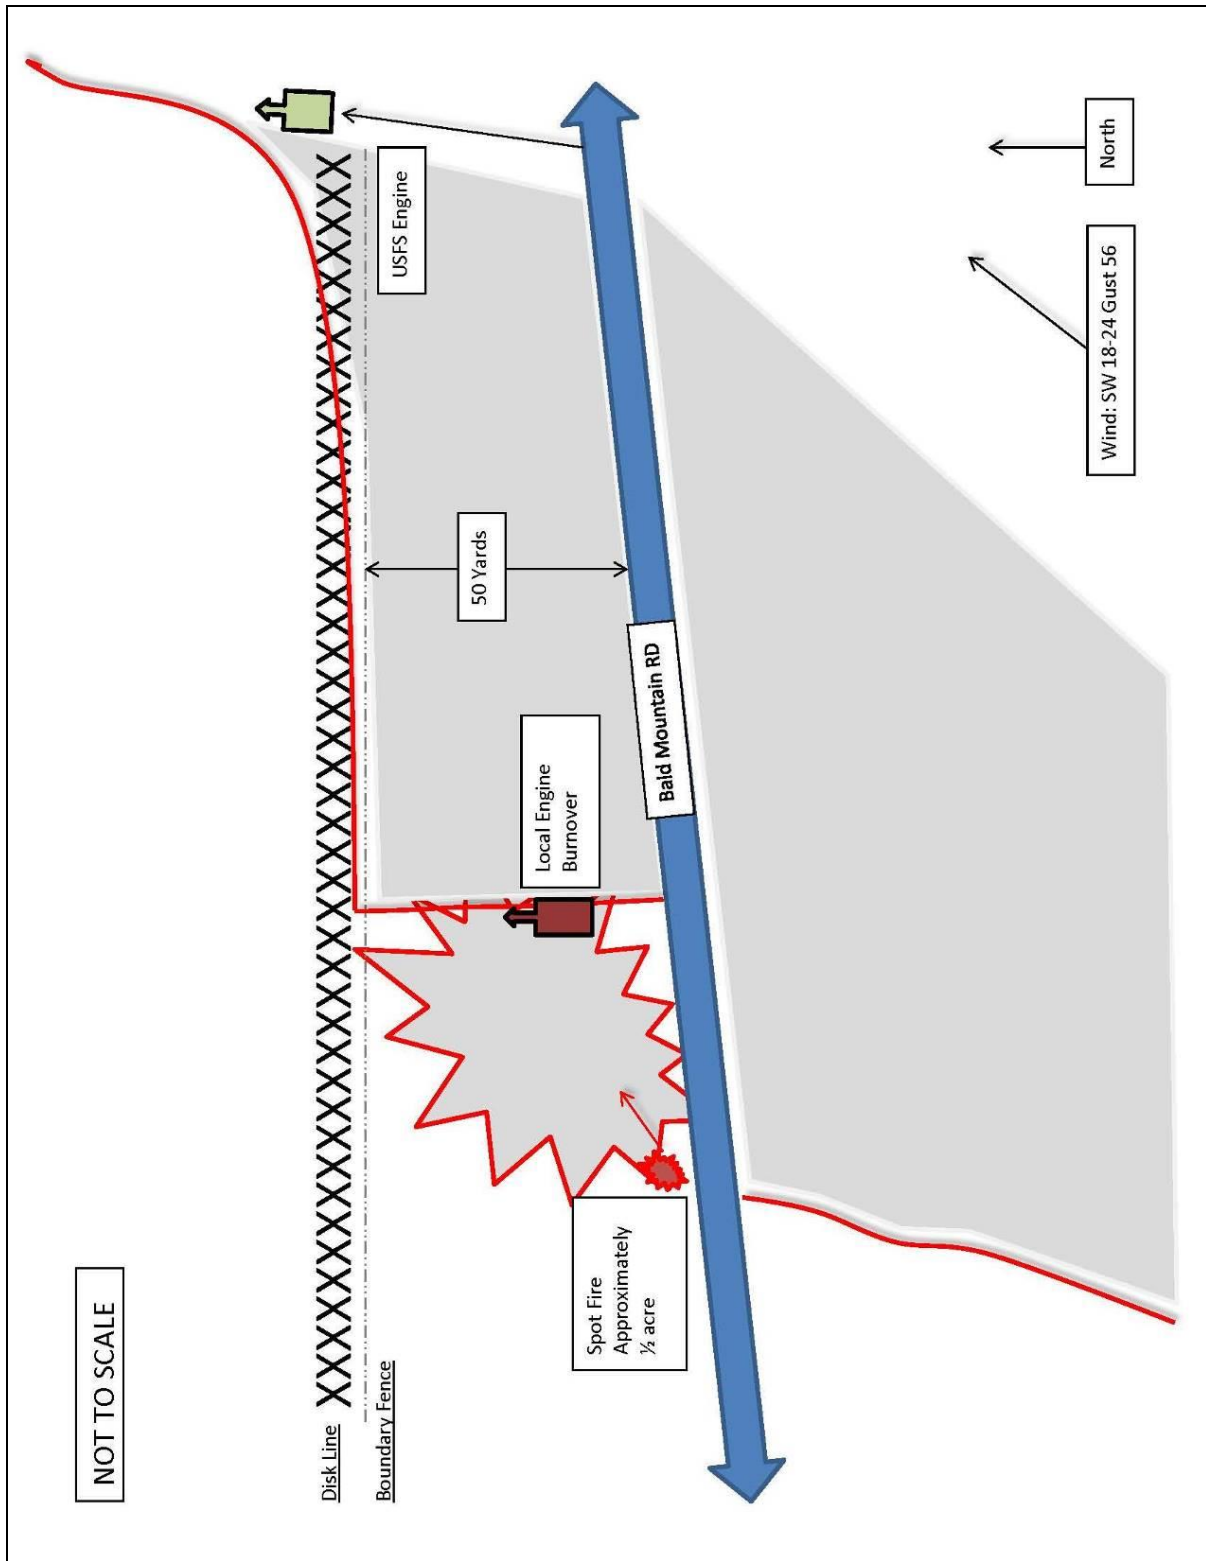
Roughly 1 hour later, **Incident 2** occurred when an equipment malfunction related to water flow warranted the engine to stop and troubleshoot the malfunction. Both firefighters moved to the black side of the truck, during which time a spot fire ignited on the green side of the engine, rapidly spreading and impacting the engine. An attempt was made to move the engine to the black, but the crew was driven back by the fire. The two engine crewmembers utilized their escape route though the black to the Bald Mountain Road, approximately 20 yards away.

Sketch depicting Incident 2 (engine burnover).

**Discussion:** When the Local Engine arrived on scene and began to work direct suppression on the fire line, the hose operator observed a lack of adequate water flow and pressure due to an equipment malfunction. Due to this, the decision was made to stop and switch hose lines. The Local Engine Captain and firefighter both went to the passenger side of the vehicle to switch hose lines, which resulted in an inability to see when the spot fire approached and impacted their engine.

**Recommendations:** Equipment checks should be performed prior to leaving the station and travelling to the incident, to ensure that crews arrive with equipment in working order.

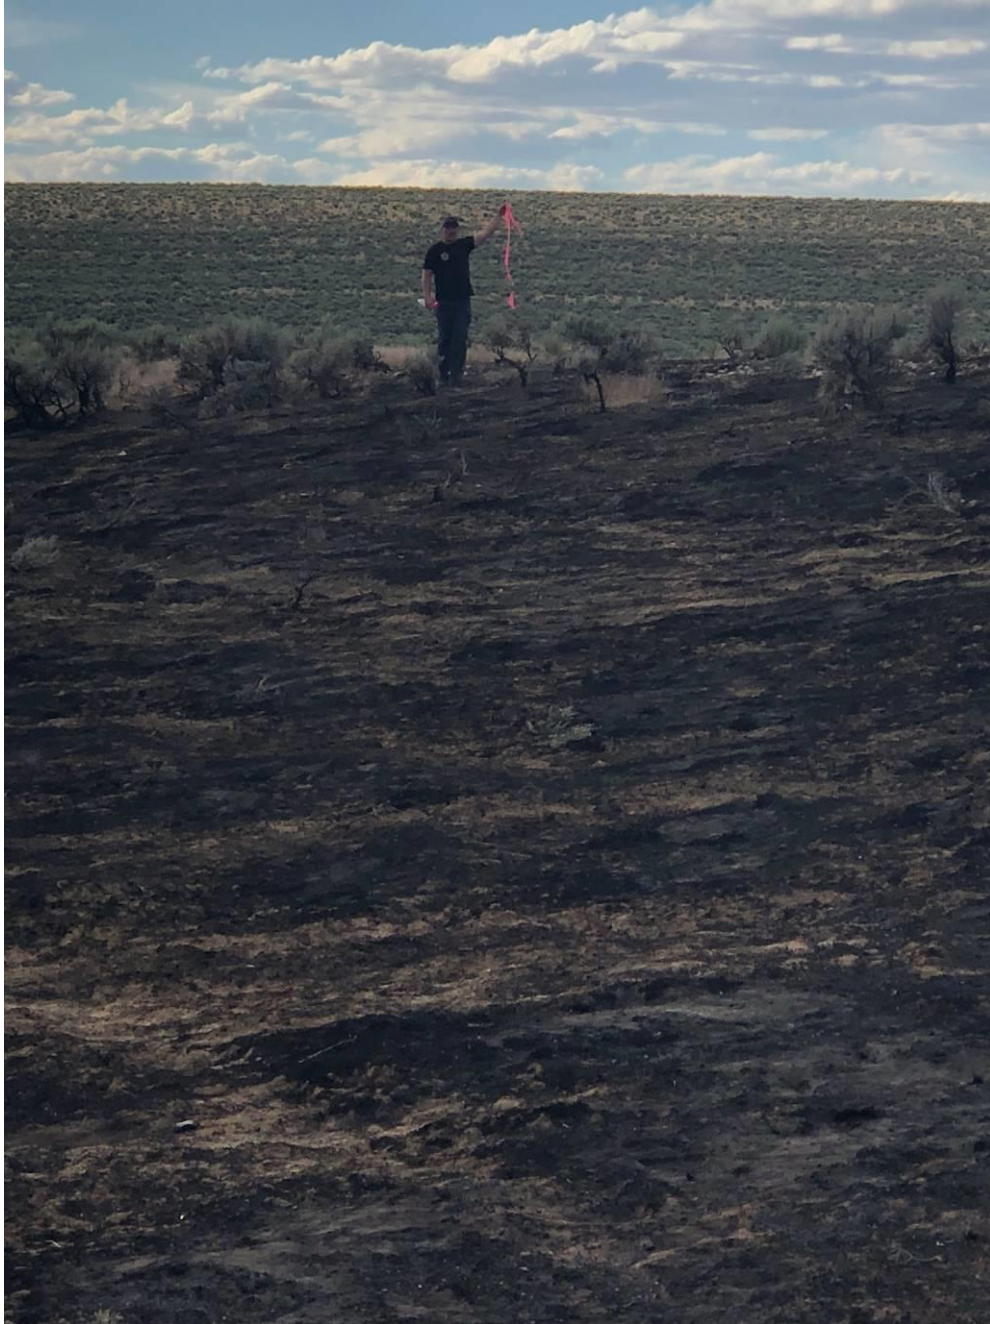
**Picture taken from the location of where the local engine burned over. The person in the photo holding the pink flagging is located where the spot fire started.**

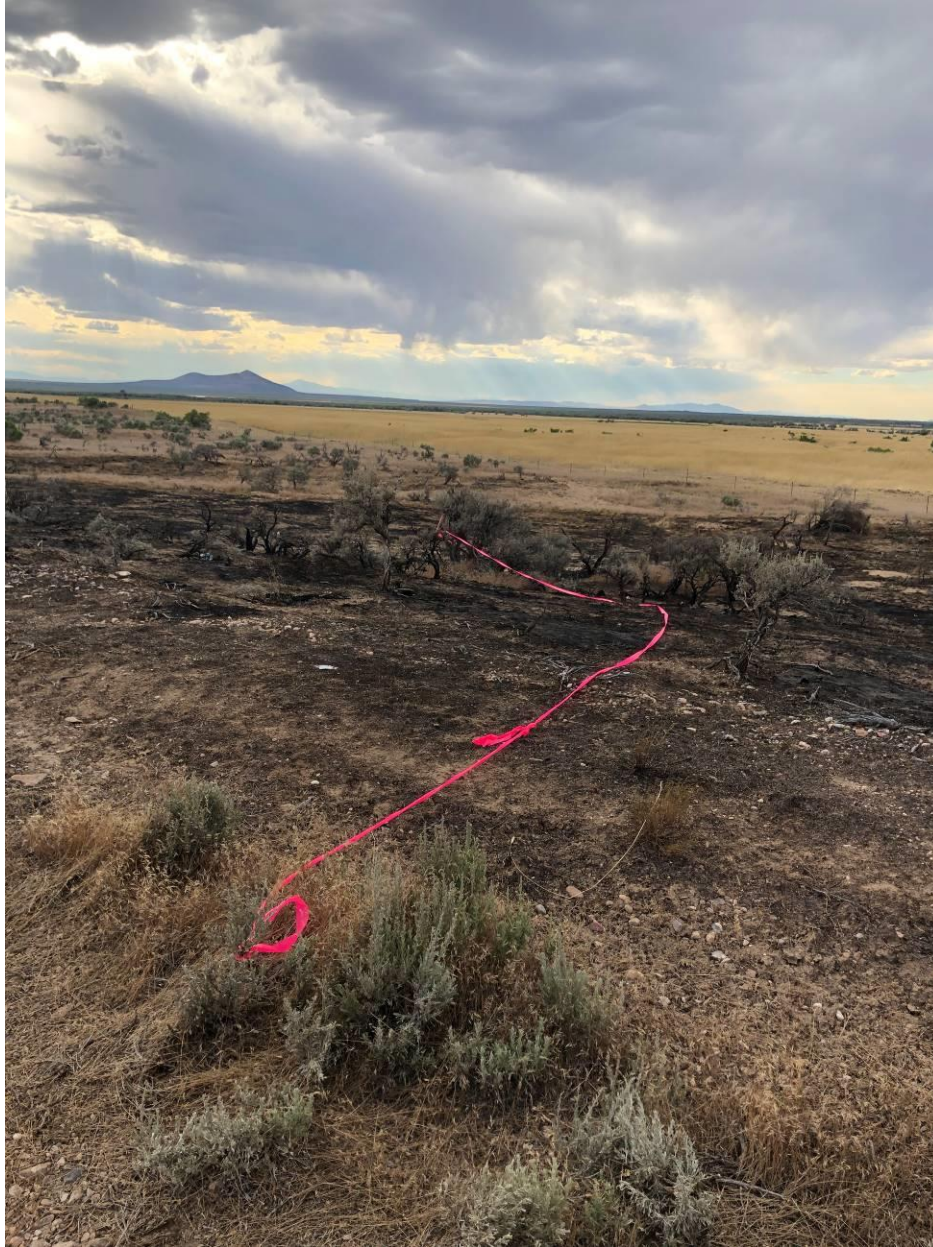
**View of Local Engine burnover site from Bald Mountain Road. Pink flagging depicts the escape route that the Local Engine crew took across the black to the Bald Mountain Road.**

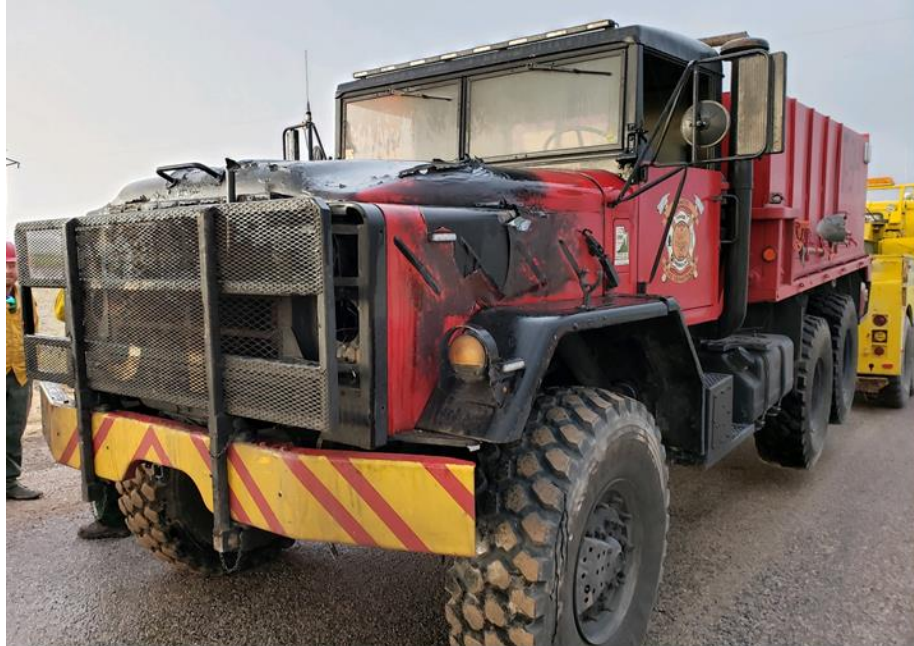
from the green side of the fire line due to tire hazards and residual heat from dense sagebrush stubs located in the black. The Local Engine encountered inadequate water volume and pressure from their hardline nozzle at approximately 20 yards north of the Bald Mountain Road. The Local Engine Captain stopped to assist the firefighter in switching to a one-inch attack line. While both were on the passenger side of the Local Engine, a spot fire crossed the Bald Mountain road and was quickly fanned by the high winds, driving the spot fire quickly toward the Local Engine. Within 30 seconds of getting out of the engine, the Local Engine Captain observed fire come under the engine, between him and the engine. At that point, the firefighter retreated through the black back to the Bald Mountain Road. The Local Engine Captain attempted to get into the engine from the passenger side and move it, but was forced out by fire. The Local Engine Captain then retreated through the black to the Bald Mountain Road, meeting up with the other firefighter who had already retreated.

**Local engine involved in burnover (Incident 2).**
