**Peer Review Report
of
Balls Canyon Near-Miss
June 27th, 2006
Humboldt-Toiyabe National Forest**

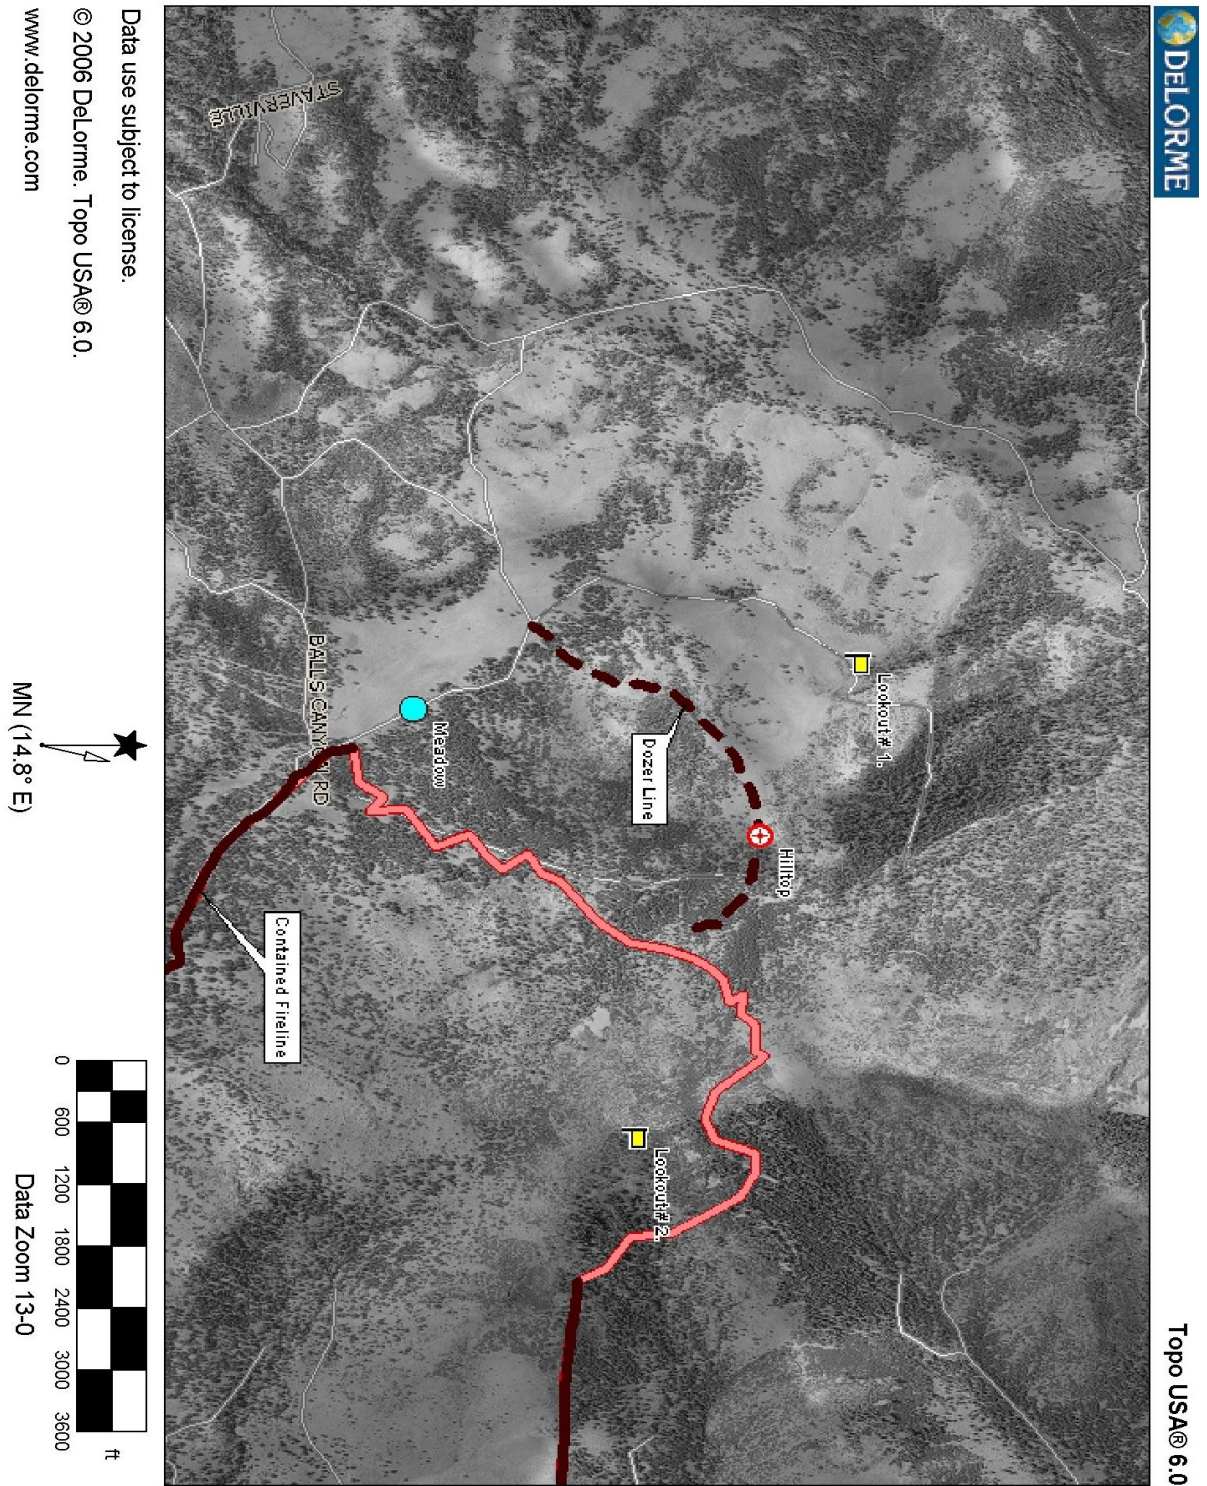
Aerial Photo #1 Shows Dozer Line Construction at 1400

Supported by the two strike teams of hand crews, a half mile of dozer line was constructed to a hilltop by 1300 {See Aerial Photo #1}. STCR #2 contacted the Division Supervisor and reported that they made excellent progress to the hilltop. From his vantage at Lookout #1 DIVS could see the dozer at the hilltop. With the approval of DIVS, the plan at this point was to construct a safety zone at the hilltop (or other suitable location nearby) and continue indirect dozer line construction to the fire's edge. The line from the hilltop to the fire's edge and from the hilltop back to the south would be

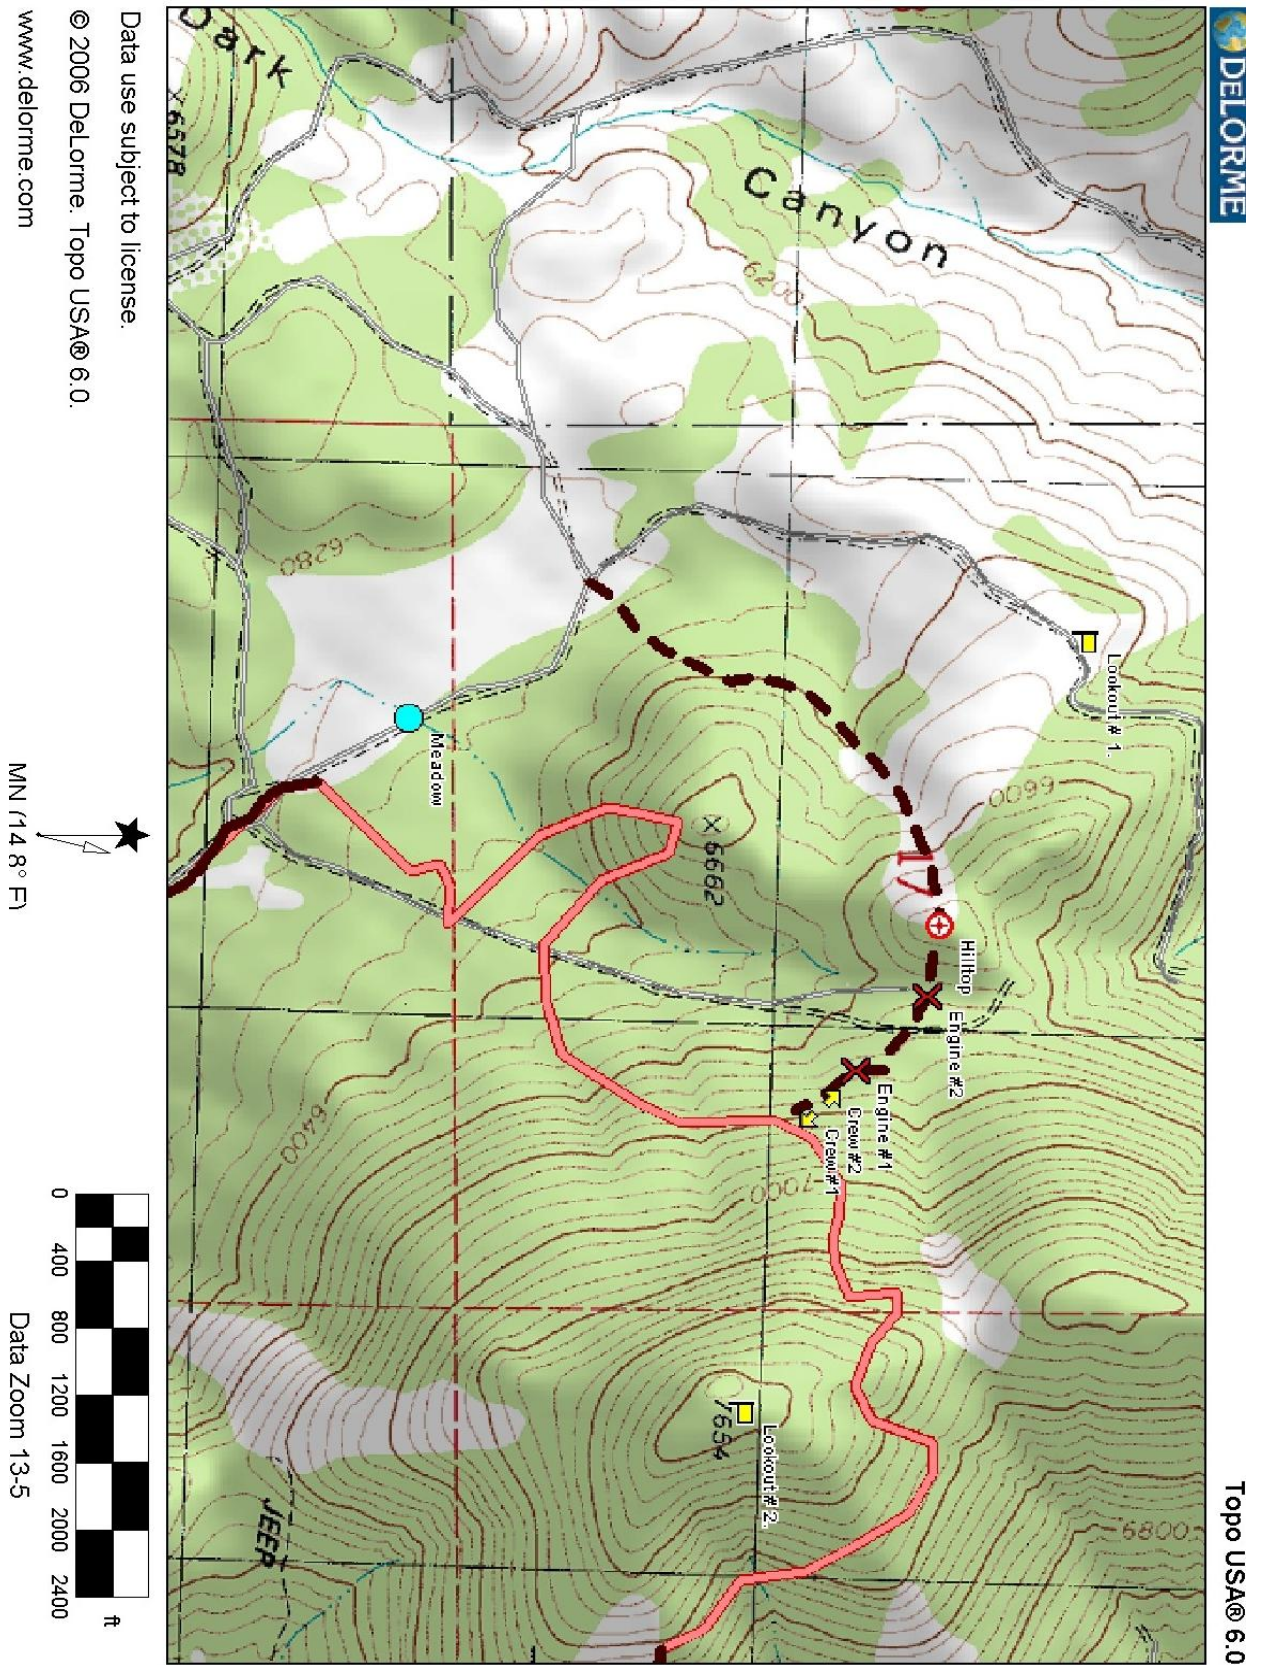
Map 2. Fire and Crew locations at 1430-1440. Two additional engines were located at the hilltop.

At approximately 1420 STCR #2 was at the end of dozer line and discussing operations with STCR #1. STCR #1 could see across the saddle to the hilltop and noticed two engines on the hilltop. STCR #1 pointed them out to STCR #2. They were both somewhat surprised to see the engines there and even more surprised moments later to see engine crew members laying hose line up to their location near the end of the dozer line. The STCRs assumed that all engines were at or near the hilltop and that the engine crews had laid 500 yards of hose from at or near the hilltop location. There had been no communications between the Engine Captains and STCR #1 or STCR #2. STCR #2 reported excellent progress to DIVS. STCR #2 then requested the dozer to return to the hilltop as he planned to use the dozer to increase the width of the line in the closed canopy ponderosa by several blade widths. Up until this time fire behavior was characterized as very low, creeping, to 1 foot flame lengths.

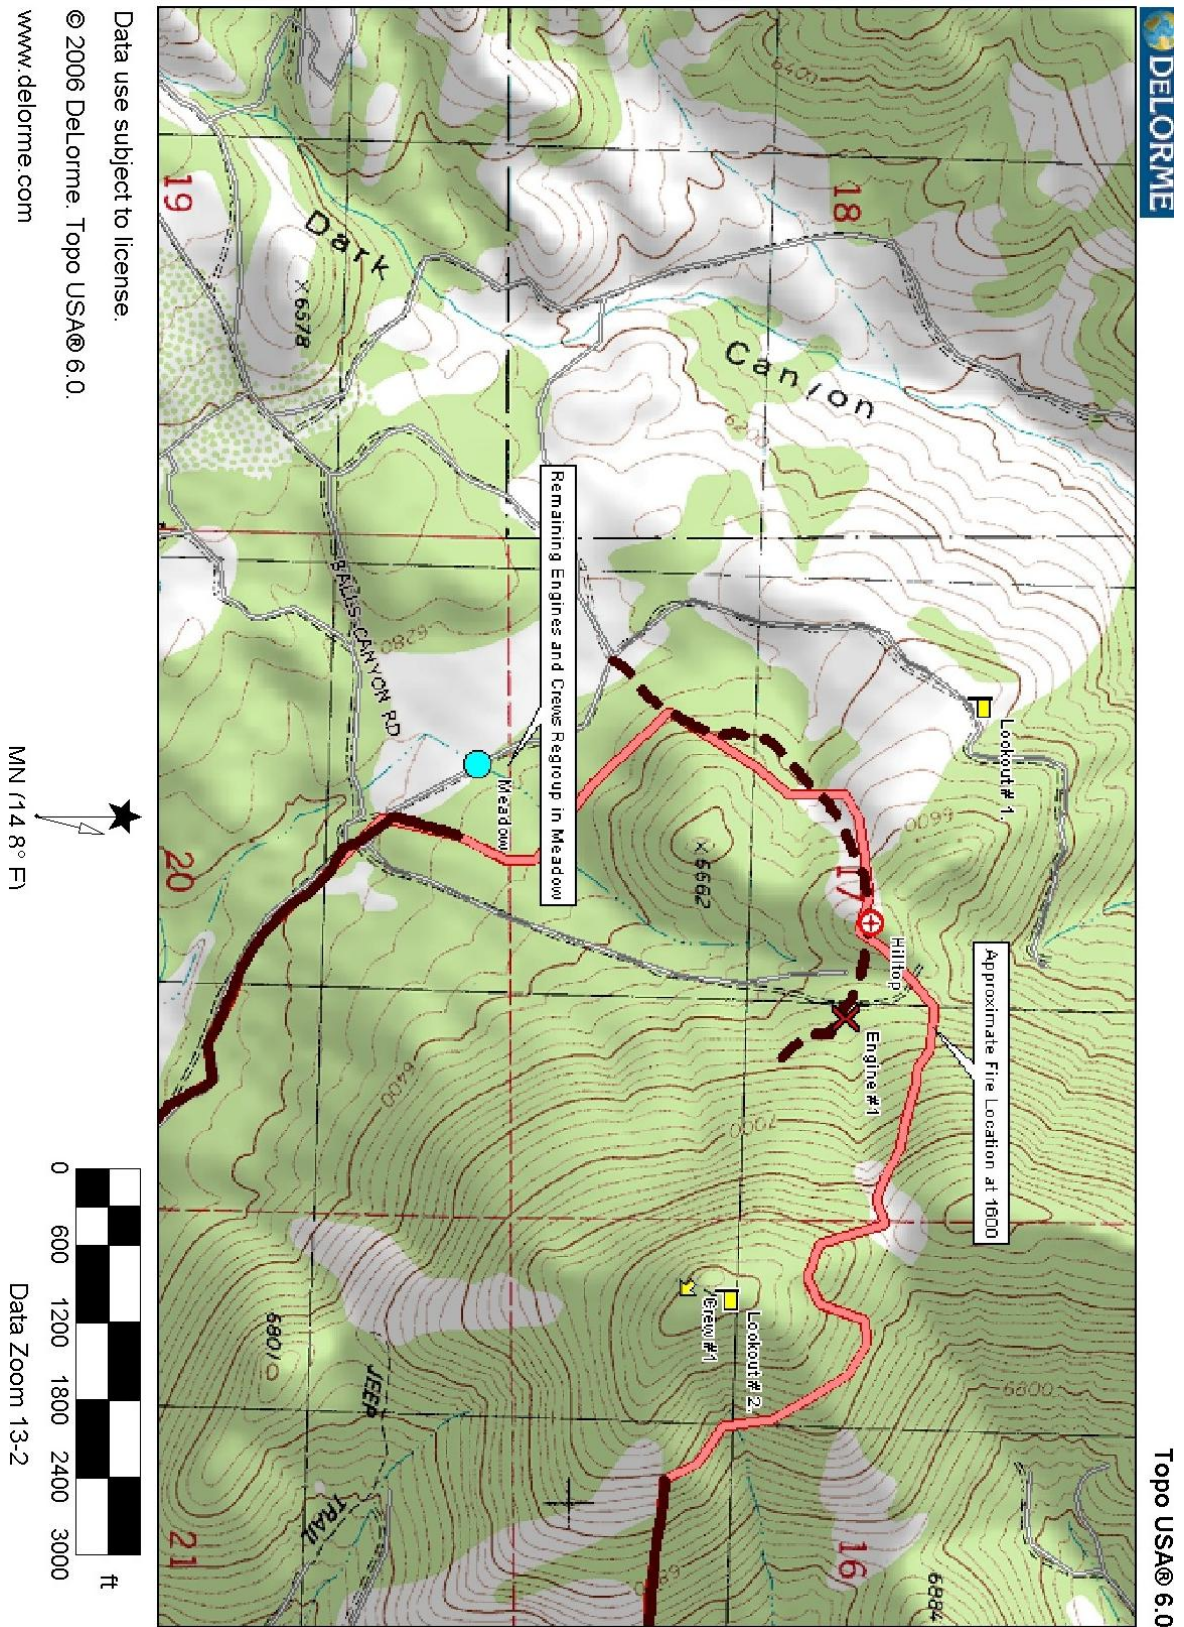
Map 3. Fire Location After Engine Burn Over

While backing, Engine #1 drove slightly off the dozer line and became stuck. The engine captain believed he did not have time to get the engine unsuck but believed he did have time to burn out around the engine before leaving. He directed his crew members to burnout around the Engine. At the same time the Type one helicopter began dropping on the main fire below the engine but could not completely suppress the emerging crown fire. With the support of the helicopter the captain believed he had additional time before he and the crew had to escape to the hilltop safety area. Once the firing was completed the captain directed his crew into the cab of the engine as the heat, embers and smoke from the fire below was a concern. The captain then used a hose to wet the crowns around the engine and cool the surrounding area. While in the engine, the crew members opened three fire shelters. The crew members pressed the fire shelters against the windshield and side windows to shield themselves from the radiant heat.

STCR #2 and others now at the hilltop became aware that Engine #1, with crew was still on the dozer line, in closed canopy ponderosa pine, at the top of a drainage with a building fire below them. STCR #2 and others noticed that the crew of Engine #1 appeared to be trying to burn out around the engine and they could see a stream of water from Engine #1 shooting into the tree crowns. Several attempts to radio the engine were unsuccessful. A CDF heavy equipment operator with a light 4WD flatbed service truck was also at the hilltop. After a brief discussion with STCR #2 and the engine captain from Engine #2, the heavy equipment operator and the engine captain from Engine #2 drove down the dozer line to Engine #1 in the service truck. When they got to Engine #1 they ordered all the crew members to abandon their efforts to protect the engine and jump on to the back of the truck. The crew of Engine #1 jumped onto the truck and were driven back out to the safety of the hilltop.
