Big Hill Fire Smokejumper Accident Learning Analysis

August 11, 2015

EXECUTIVE SUMMARY

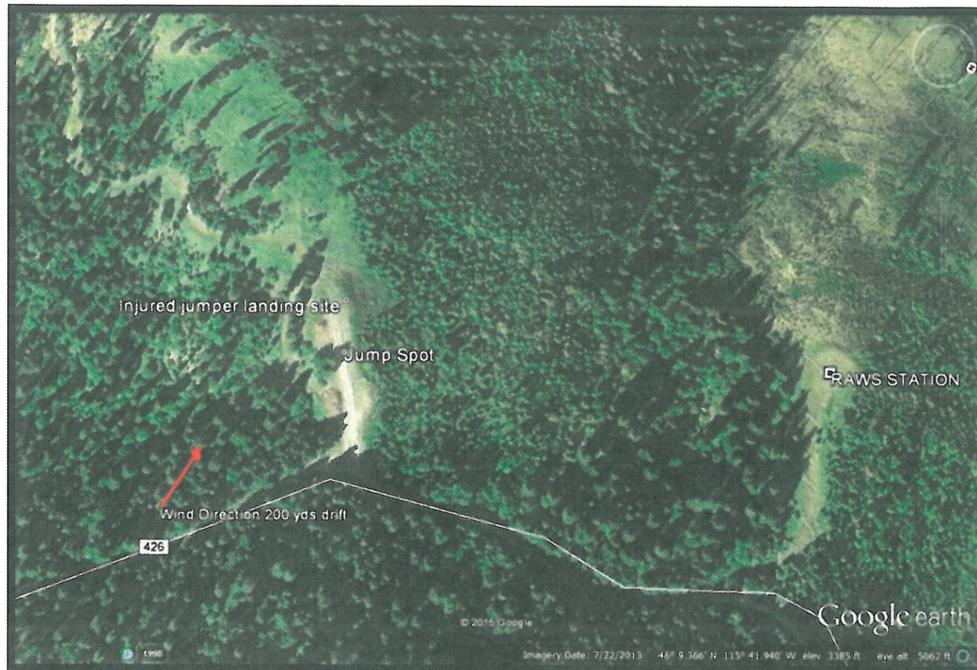
Map of jump spot and the injured smokejumper's landing spot.

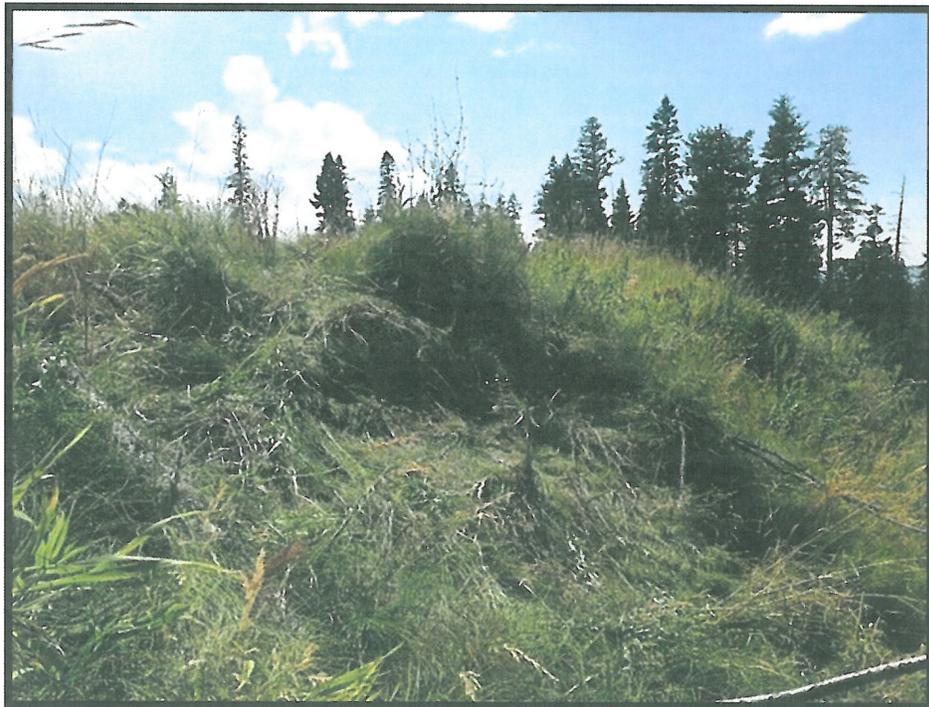
He flew a left hand pattern (same as the jumpers before him) to set up his approach to the jump spot. At this time, he was in "deep brakes" which is a steep descent angle because he didn't want to overshoot the jump spot into the trees. When he was about 20-30 feet off the ground, he realized he was in too deep of a descent and didn't have enough elevation to correct his trajectory. He landed just short of the jump spot into a steep embankment (see photo on Page 7).

The injured smokejumper from his interview indicated he didn't want to overshoot the jump spot. As a result, he went into "deep brakes" creating too steep of an approach. He tried to correct his brake setting but he didn't have enough altitude. As a result, he came up short of his intended jump spot, landing into a steep embankment (see photo).

Injured smokejumper landing site.

Recommendation 1: Include analysis of accident reports and performance data into established training for landing in unintended jump spots.

Smokejumper Program managers and training supervisors should continue improving upon the collection of accident reports and performance data for further analysis, trends, and enhancement on how smokejumpers can mitigate hazards in rough terrain jump spots. Develop training for smokejumpers on how to analyze/recognize/mitigate what is “adequate time” to identify a hazard and make the needed adjustments.
