ACCIDENT INVESTIGATION

Tractor Accident Resulting in Injury to Service Personnel and Damage to Government Property

Blackwater National Wildlife Refuge

September 16, 2014

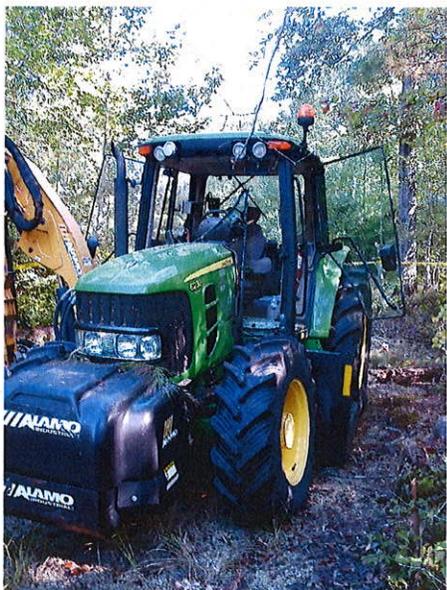
PICTURE: 1-1

DEPICTING: Tractor Damage

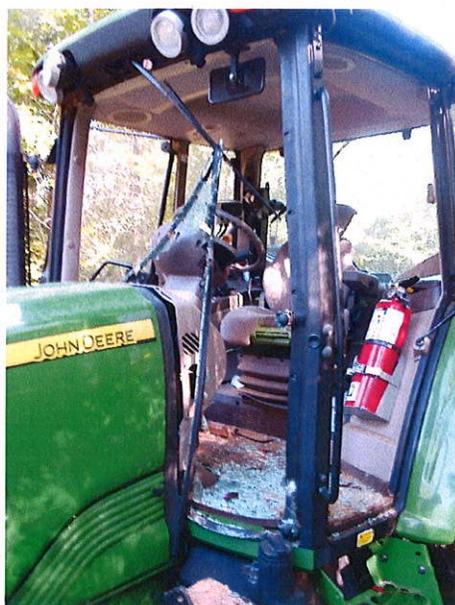
PICTURE: 1-2

DEPICTING: Tractor Damage

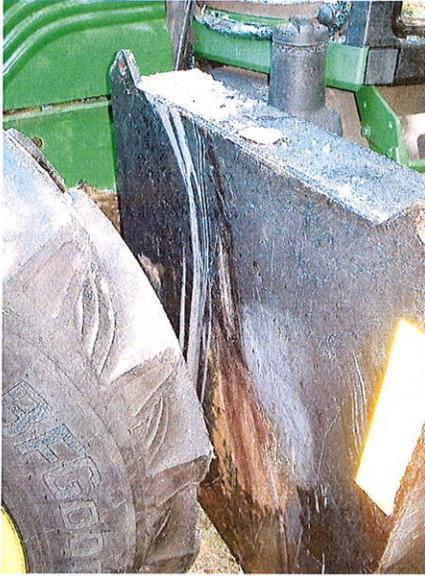
PICTURE: 1-3

DEPICTING: Tractor Damage

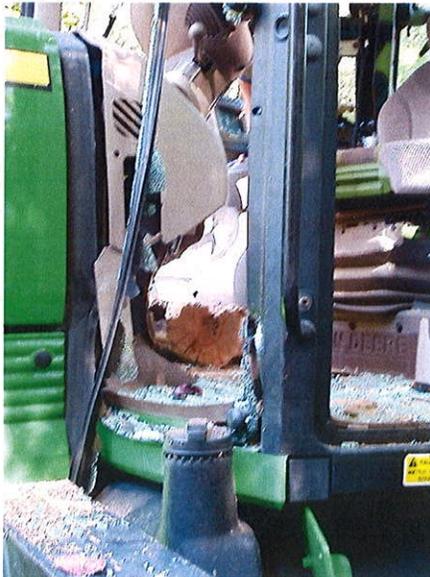
PICTURE: 1-4

DEPICTING: Tractor Damage

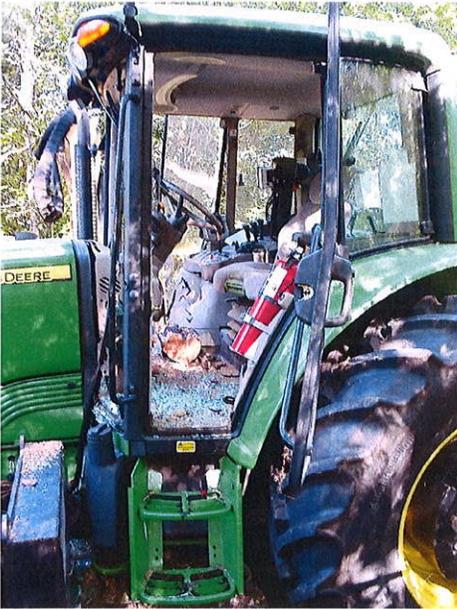
PICTURE: 1-5

DEPICTING: Tractor Damage

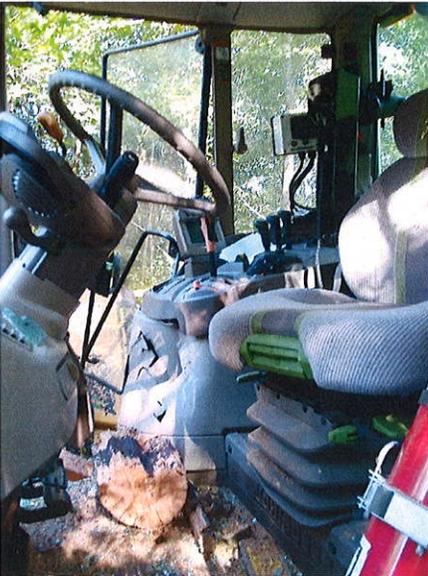
PICTURE: 1-6

DEPICTING: Tractor Damage

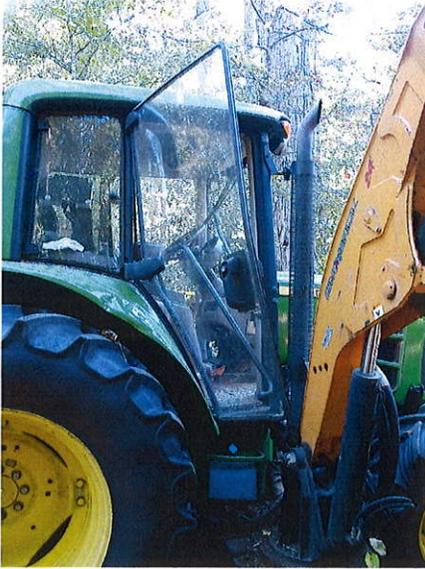
PICTURE: 1-7

DEPICTING: Tractor Damage

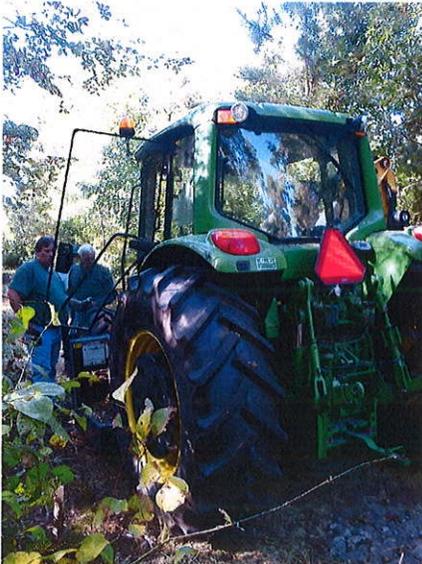
PICTURE: 1-8

DEPICTING: Tractor Damage

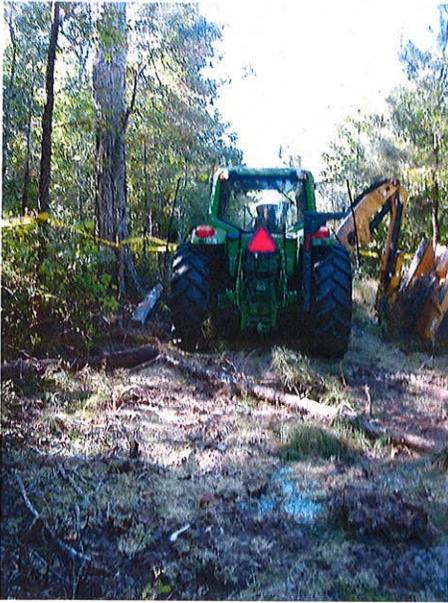
PICTURE: 1-9

DEPICTING: Tractor Damage

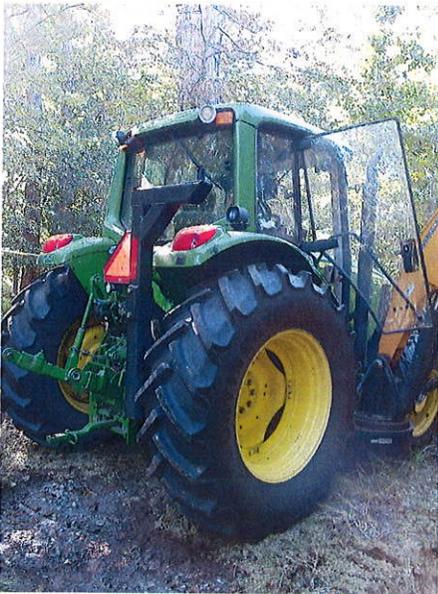
PICTURE: 1-10

DEPICTING: Tractor Damage

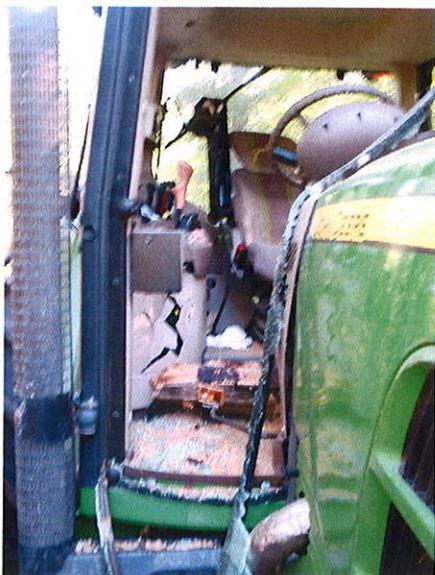
PICTURE: 1-13

DEPICTING: Tractor Damage

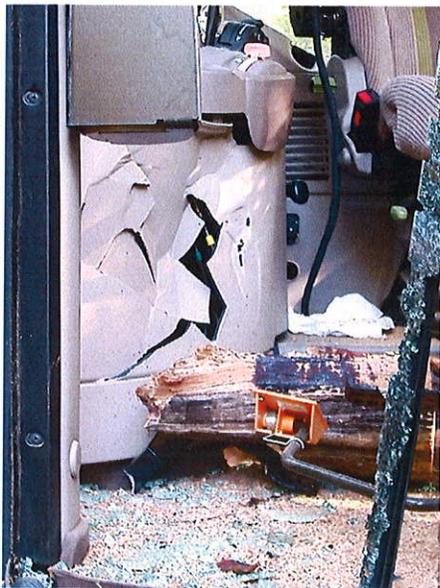
PICTURE: 1-14

DEPICTING: Tractor Damage

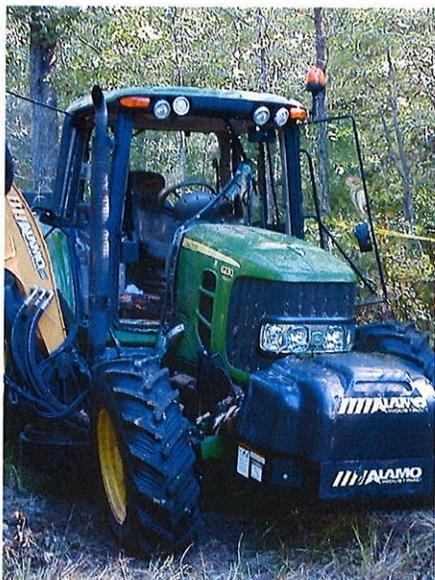
PICTURE: 1-17

DEPICTING: Tractor Damage

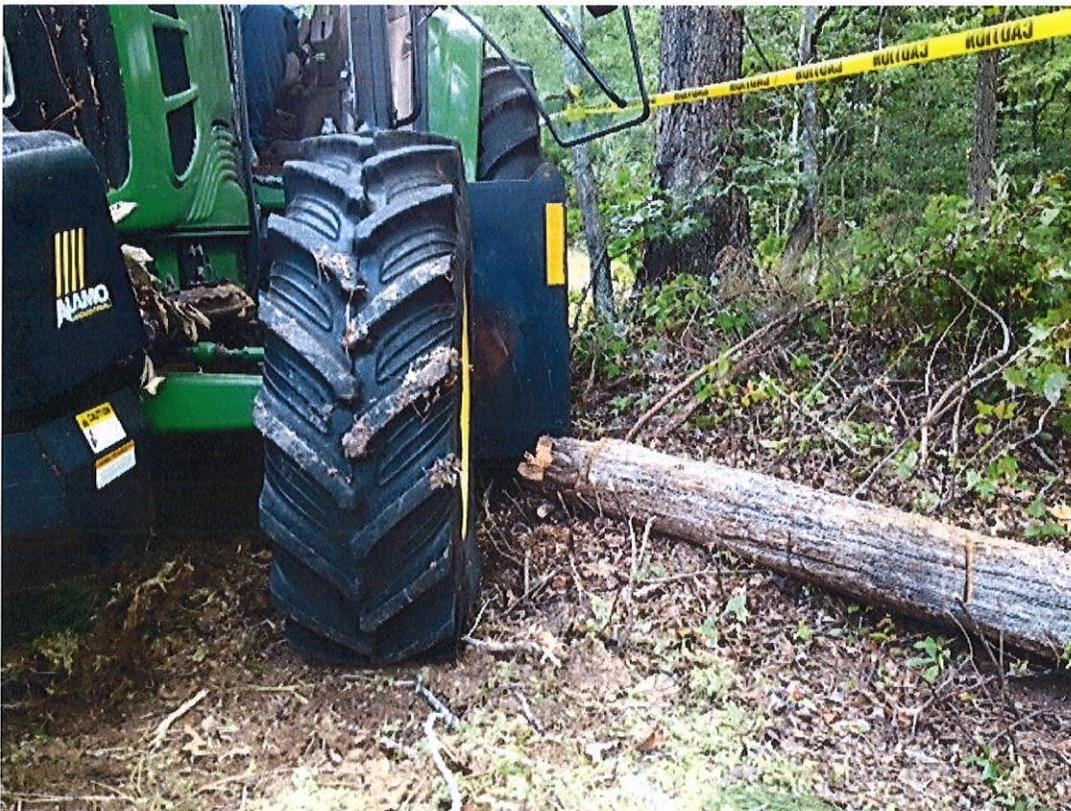
Figure 1. Reconstruction of log and initial point of contact with the tractor.

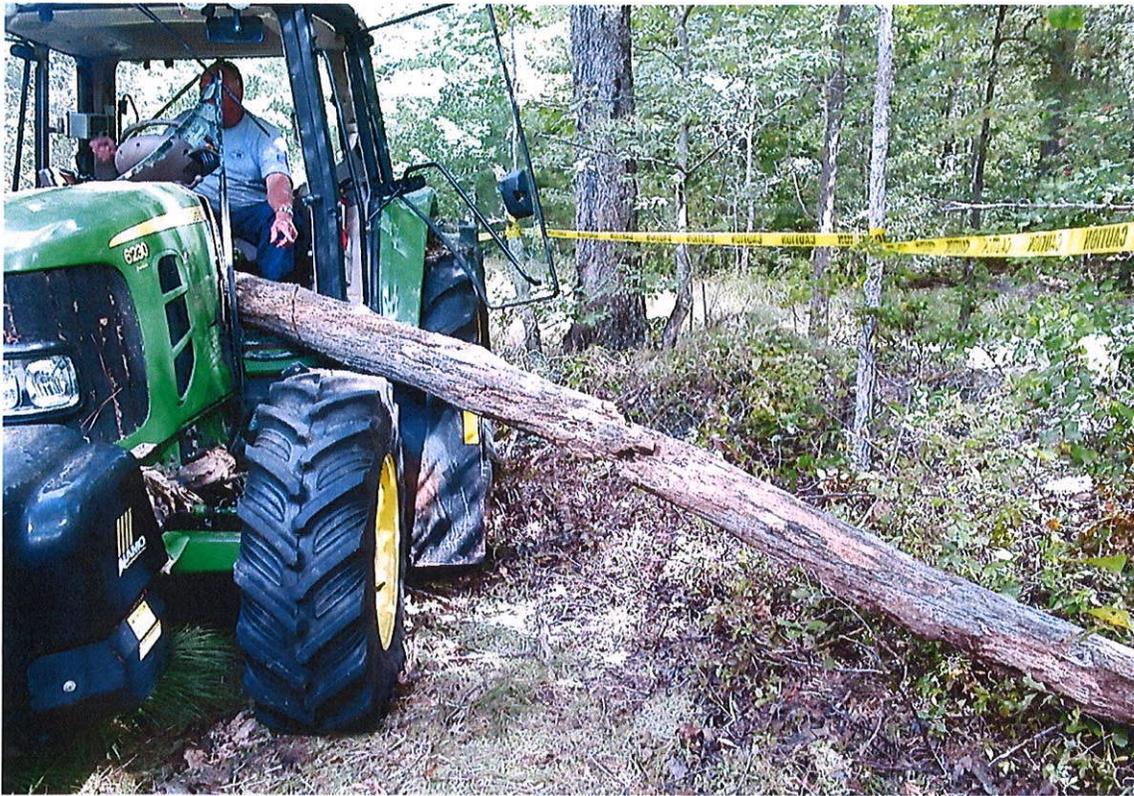
Figure 2. Reconstruction of log entering tractor.

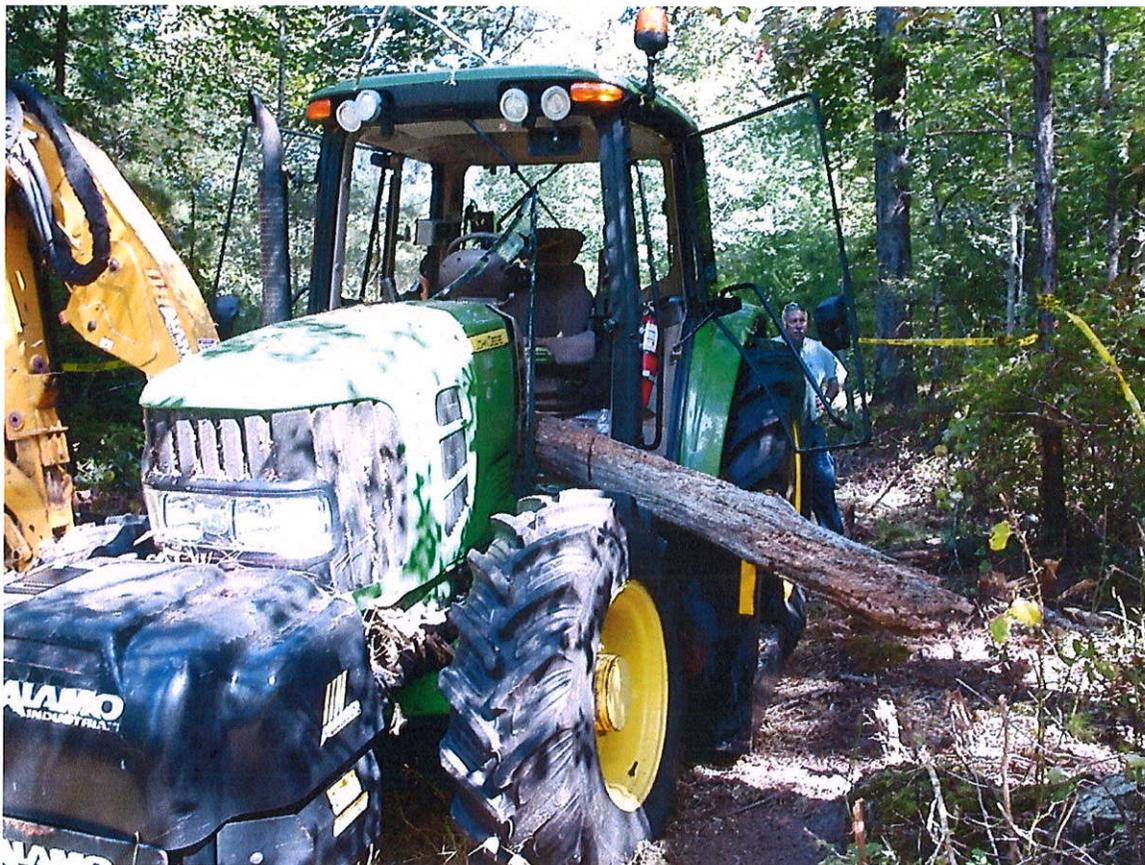
Figure 3. Reconstruction of log inside tractor at final point of forward progress.
