Preliminary Summary Report of Serious CAL FIRE Injuries, Illnesses, Accidents and Near-Miss Incidents

Vehicle Accident

July 23, 2014

Bully Incident

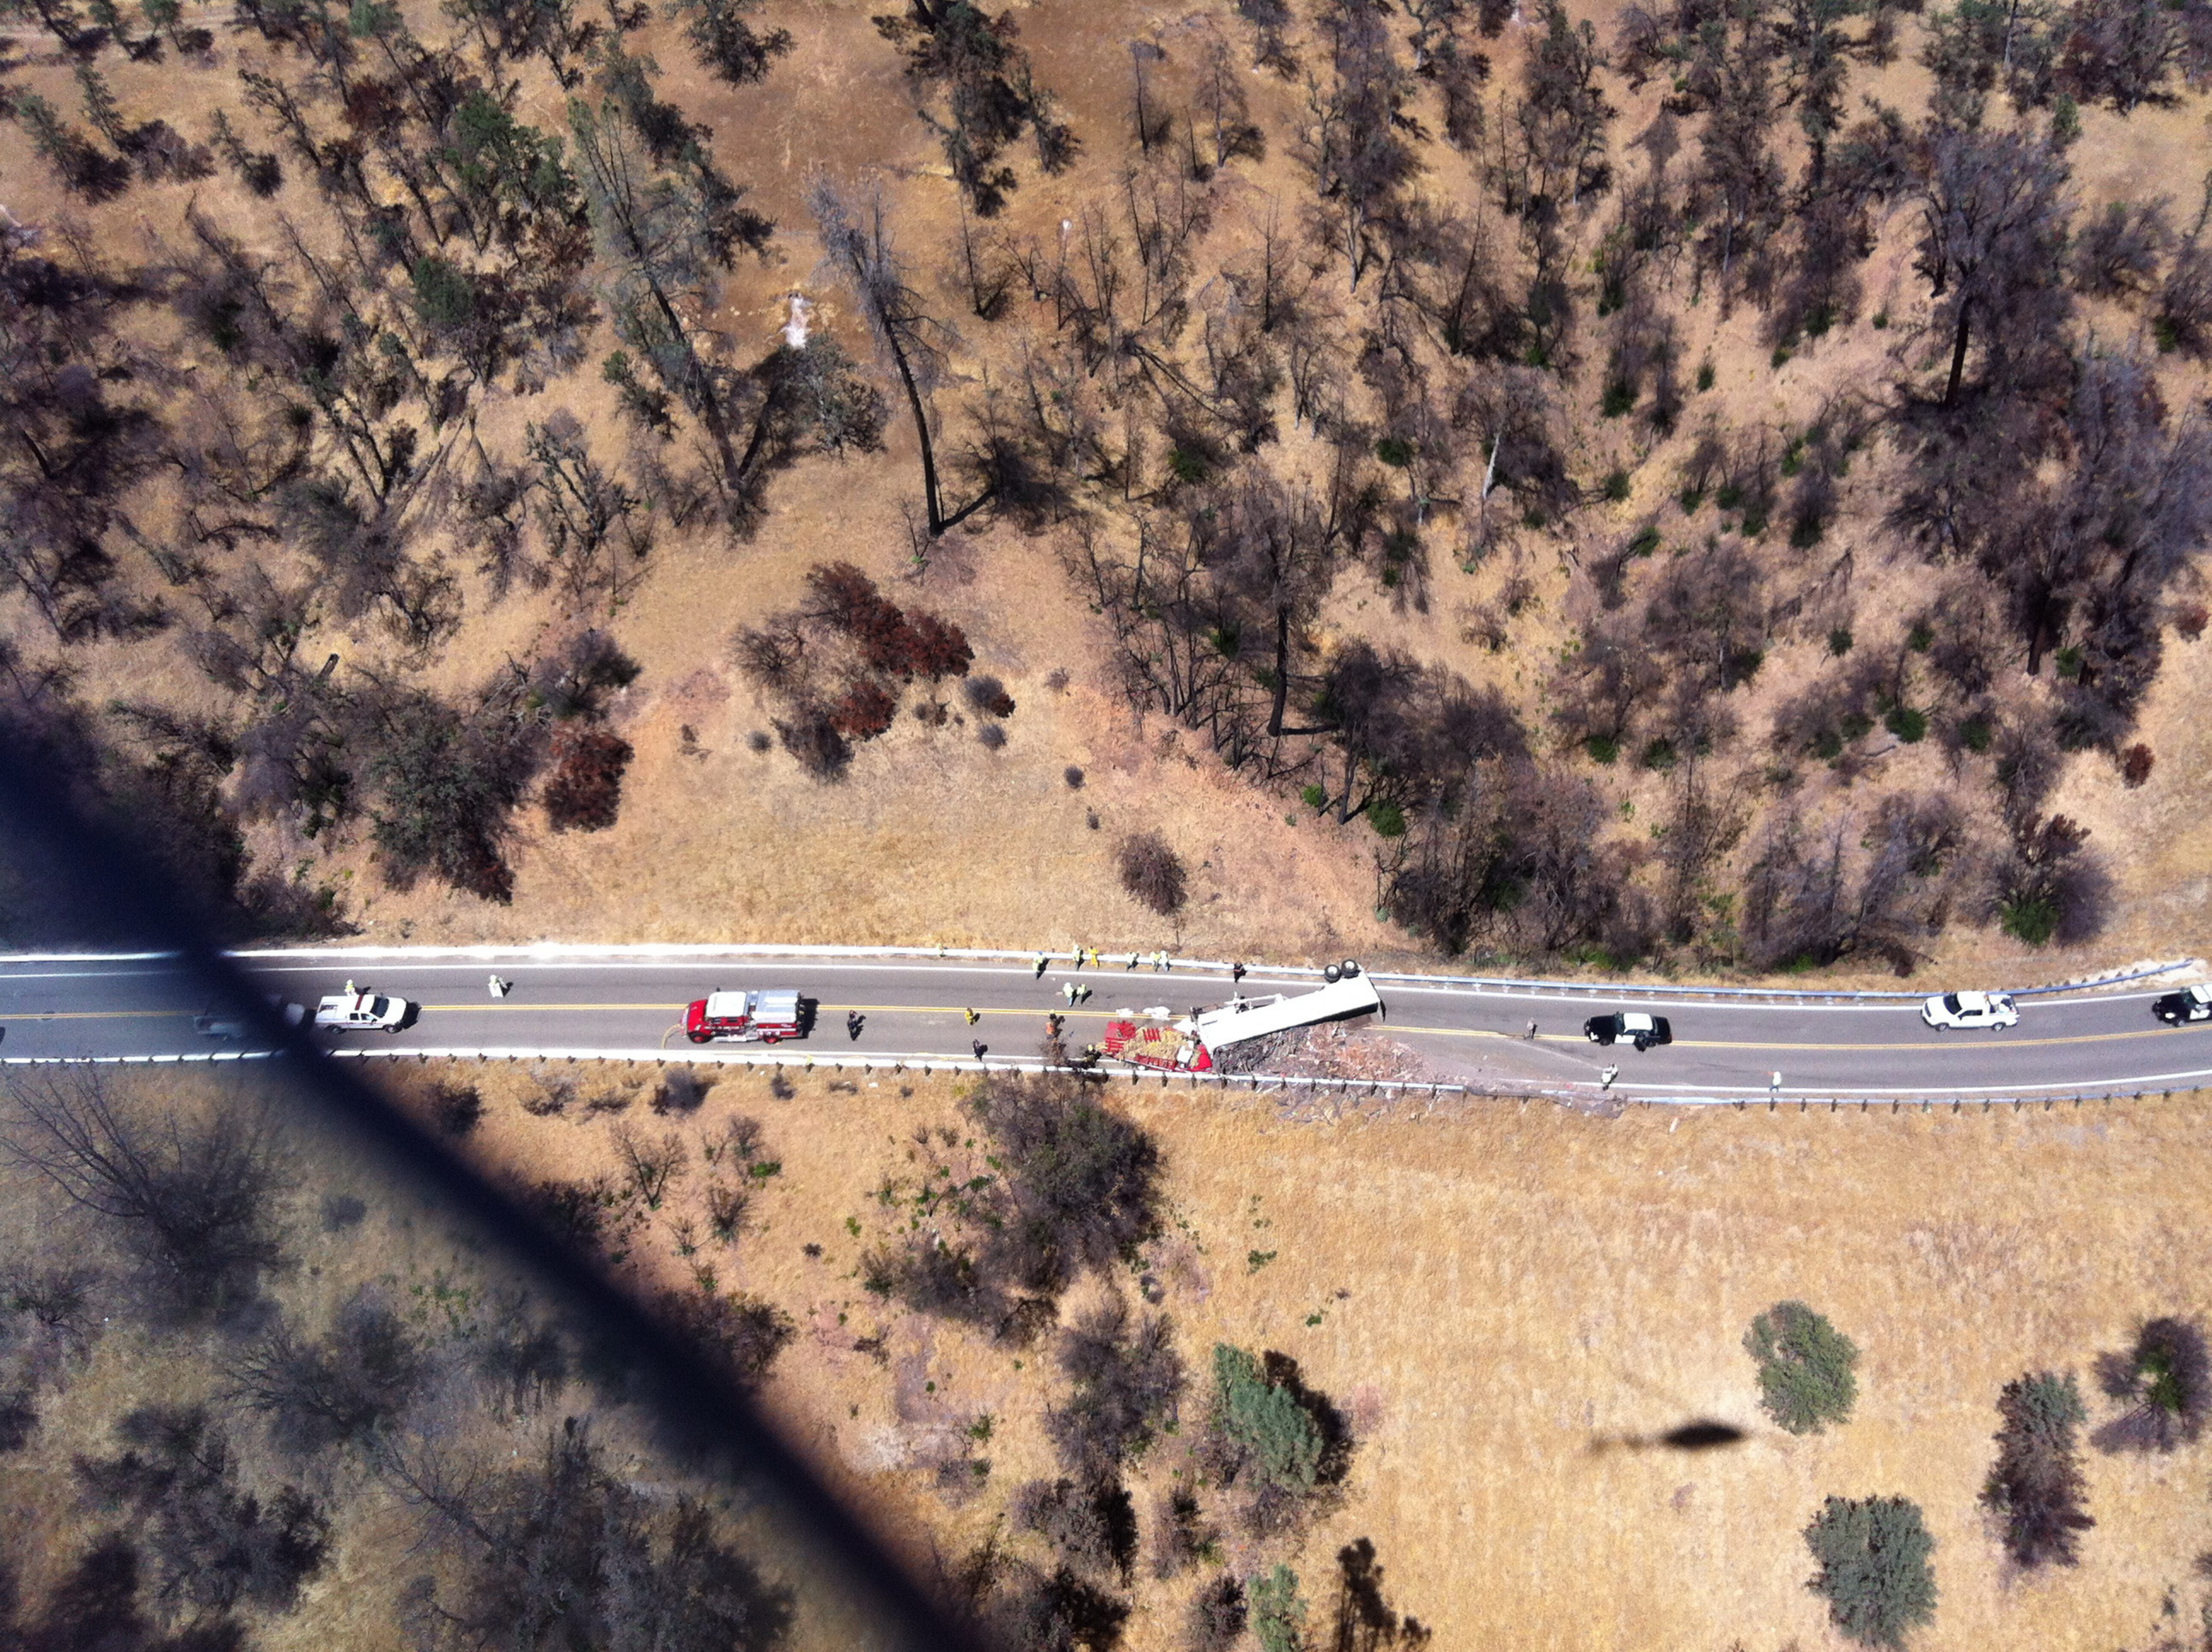
U2438

The following is a Preliminary Summary Report of a multiple vehicle accident that occurred during the Bully Incident. A CAL FIRE utility providing logistical support collided with a tractor trailer. Minor injuries occurred to two CAL FIRE firefighters. No injuries were reported by the civilian commercial vehicle operator. The CAL FIRE utility vehicle and trailer of the commercial vehicle sustained extensive damage.

- Ensure **SITUATIONAL AWARENESS** at all times.
- Drive defensively and **ALWAYS WEAR YOUR SEAT BELT**
