72 Hour Expanded Report Bowles Creek Bottom Fire

Subject: Expanded (72 Hour) Report

Date: August 21, 2011

LOCATION: 11 miles west of Henderson, Texas

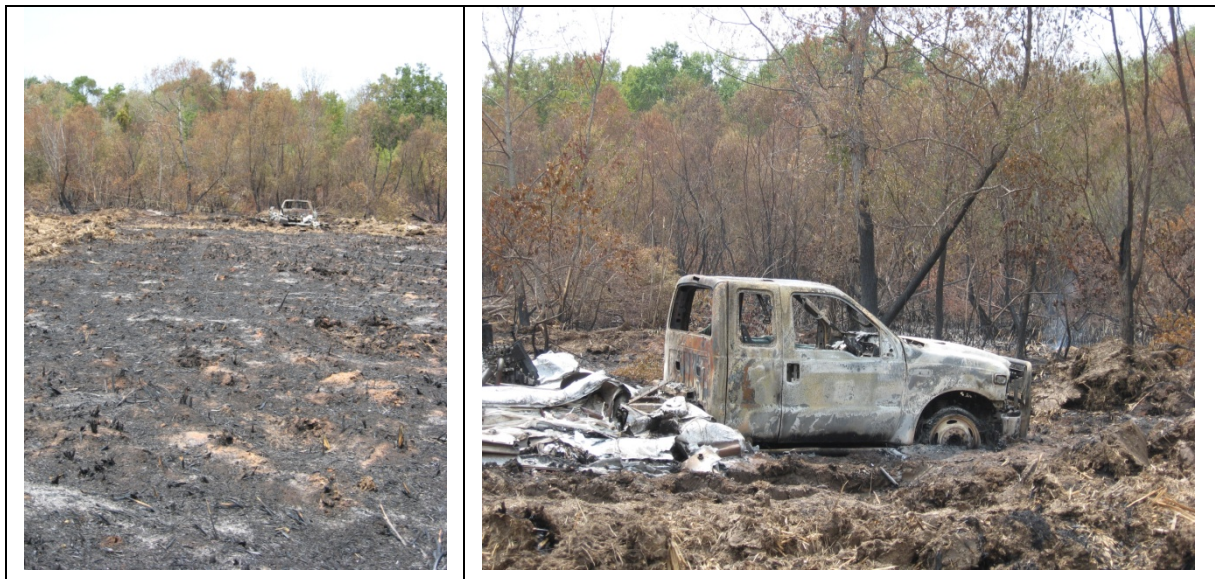
PROPERTY DAMAGE: A Type 6 Wildland Fire Engine was burned to a total loss

As dozer line construction progressed, the three person engine crew was engaged in holding operations behind the dozer. As line construction efforts neared the northwestern corner of the fire, a wind shift associated with an active thunderstorm occurred over the fire area. This wind shift caused a significant increase in fire behavior, and motivated the ENGB to reposition his engine. As the engine was backed away from the fire's edge, both of the front wheels settled into the ground and the engine became stuck. The dozer worked quickly to pull the engine out, and after several unsuccessful attempts, a dozer line was built around the engine. As the dozer worked, engine crewmembers attempted to extinguish spot fires beneath the engine, and as these spot fires grew, the pump quit running. After a number of tries to restart the pump, each with no luck, the engine's fire extinguisher was deployed to contain fire burning under the engine's chassis with only

minimal success. At this point, with all engine protection options exhausted, the ENGB elected to depart the area due to extremely heavy smoke, building radiant heat, and increasing spot fire activity in the area surrounding the engine. The engine crew walked a short distance down their escape route to a predetermined safety zone. No crewmembers were injured. The Type 6 Engine burned to a total loss.
