# **Bowles Creek Bottom Fire**

## **Lessons Learned Review**

**Texas Forest Service**  
**August 18, 2011**

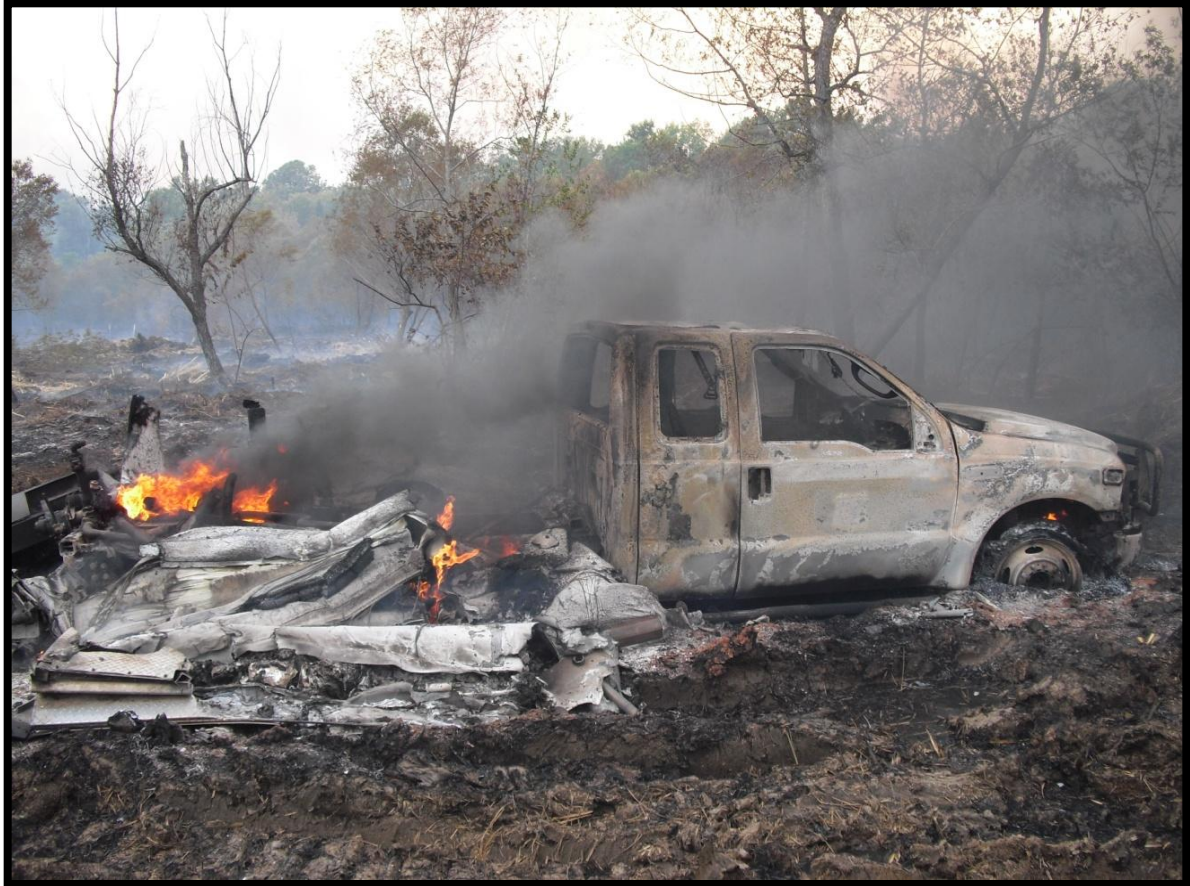
After initially chasing spots with the tractor plow and the hard line from the engine, the Engine Boss decided to reposition his engine away from the increased fire activity. As the Engine Boss began to back the engine out, the front end sank and the engine immediately became stuck.

The tractor plow worked quickly to pull the engine out, and after several unsuccessful attempts, a plow line was built around the engine. As the tractor plow worked, engine crewmembers attempted to extinguish spot fires beneath the engine, and as these spot fires grew, the pump quit running. After a number of tries to restart the pump, each with no success, the engine's fire extinguisher was used to contain fire burning under the engine's chassis with only minimal success.

At this point, with all engine protection options exhausted, the Engine Boss elected to depart the area due to extremely heavy smoke, building radiant heat, and increasing spot fire activity in the area surrounding the engine. The engine crew walked a short distance down their escape route to a predetermined safety zone. No crewmembers were injured. The Type 6 Engine was burned and destroyed.

*The Type 6 Engine after it caught fire and burned. The soil surrounding the engine was disturbed by the tractor plow as part of the engine protection measures. Note the front wheel settling into underlying soil.*

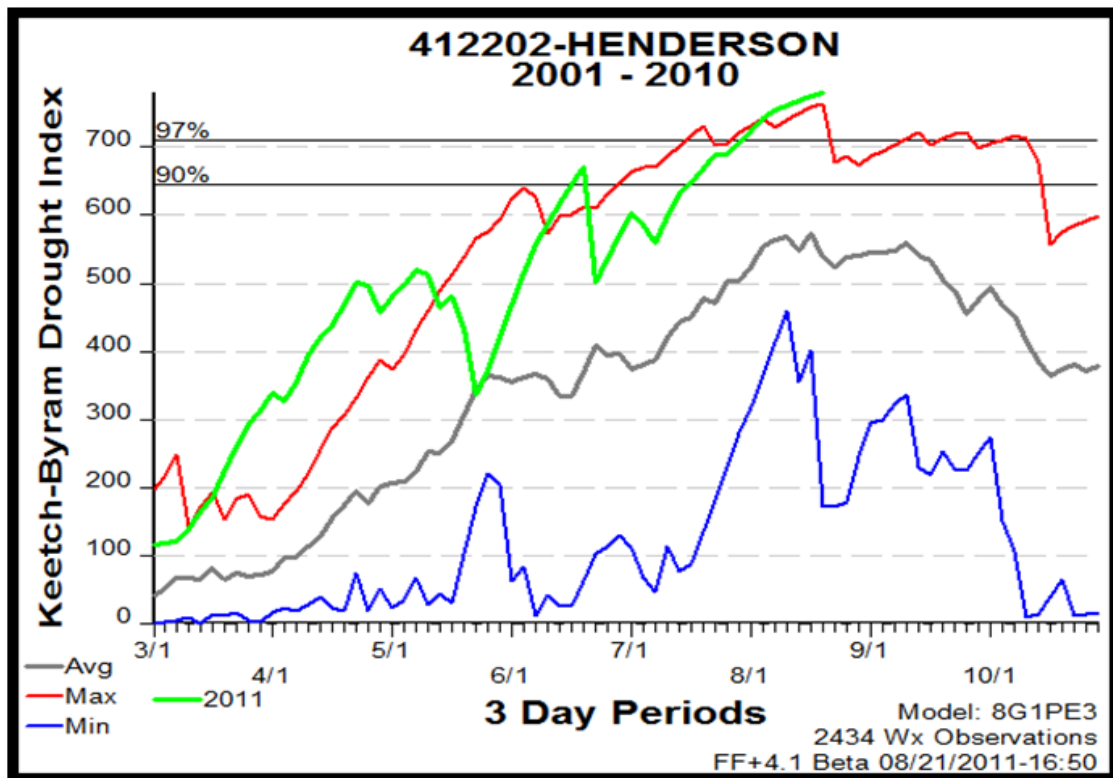
*The Keetch-Byram Drought Index (KBDI) from **March –August 2011** from the Henderson RAWS.*

By early August, KBDI readings were establishing new records on a daily basis. (Indices were taken from Henderson Remote Automated Weather Station (RAWS) located approximately 10 air miles east northeast of the fire area, which has data from 2001 to present (2011)).

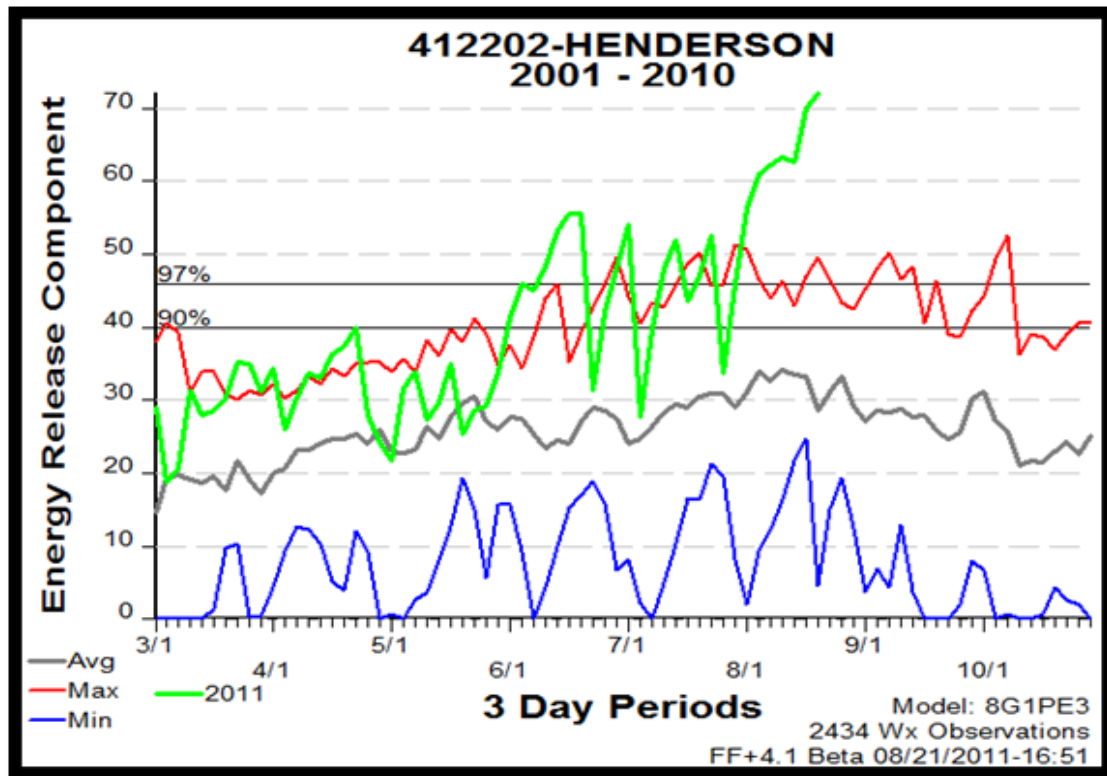
Energy Release Component (ERC) is the National Fire Danger Rating System (NFDRS) index used to track the combined effects of fuel dryness on fire potential. ERC Model G was also setting new historic highs and was well above the 97th percentile for the nine years of data.

*The Energy Release Component (ERC) from **March –August 2011** from the Henderson RAWS.*

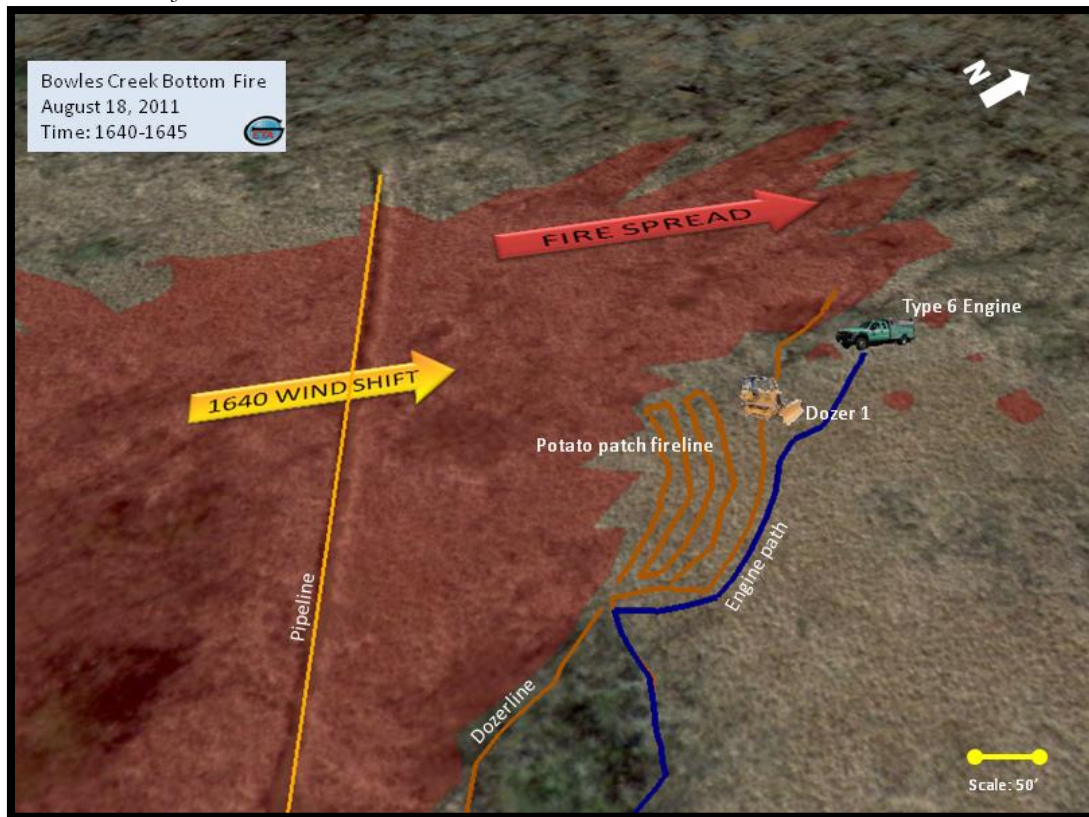
*The Bowles Creek Bottom Fire at approximately 1640, when the significant wind shift occurs.*

- The Engine Boss attempts to back up engine to reposition away from increased heat and spot fire activity. The Engine's front wheels quickly sink, and the engine becomes stuck.
- At the direction of the Engine Boss, one of the engine crewmember retrieves the tow chain to pull the engine out. The second crewmember and the Engine Boss work to suppress spot fires around the engine.
- The Engine Boss reports that the smoke is thick enough to "put me to my knees" as he works to contain spots around the engine. As he finds fresh air, he realizes he needs to step back from suppression activities and serve as a lookout for his crew and his stuck engine.
- The swamper from the tractor plow notices the engine is stuck, and directs the tractor plow to move into a position to pull the engine out.
