BRUSH 18

FACILITATED LEARNING ANALYSIS

Bridger-Teton National Forest • September 2012

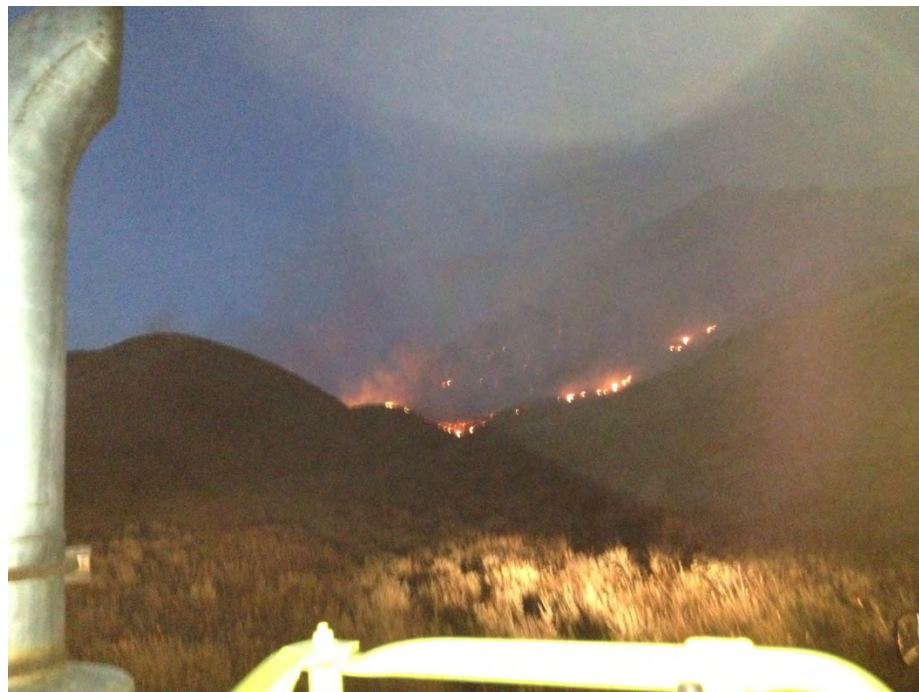
Photo 1

Photo of fire behavior taken from Brush 18 as they arrived on scene.

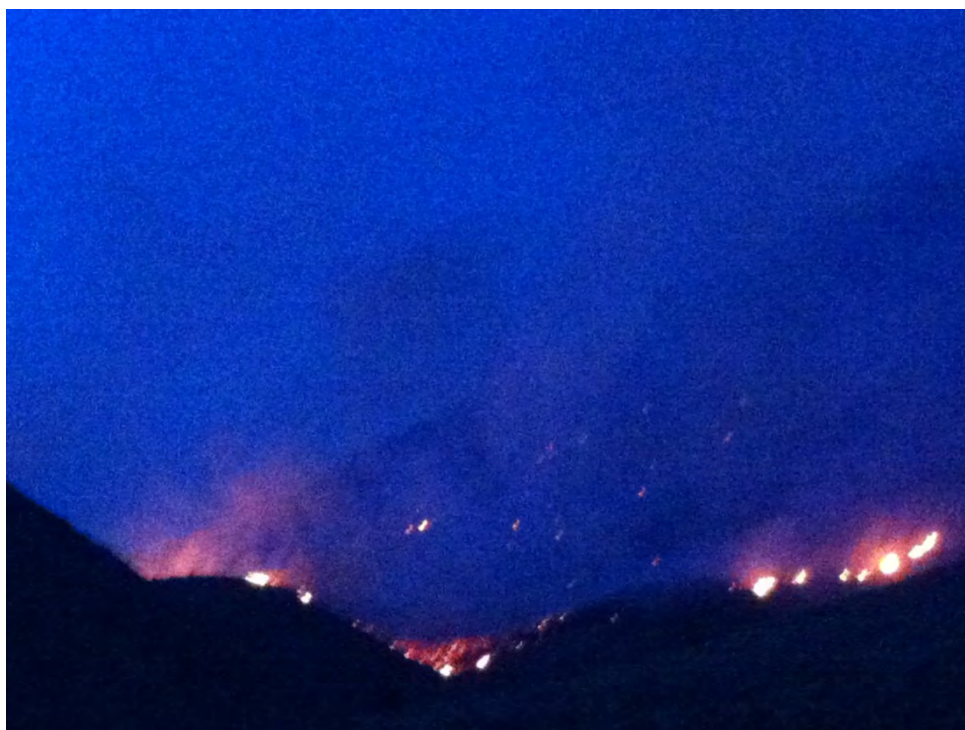
Photo 2

Photo of fire behavior taken as crew is deploying hose

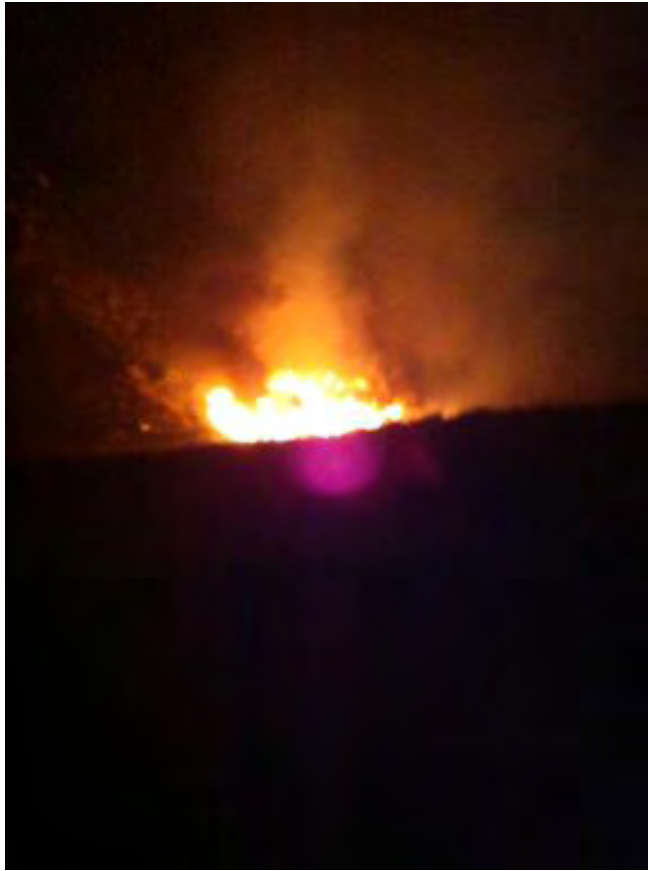
Photo 3

Photo of fire behavior taken four to five minutes after Brush 18 caught on fire

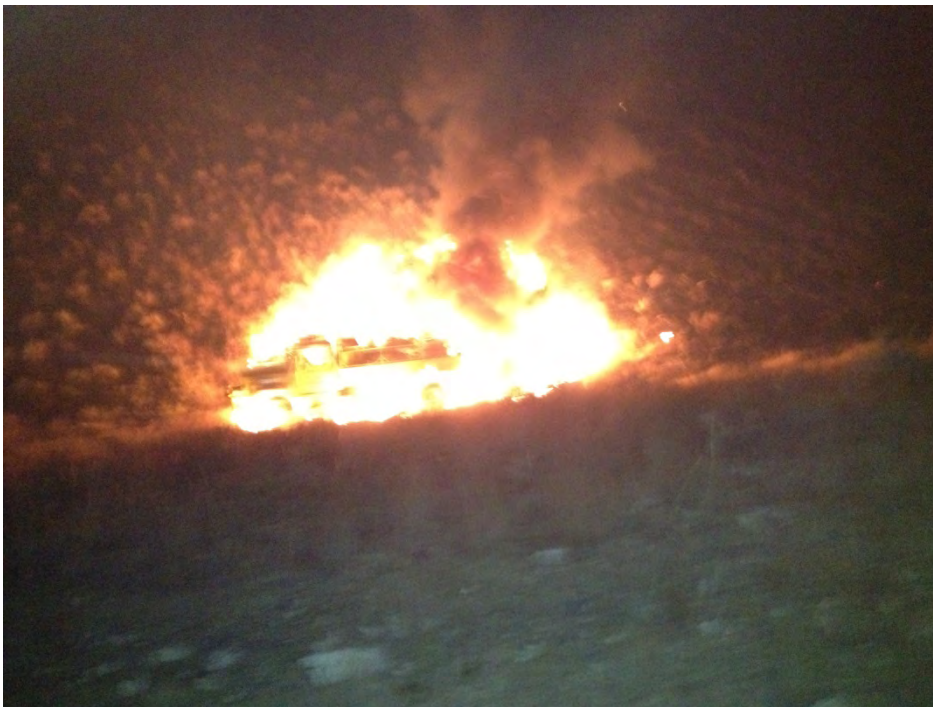
Photo 4

Photo showing that the main fire never touched Brush18. It was ignited by a spot fire.

It is unclear whether the fire that burned Brush 18 started in the back of the truck and then went to the ground, or whether it started on the ground first and then traveled to the truck. Post incident review of the site made it clear that the fire that consumed Brush 18 was not part of the main fire (see Photo 4). “It must have started from an ember.”

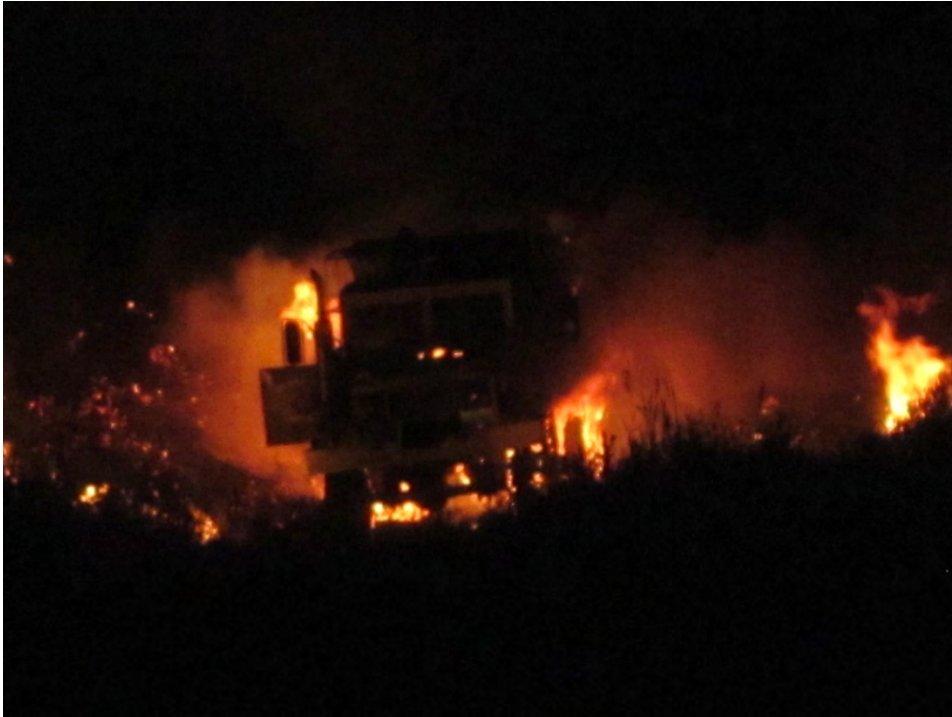
Photo 5

Photo taken by Operations, showing the ambiguity surrounding the origin of the fire.

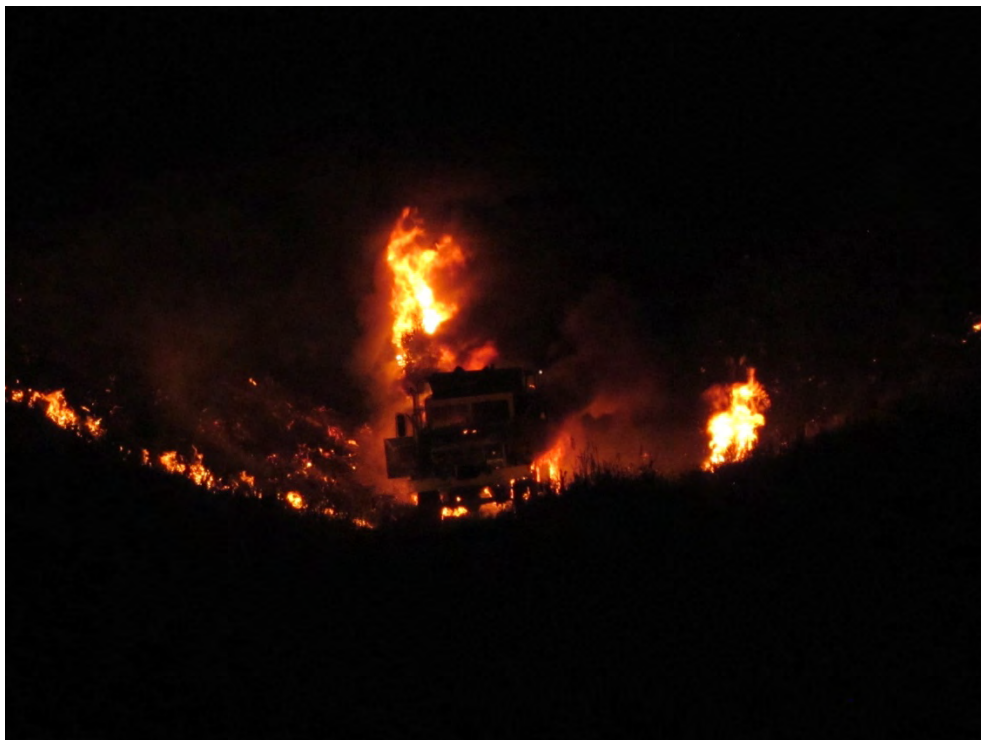
Photo 5

Second photo taken by Operations when he arrived on scene.

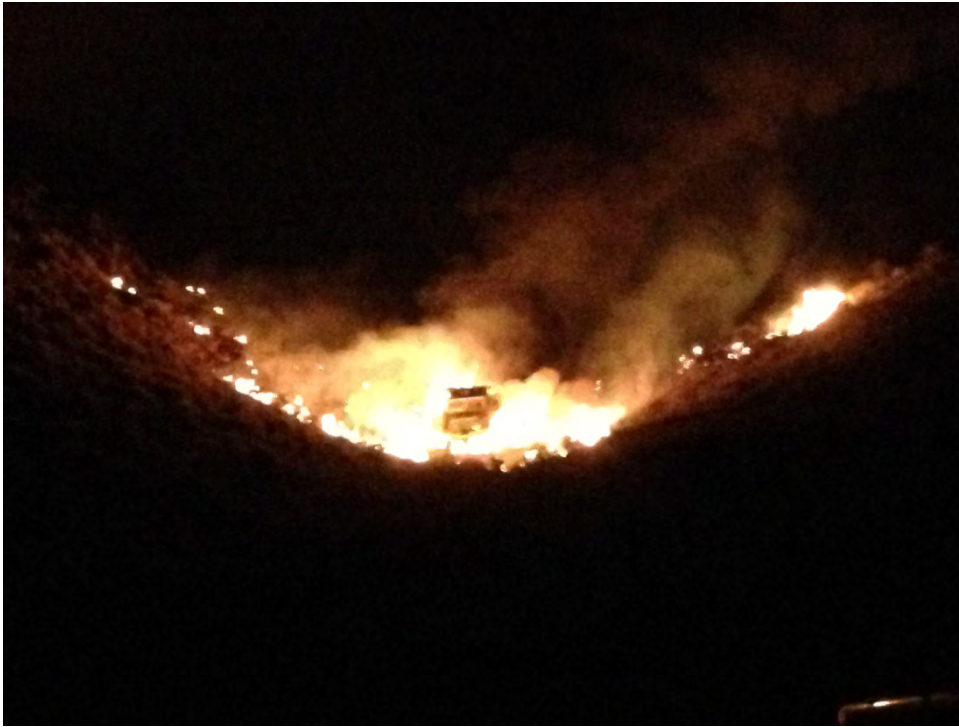
Photo 7

Photo of fire behavior rapidly burning uphill toward the main fire.

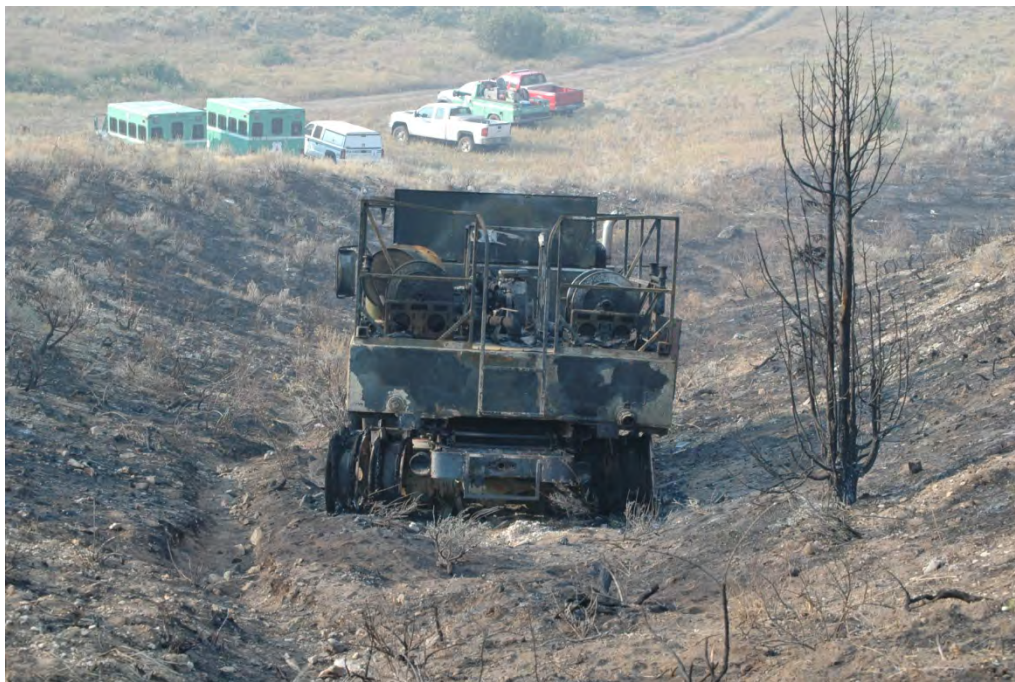
Photo 8

Photo showing distance to and condition of ingress/egress route.

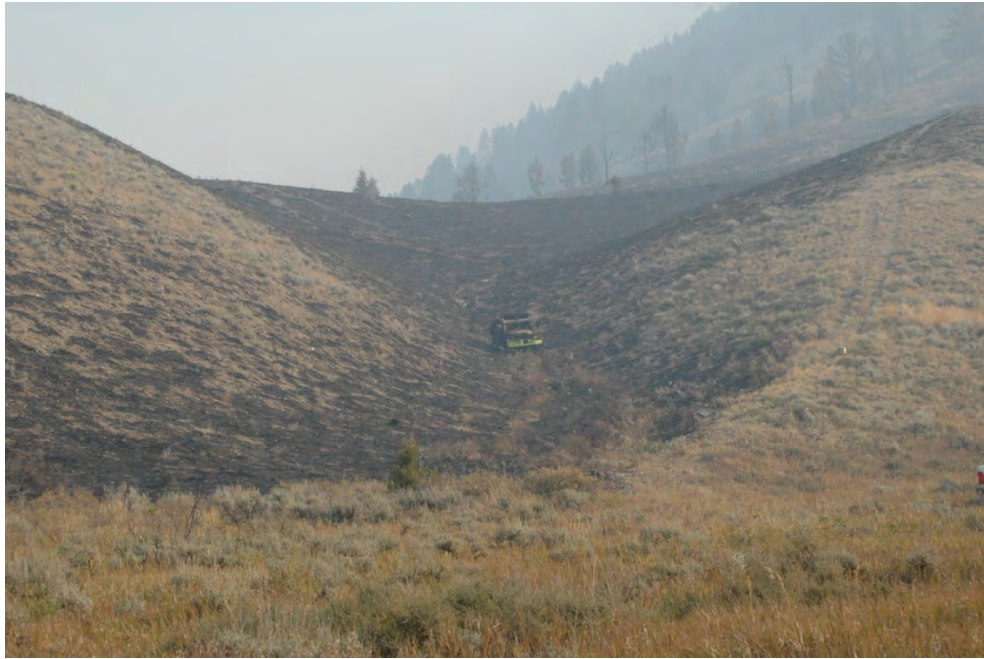
Photo 9

Photo showing how the Engine was oriented in relation to the topography.

Engine 18 was parked on a steep hill in pretty heavy grass and sagebrush. Each of the crewmembers stated that in the future they will take greater care when deciding where to place the engine when engaging in direct attack and deploying a hose lay.

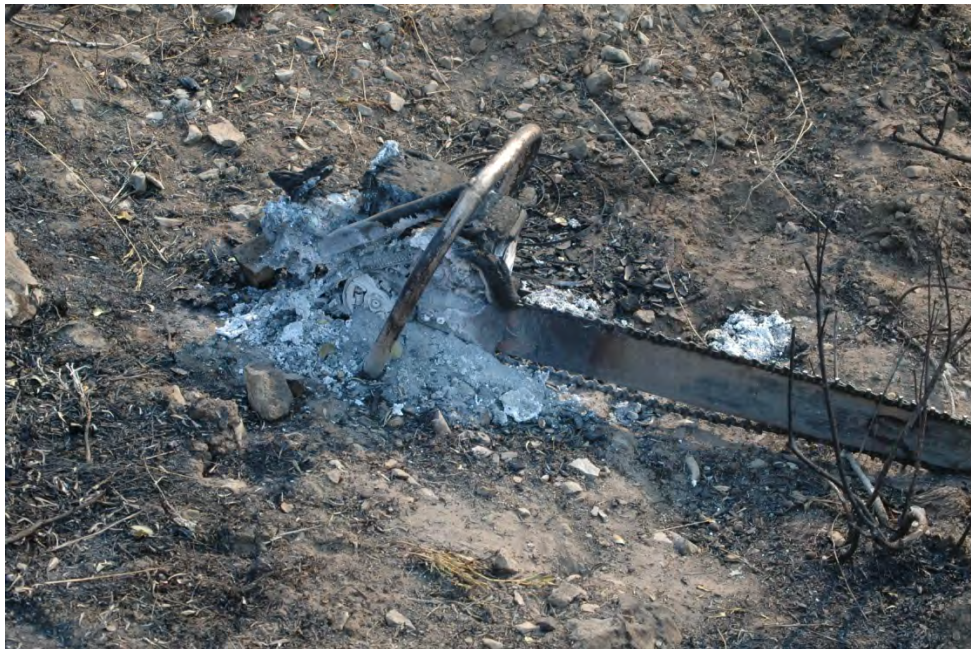
Photo 10

Photo showing what's left of the chainsaw that the crewmembers were trying to save.
