Informational Summary Report of Serious CAL FIRE Injuries, Illnesses, Accidents and Near-Miss Incidents

Shasta Trinity Unit Tree Felling Accident – Near Miss

February 4, 2011

Buckhorn

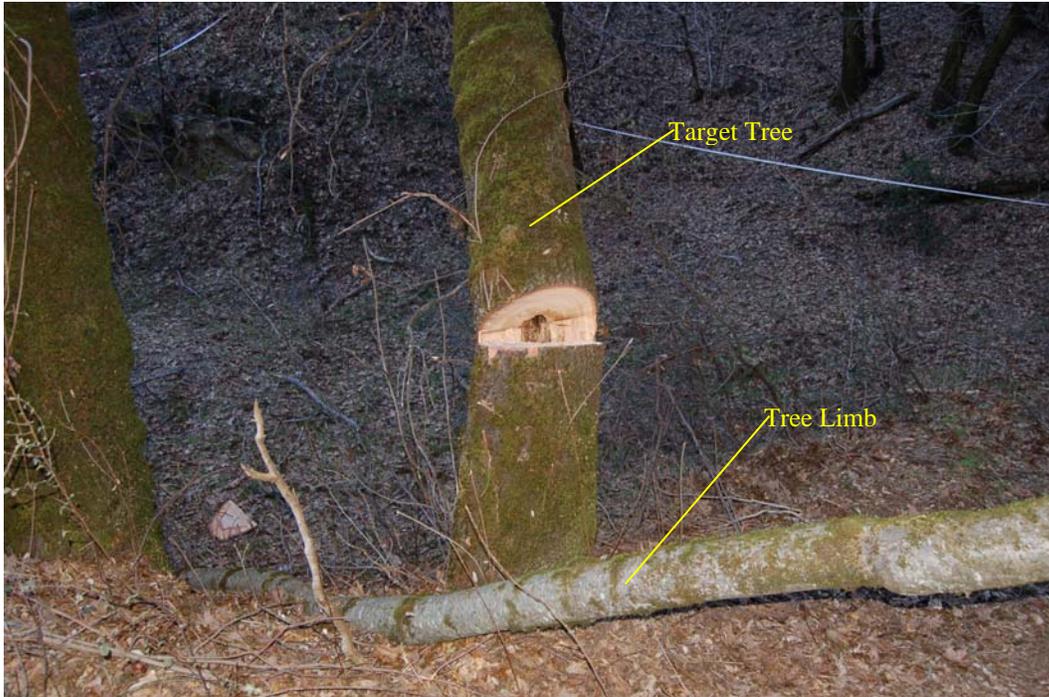
Target tree with broken limb on ground.

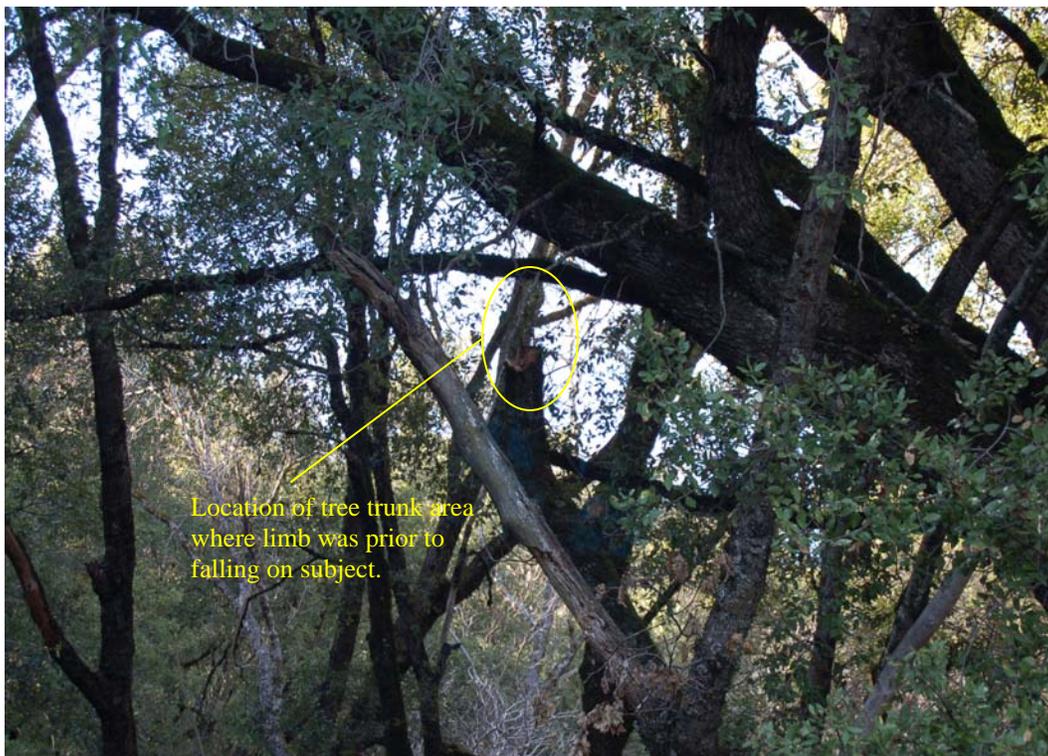
View of where branch was connected to tree trunk.

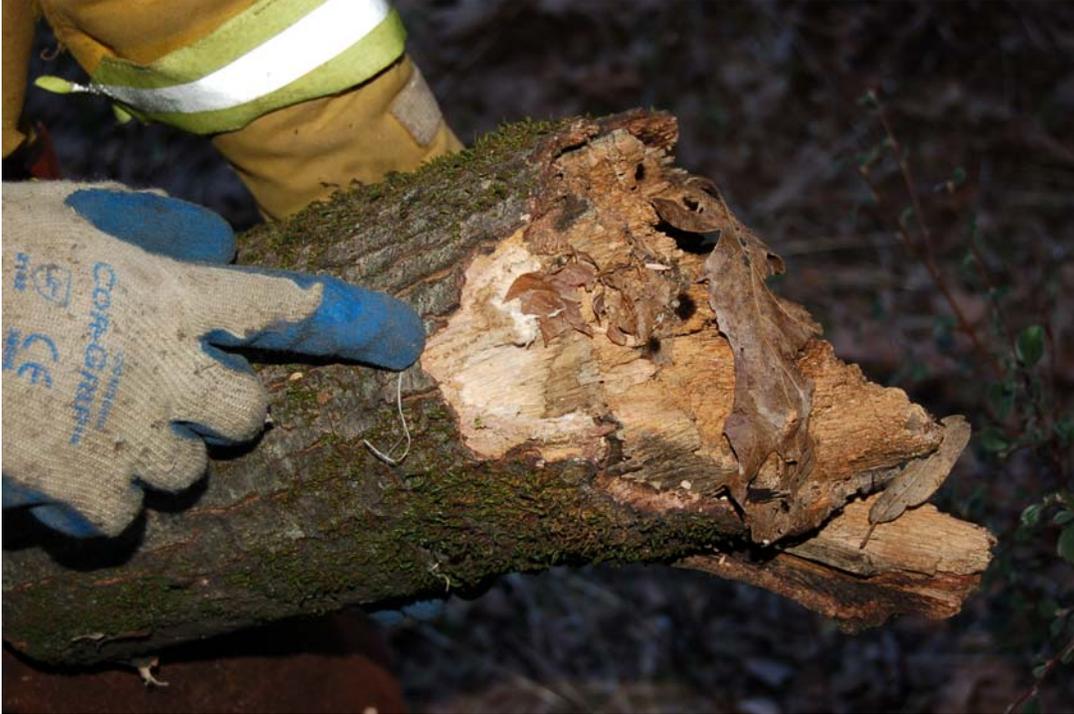
Rotted base of broken limb

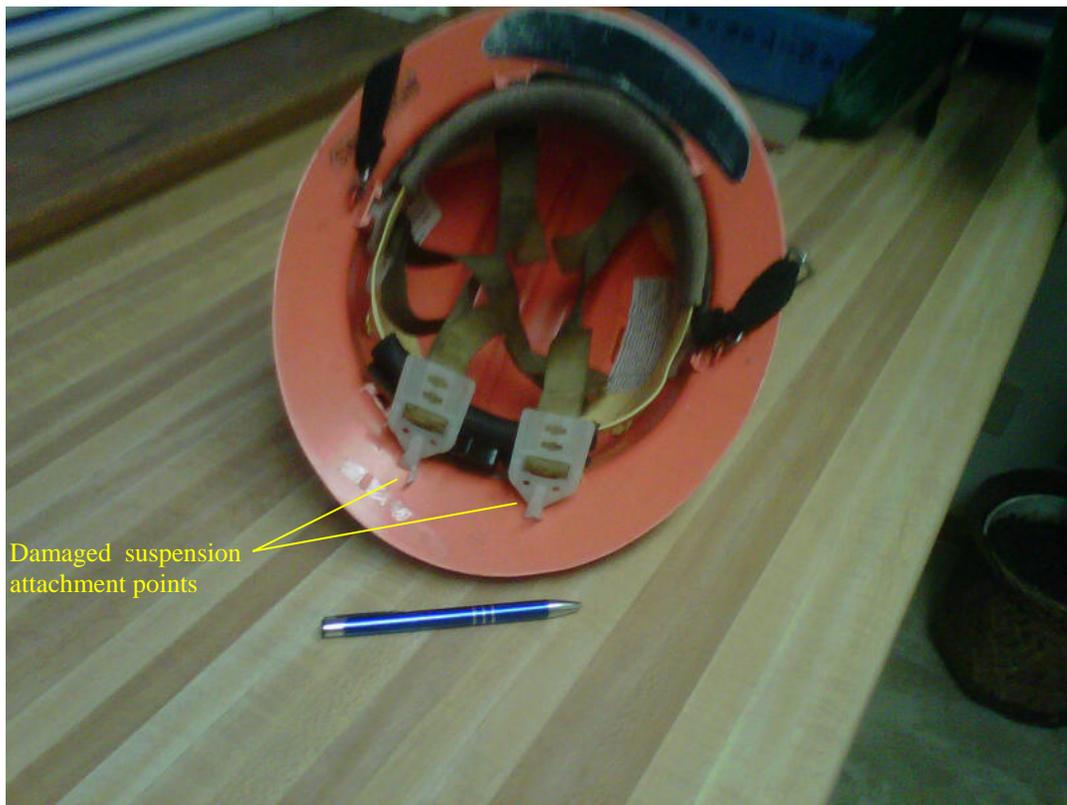
Upon inspection of the sawyer's helmet, the headband suspension was collapsed with damage to the attachment points. There were no marks or scuffs on the helmet exterior. The limb glanced off the helmet before striking the sawyer on the shoulder.

Damaged suspension attachment points

Helmet with collapsed suspension
