Rapid Lesson Sharing

Event Type: Structure Burns Beside
Secured Prescribed Fire

Date: Oct. 28, 2016

Location: Valles Caldera National Preserve;
New Mexico

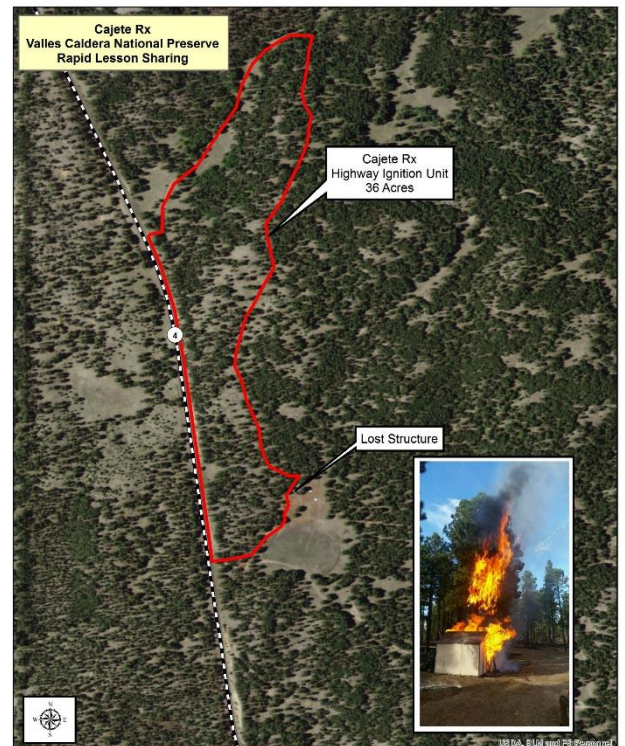
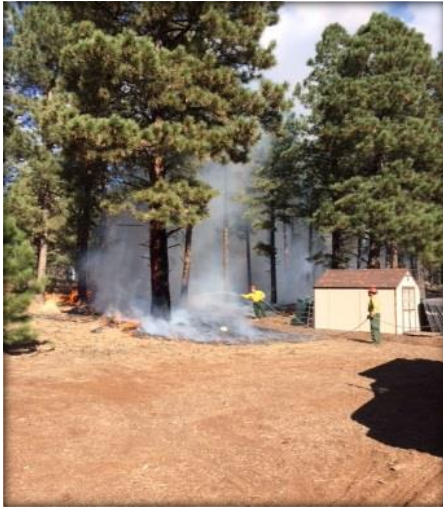
Firefighters burn out around the small shed and woodpile on Oct 24.

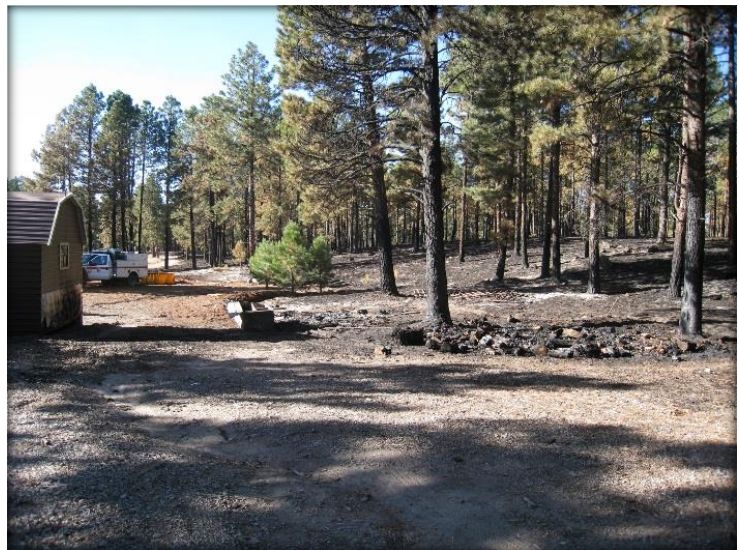
On right – where the woodpile and small shed burned. On left – the structure that the firefighters were able to save.

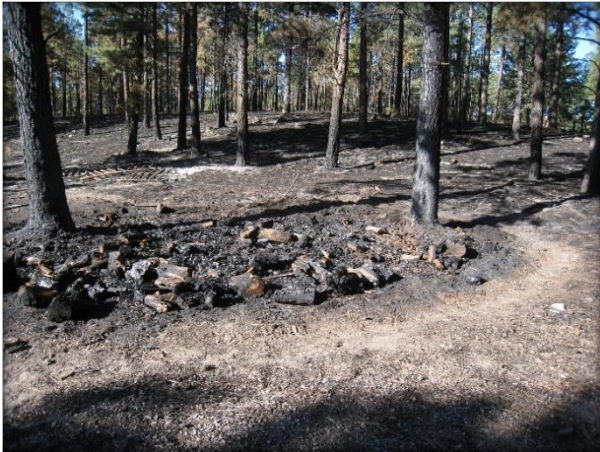
The remnants of the burned woodpile. The theory is a smoldering root may have burned under the burn unit's handline and ignited the woodpile, which was located beside a shed that also burned.

While an official fire cause could not be determined, it appears that a smoldering root may have burned under the handline and ignited the woodpile adjacent to the shed.

- ❖ Agency owned structures were not at/maintained to the defensible space guidelines recommended under the FireWise initiative.

- ✓ “Did we ever consider moving the woodpile before we burned the unit?”
- ✓ “Did we verify what was in the shed before we burned?”

- ❖ Consider developing mop-up specifications (timeframe/depth) when securing around Values at Risk.

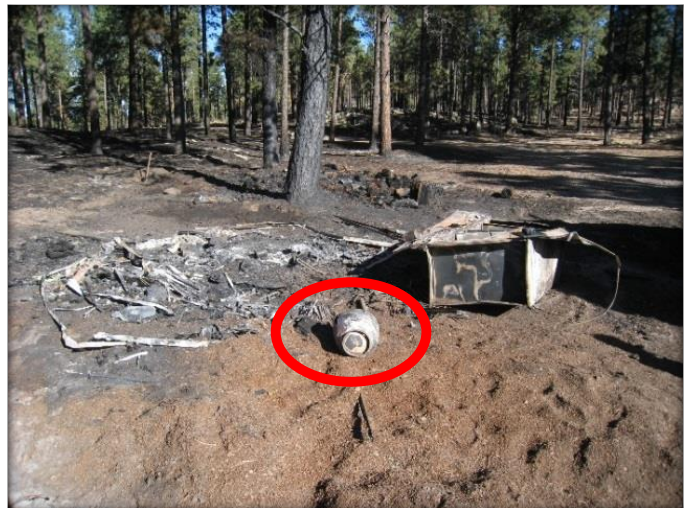
Next, a "hissing" sound was heard, followed by a loud "boom." It was later discovered that a five-gallon propane cylinder had been stored in the shed and exploded during the structure fire.

The remnants of the five-gallon propane cylinder (circled in red) that had been stored inside the shed and exploded when the shed caught fire.
