Rapid Lesson Sharing

Event Type: Smokejumper Para-Cargo Burnover **Date:** July 21, 2013

Location: Citadel Fire – Jump Spot

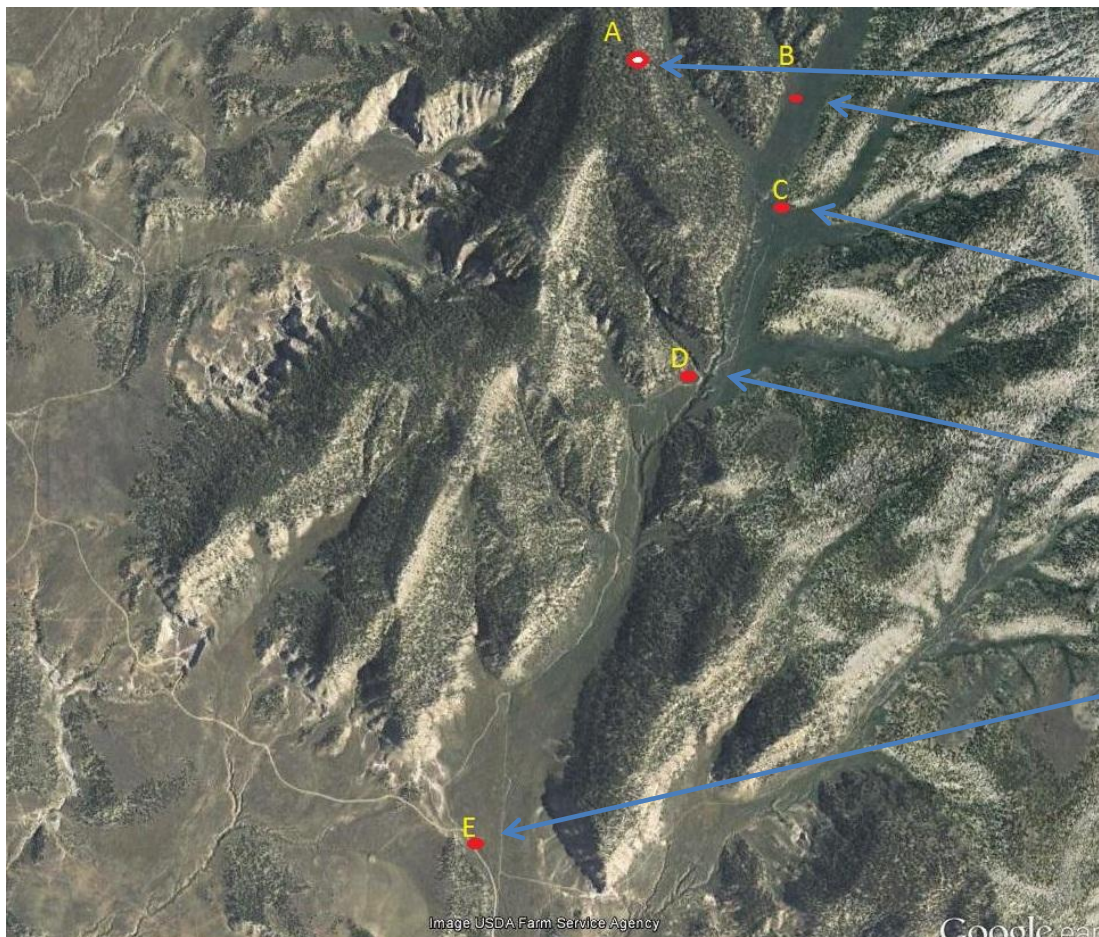
- A.
The Citadel Fire
- B.
Jump Spot/Cargo Drop
- C.
Location where jump gear was moved before going back for cargo.
- D.
Location where jump gear was moved the second time.
- E.
Main dirt road, final location of jumpers, jump gear, second resupply, Type III ICP.

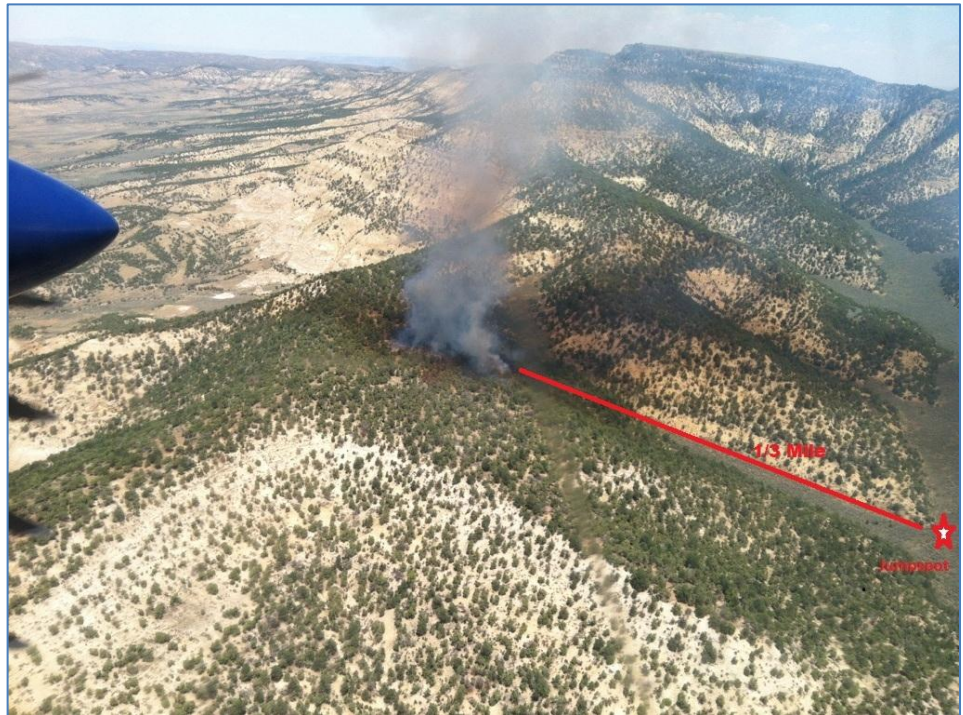
Photo 2

The fire call came at about 1230 on July 21, 2013. Flight time from Grand Junction to the fire was approximately 30 minutes. When the jump ship arrived at the fire it was about one acre, 50 percent active, with retardant around the heel. A jump spot was selected in a sage flat below the fire, approximately one third of a mile away. (See Photo 2.)

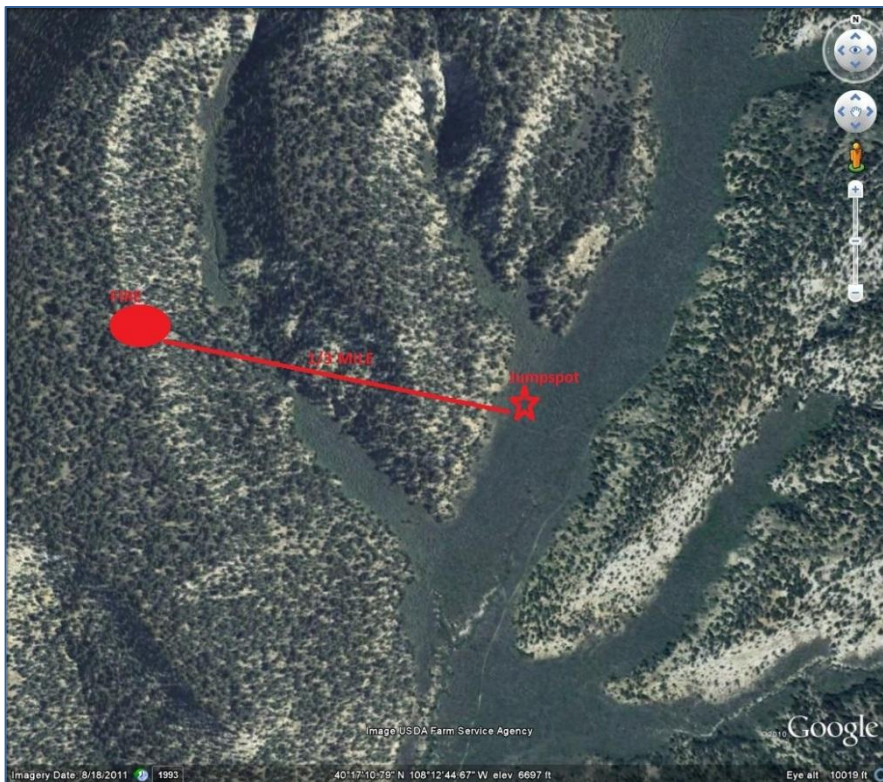
Photo 3

There was a two-track that ran down the east side of the sage flat and connected to a main dirt road about 1.3 miles to the south. (See Photo 3.)

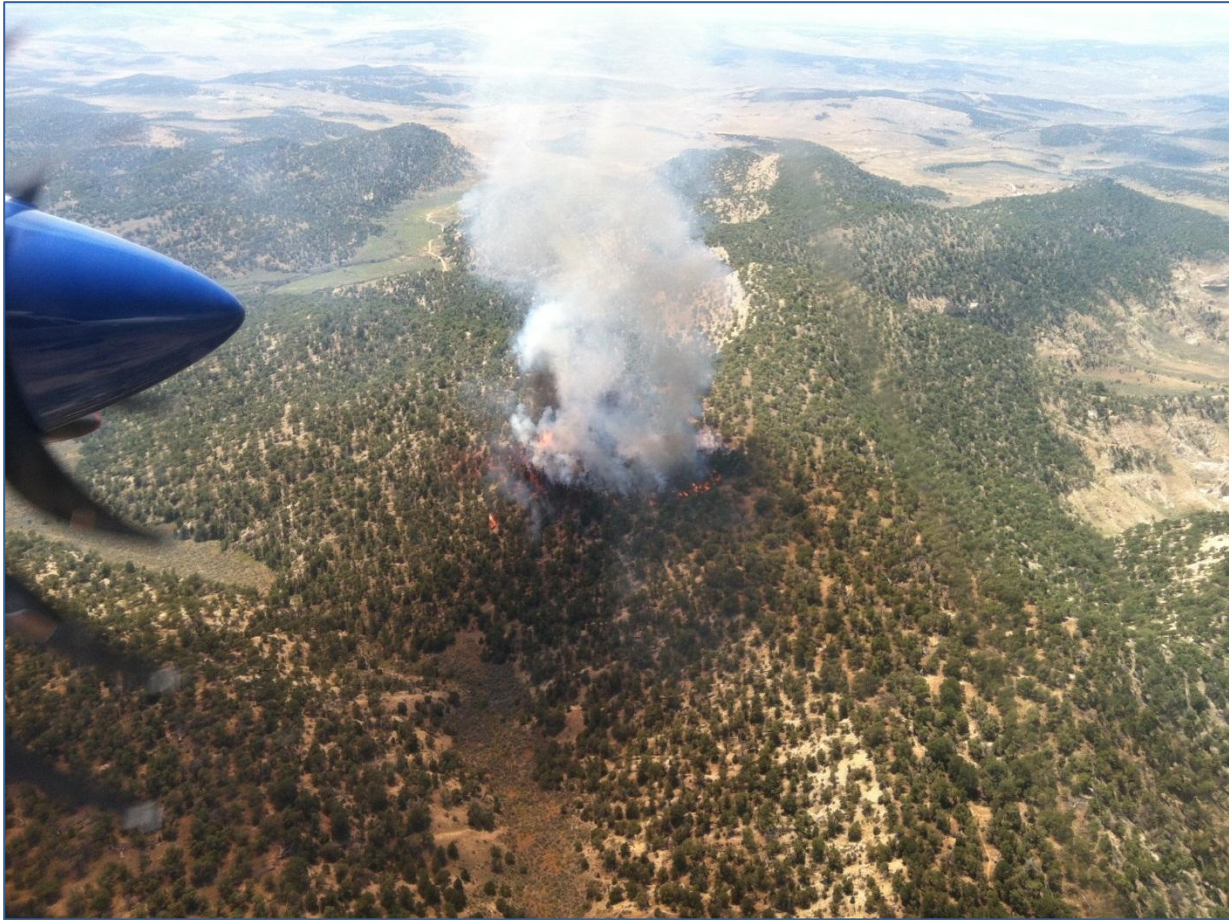
yards (approximately 3 mph wind speed) of drift up valley. For jump operations, these are very light and favorable winds. Sometime after the low pass and the start of jump ops, a spot developed about 30 yards below the main fire. (See Photo 4 on next page.)

1. Once the spot developed, the strategies for catching the fire had changed. There was an opportunity to reevaluate the jump spot at that time. Smokejumper management will ensure all smokejumpers are reminded to reassess and change plans in these kinds of situations.
