Subject: 1700 SAFETY
1716 Serious Accident Investigations
(Collins Fire - Burn Injury)
Firefighter I Craig Rogers
Region III

SERIOUS ACCIDENT

INVESTIGATION

Accident Type. Fire Line Burn Injury
Incident Name/Number "Collins Fire" BDU 21377
Accident Date. April 14, 1992
Accident Location. Region III, San Bernardino R. U.
Investigation Level Regional Review

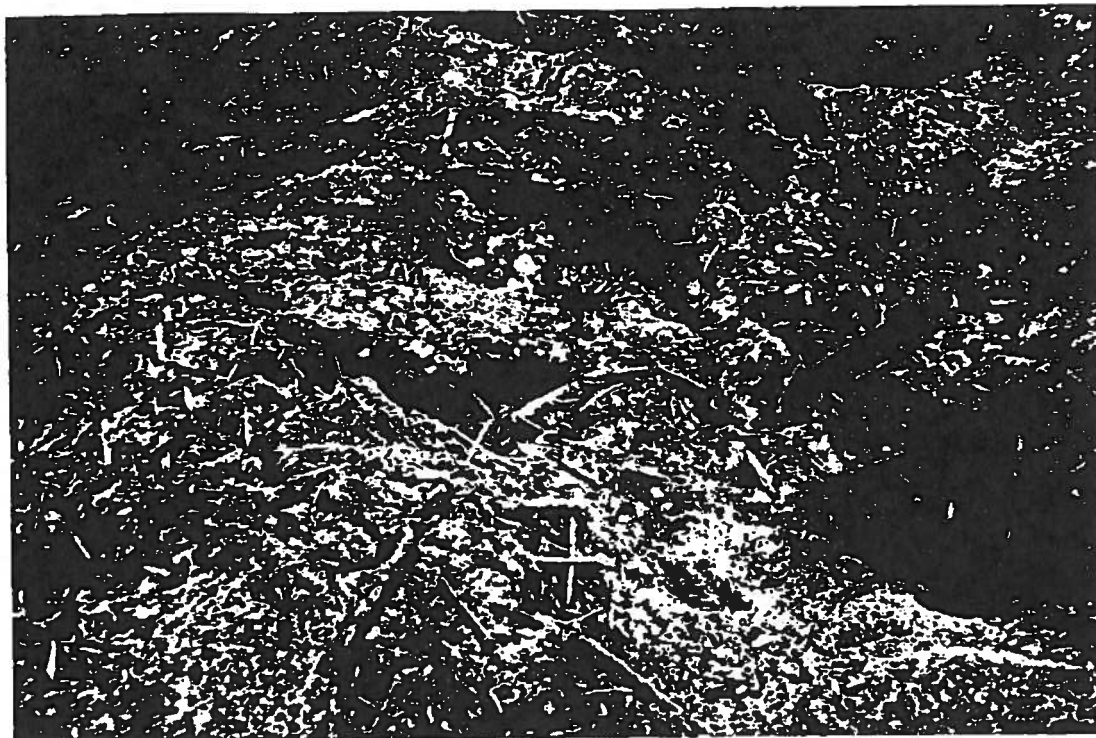
The specific mechanism whereby Firefighter Rogers received his burn injury may never be determined. It may indeed be possible that a combination of factors were involved. Nevertheless, the major cause/factor is that Firefighter Rogers simply had the misfortune to step into a hole packed with hot, smoldering material.

Photo of accident site where ground surface collapse occurred. Arrow points to area where it is believed FF I Rogers' leg sank into ground.

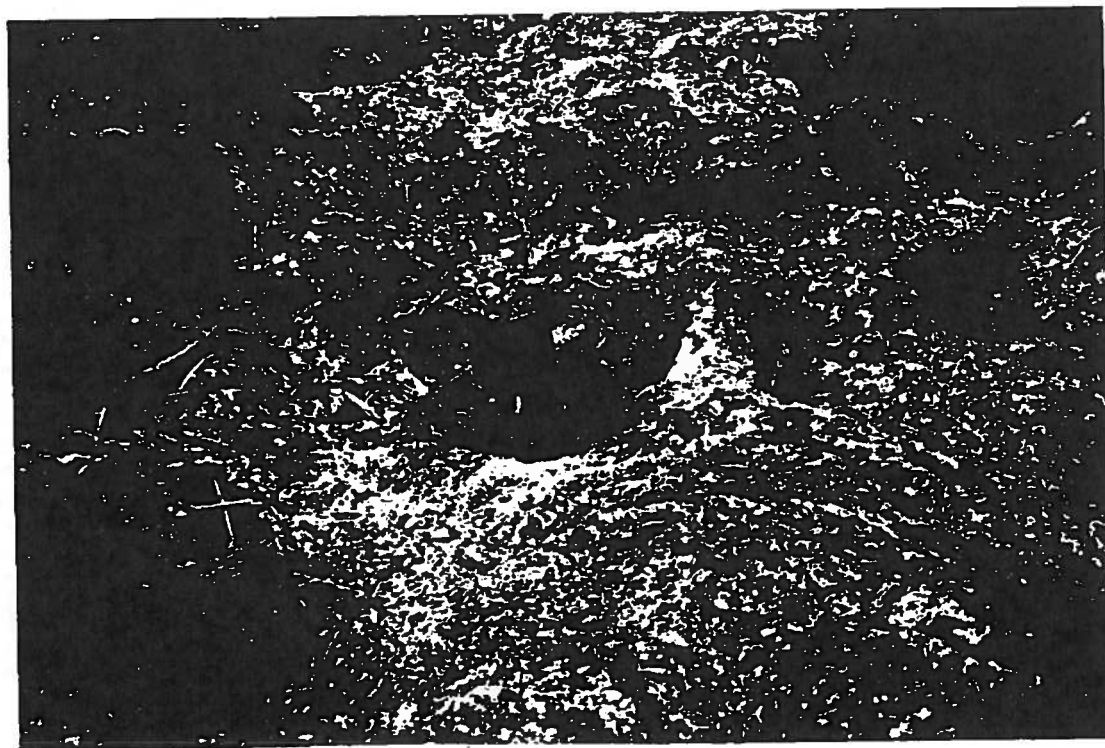
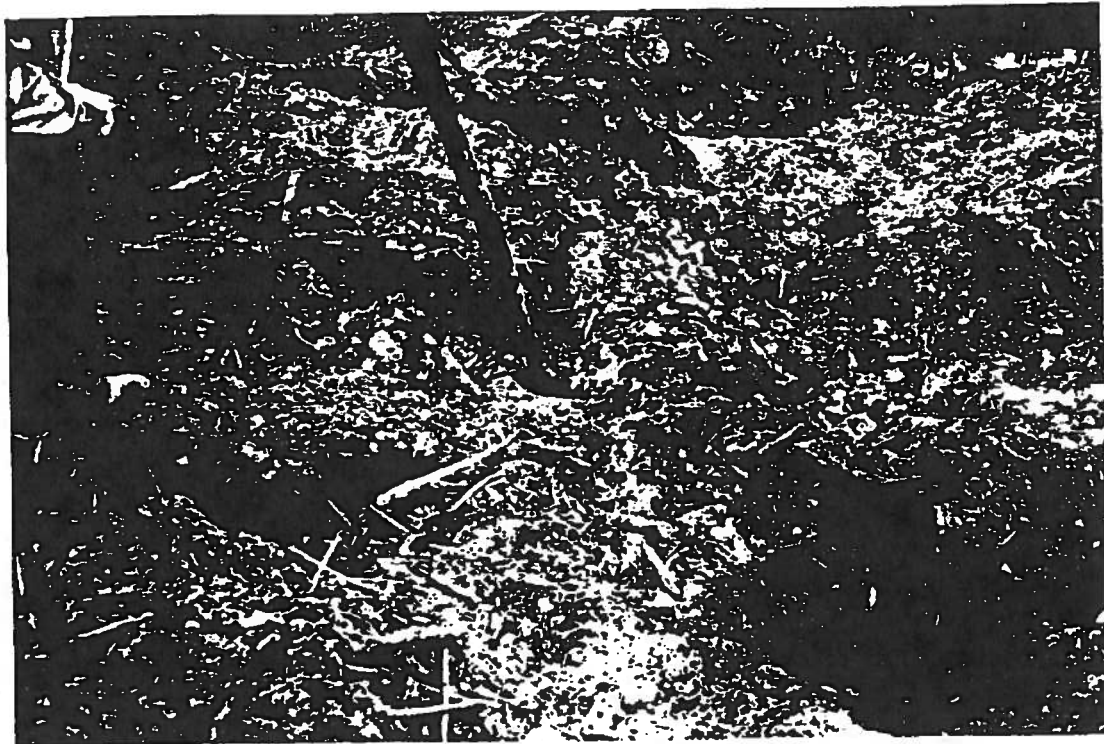
Photos of depth measurement being made
with branch. Depth was approximately
 $3\frac{1}{2}$ ' from arrow to arrow.

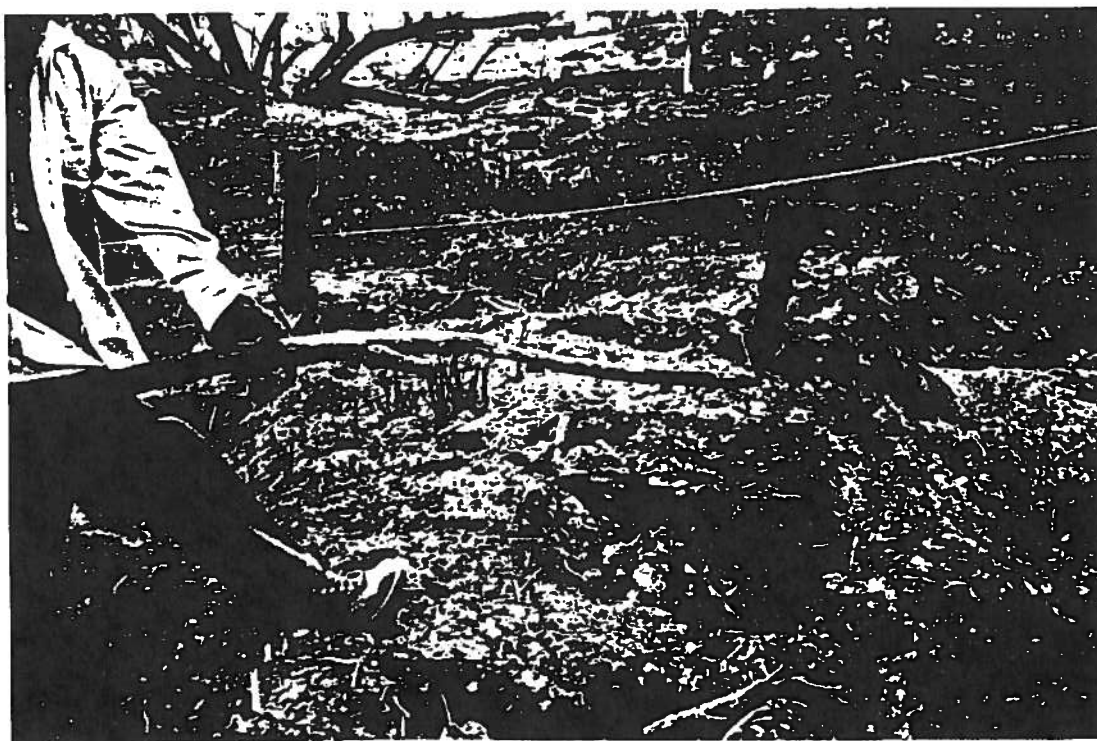
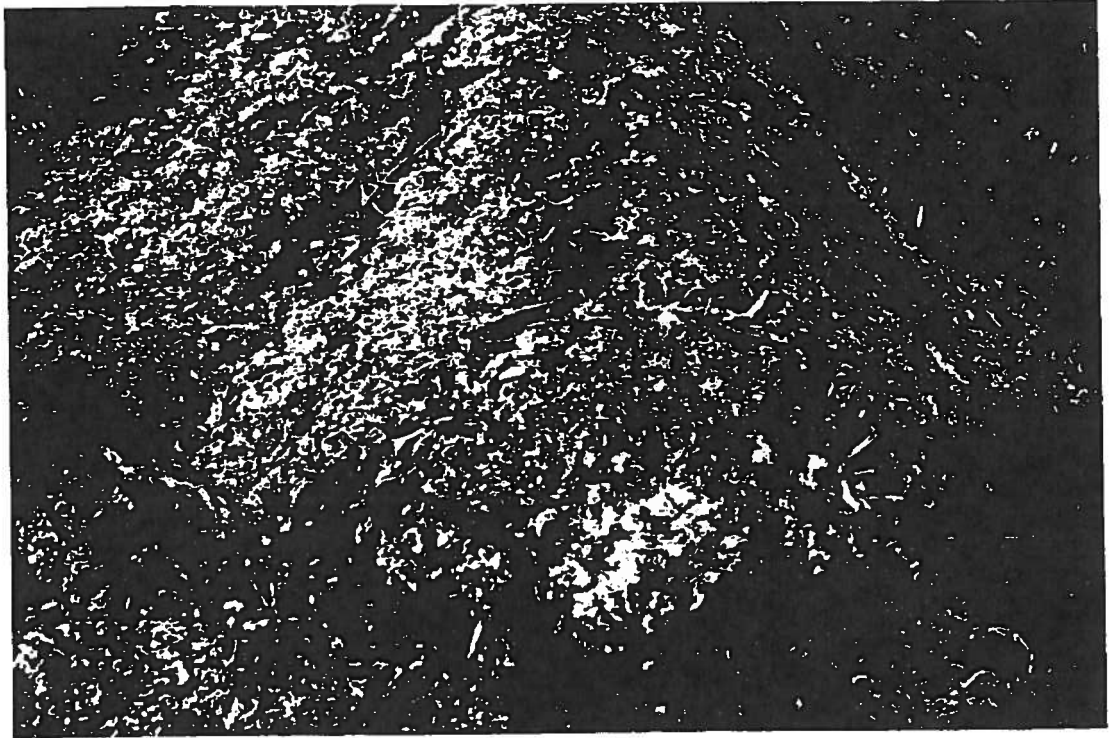
Photo of smoldering ground material
at accident site.

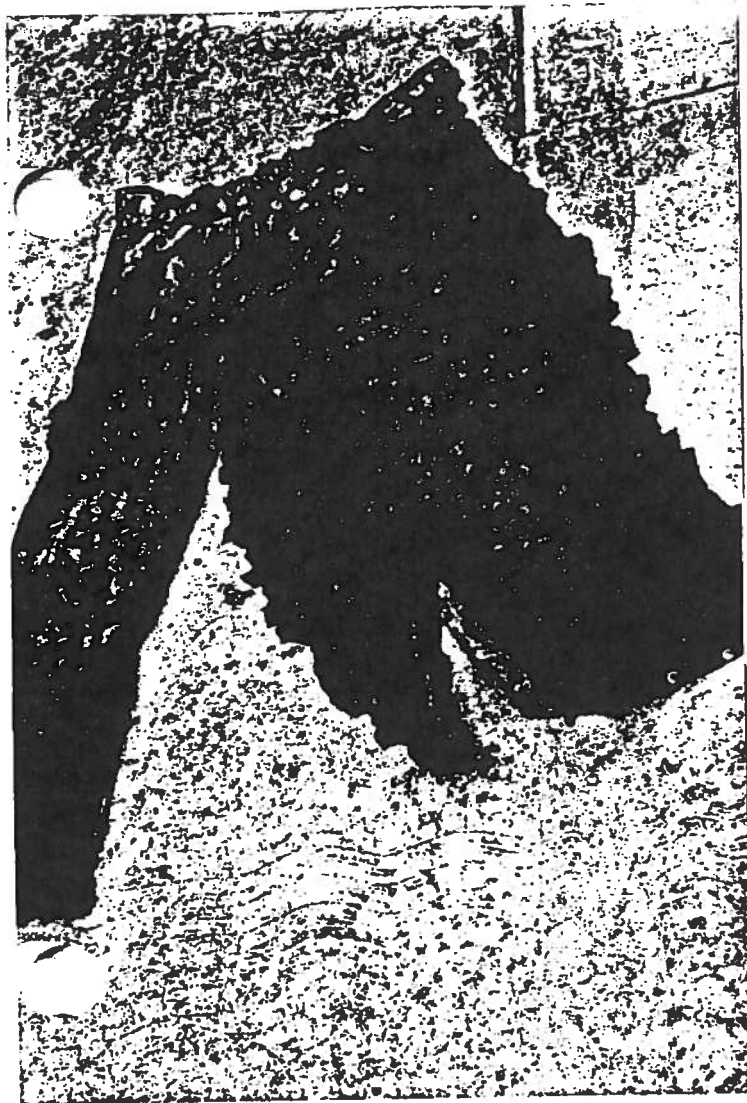
- a. The firefighter's safety and uniform clothing were wet from earlier falls into the stream. Hot ash material managed to enter and work it's way up, inside pant leg of firefighter's safety/uniform clothing. Hot ash material entered wrist gauntlet area of right glove which caused burn injury to wrist.

Photo of outer side of Nomex pants
worn by FF I Rogers. Pants were found
to be wet and dirty from soot and mud.
Top photo - rear side, Bottom photo- front
side

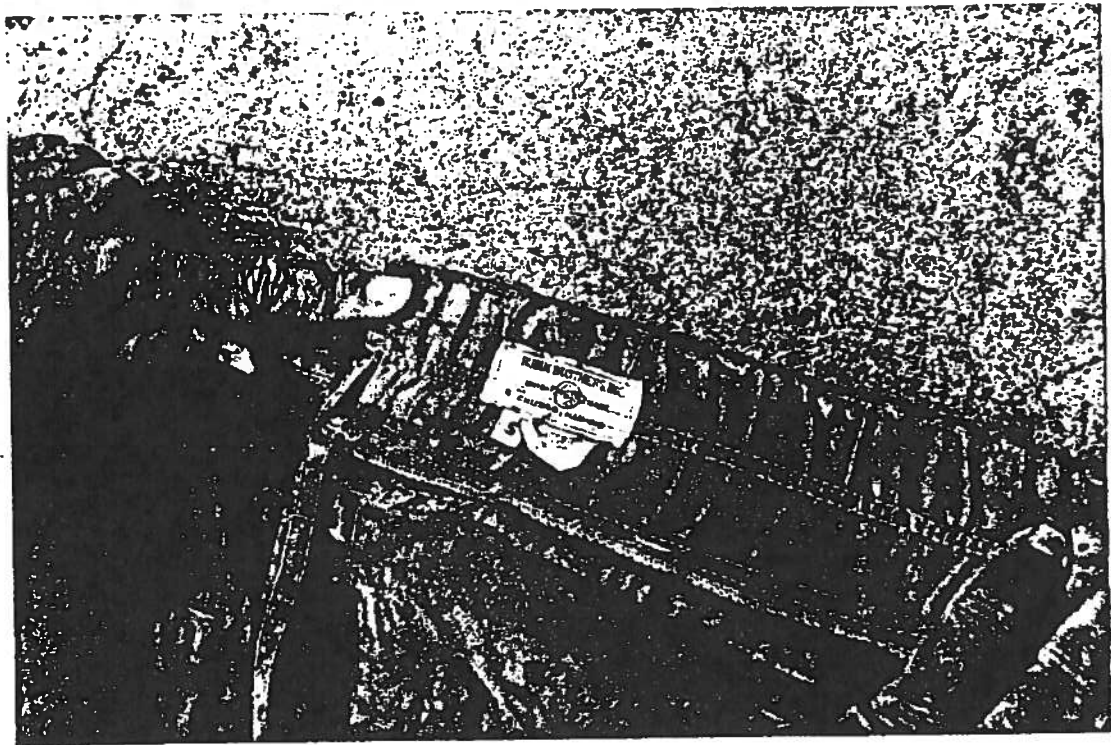
Manufacturers label affixed to waist band of Nomex pants. Smaller label indicates 6 oz. Nomex material. However, there was no Cal-Osha label attached to pants.

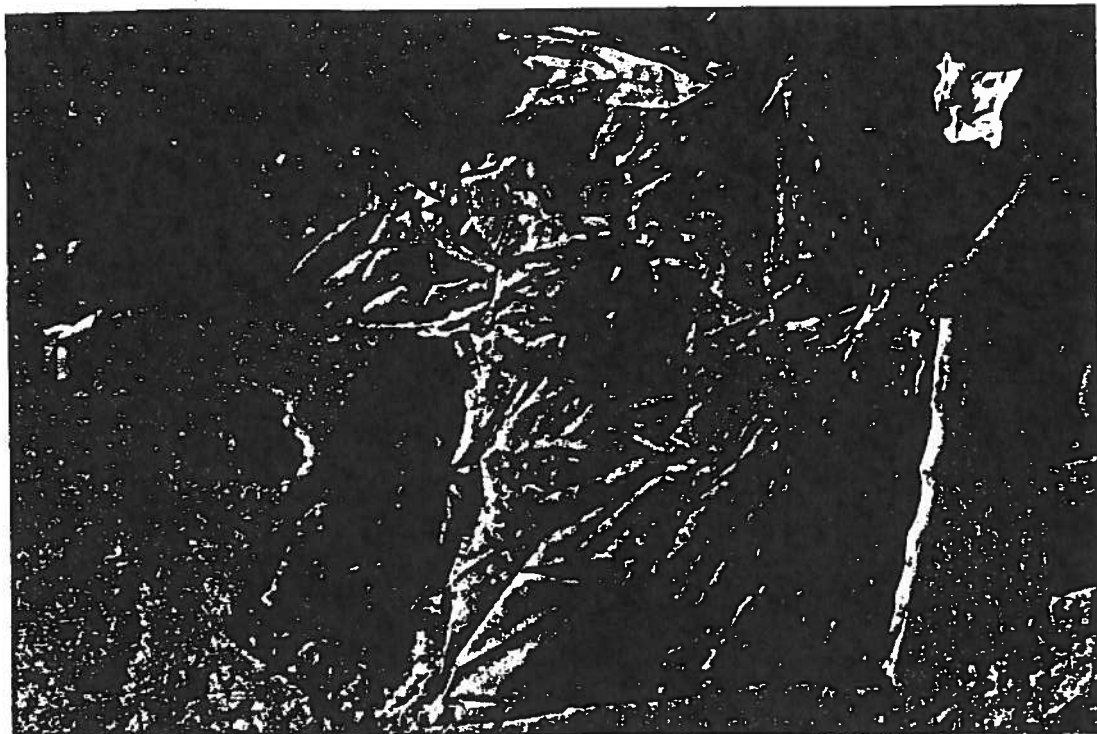
Rear outer side of Nomex shirt worn by
FF I Rogers. Note right sleeve was cut
off during treatment of wrist burn. Shirt
was found to be wet and dirty from soot.

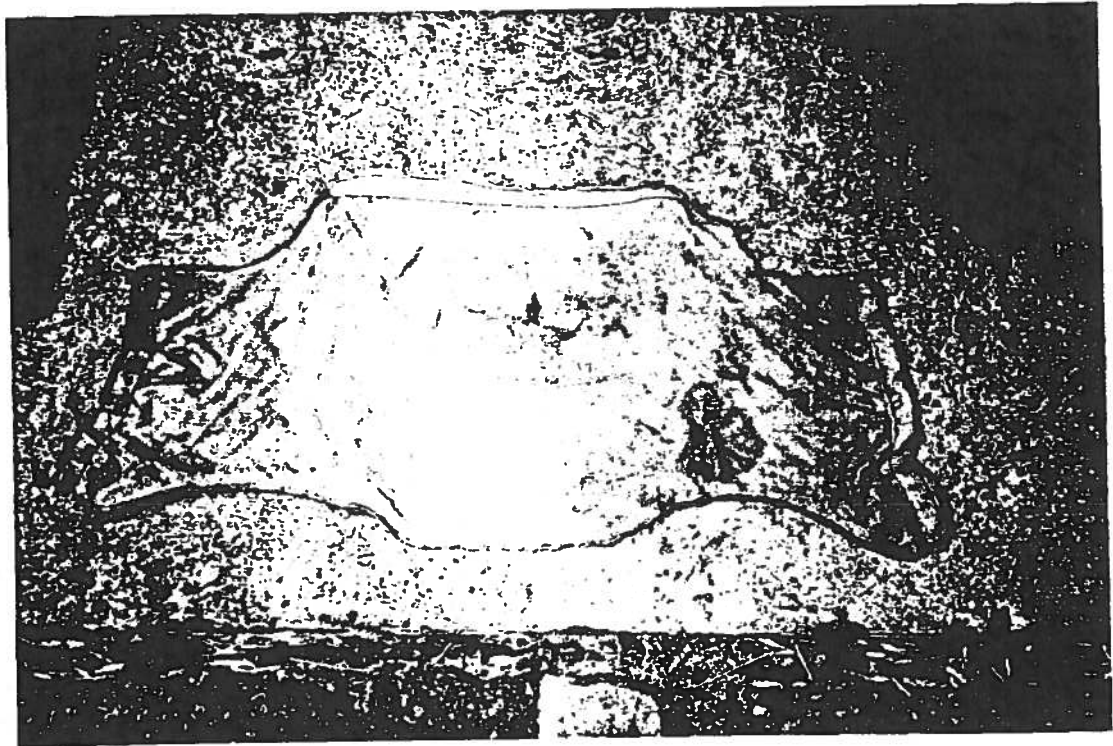
Helmet shroud from FF I Rogers helmet.
No Cal-Osha labeling was found on this
garment.

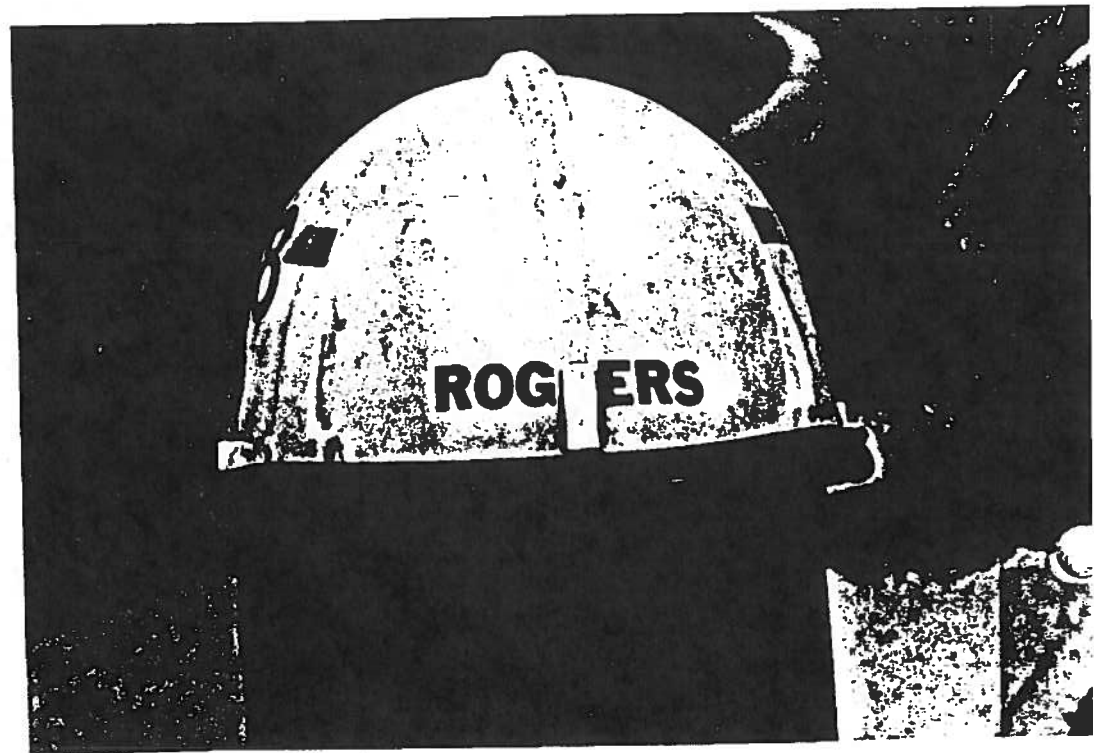
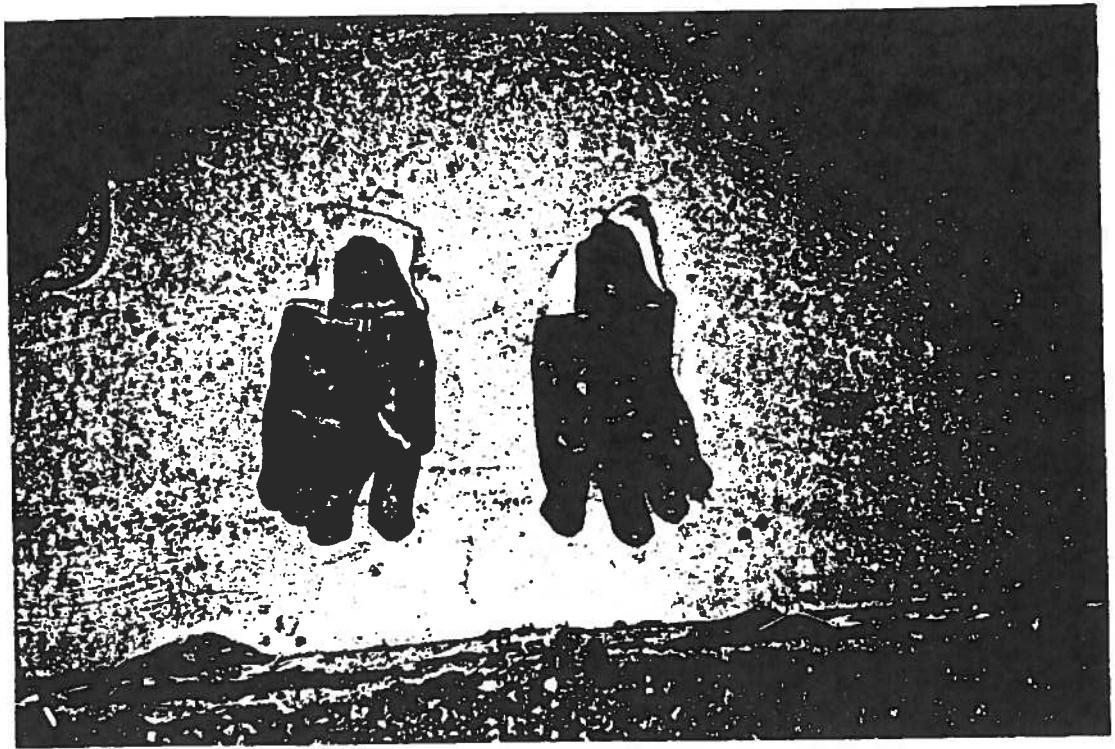
- a. The firefighter was wearing his structural fire suppression gloves, instead of his wildland gloves. The gloves prevented severe burns to the rest of his hands; the gloves construction allows for a vapor barrier, thermal protection, and thicker leather construction.

Structural gloves worn by FF I Rogers.
Manufacturer label displayed.

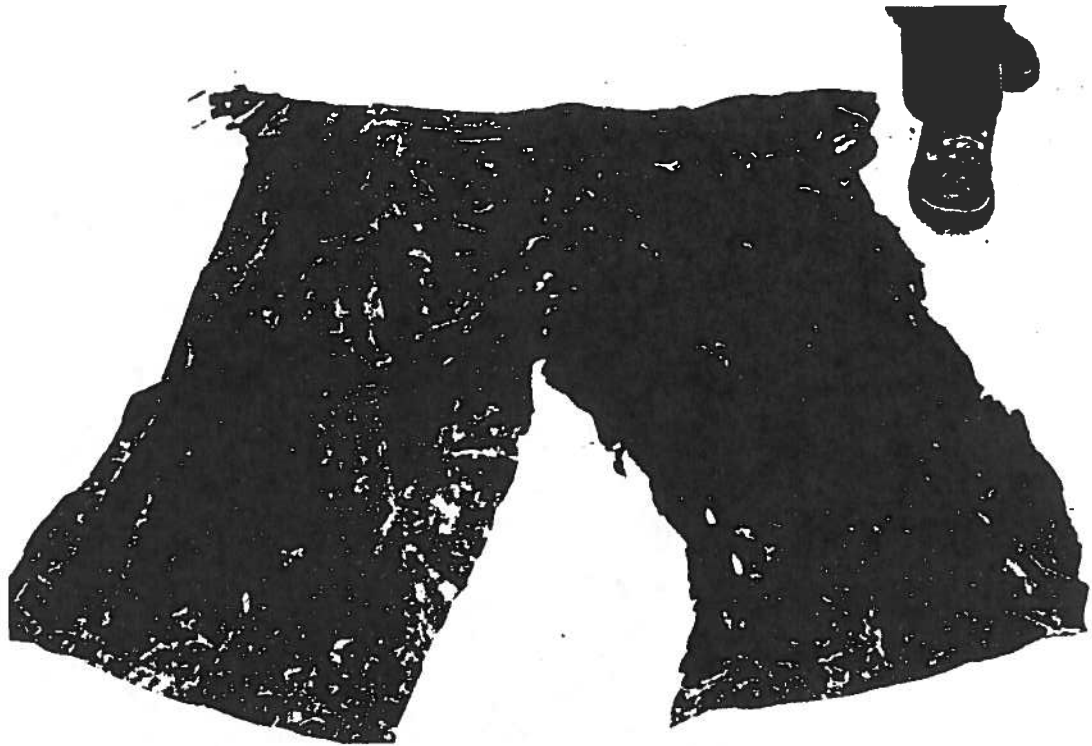
Photo of uniform pants worn by FF I Rogers beneath Nomex pants. Department approved Oshkosh brand, 50% cotton 50% polyester. Pants were found to be wet and dirty from soot and mud. No burn marks were found.
