Accident Investigation Final Report

Committee Drive Fire Burnover

Brunswick County

October 7, 2008

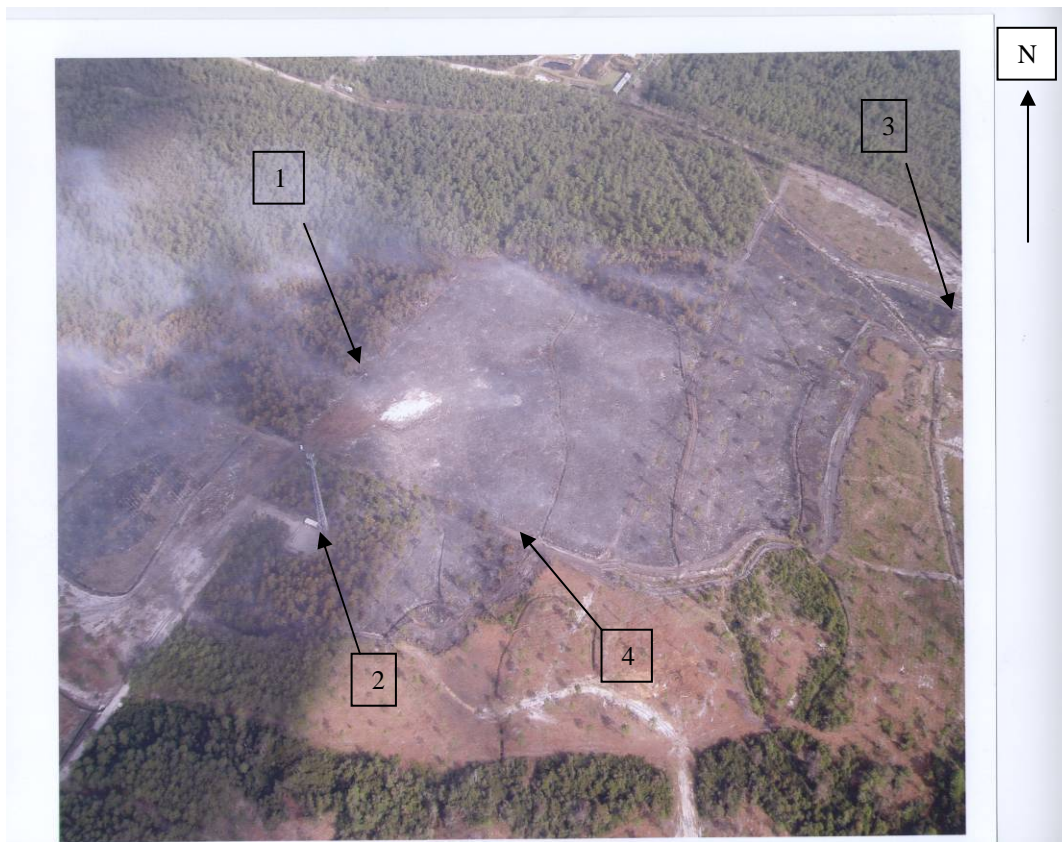
1. Site of engine turnover
2. Tower site
3. Near the point of origin
4. Road adjacent to tower where mutual aid resources responded
