204 Cow Fire, August 29, 2019

USFS Pacific Northwest Region, Malheur National Forest

Tree Strike Injury Facilitated Learning Analysis

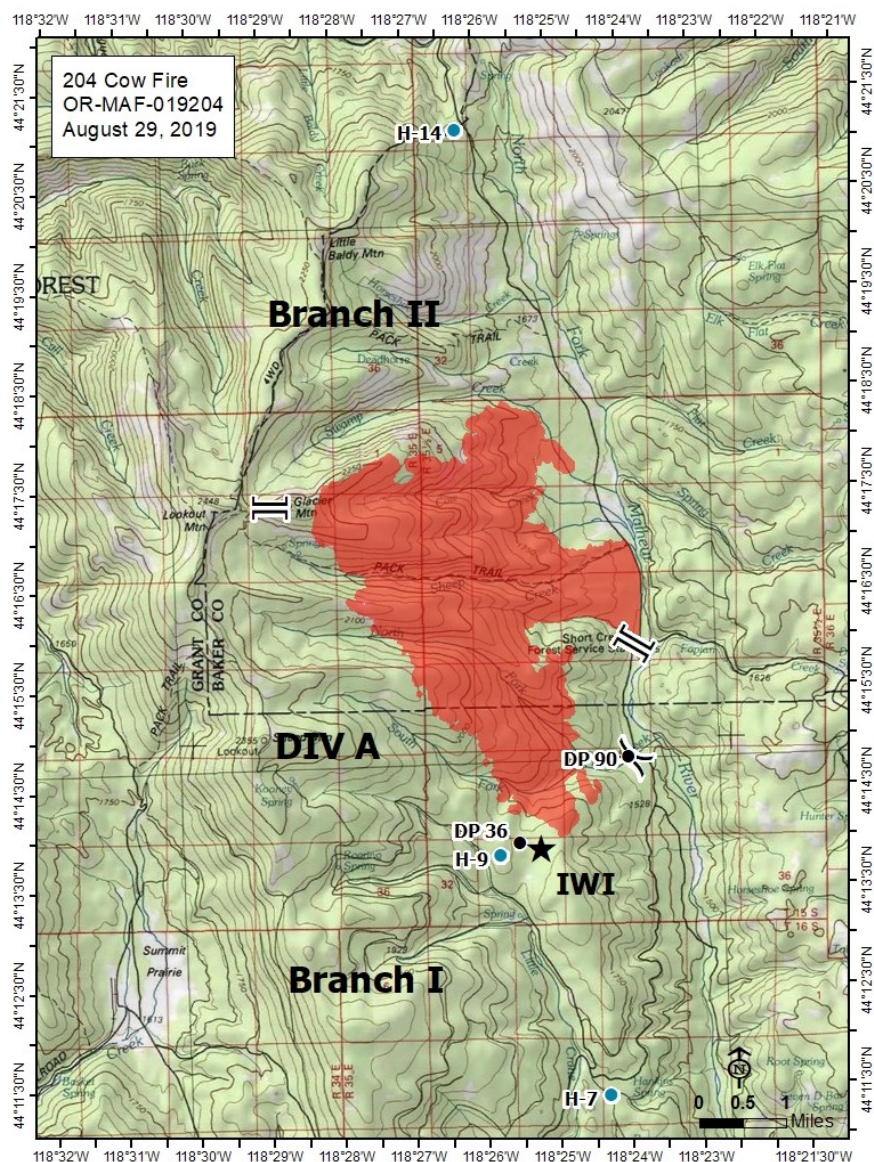
On August 29th, an interagency hot-shot crew (IHC) was assigned the mission of catching spot fires on a portion of the 204 Cow Fire, designated as Division A. The IHC was engaged in identifying primary and contingency line locations, and locating and catching spot fires outside the primary line. The tactics for Division A had recently transitioned from building indirect fireline by prepping a road/ridge system around the fire with the intent of burning the lines out to addressing spot fires in the area. The fire had made a run to the south the day before, stalling out near the pre-identified control line. The resources in the area were highly aware of snag hazards and were making sound risk-based decisions on line locations, due to the snags. The IHC was split into several groups to address numerous small spot fires. The IHC saw team (IHC 1 and IHC 2), engaged on a 1/10 acre spot and cut saw line through some recent logging slash around the spot. On the edge was a burning stob about 10-12 feet tall and approximately 30" DBH. The IHC saw team sized up the stob and determined it should be cut, but it and the surrounding area were too hot to address without cooling.

After discussing their options, the saw team decided to call in a nearby skidgine to apply water to the stob to cool it before cutting. The stob had a slight lean and a small cat face on the side of the lean. IHC 2 then stepped away from the stob to make radio contact with the skidgine. IHC 1 moved over near the stob to use a handtool to clear away slash from the intended lay. IHC 2 observed movement in their peripheral vision, looked over to see the stob falling over directly onto IHC 1, knocking IHC 1 face first onto the ground. IHC 1 quickly reacted by scrambling 20 feet forward away from the stob to an unburned area where IHC 1 came back to rest face down. Crewmembers then helped IHC 1 to a safe location away from the fire. IHC 2 immediately called via their radio crewnet for assistance and injury assessment of IHC 1. One of the crew's two EMT's, (IHC EMT) responded first, as they were close by. IHC EMT left IHC 1 face down and began an initial assessment for injuries including checking airway, vital signs, and chief complaints. Due to mechanism of injury and potential spine injury, IHC EMT decided to leave the patient face down until enough responders arrived to safely turn IHC 1 over to a face up position. The remaining IHC crewmembers began retrieving medical supplies from their vehicles including trauma kits and backboard/litter and also started to cut a P-Line (path) to the nearby road (about 400 feet) for evacuation and transport.

- Snags vs stobs: Snags are and have been a primary concern for firefighters for decades. There are countless incident reports on snag incidents ranging from minor injuries or close calls to fatalities and serious injuries directly attributed to firefighters falling snags or working in the area around snags. Snags were at the forefront of discussion from the start of the 204 Cow Fire. The strategy chosen on the incident was driven by the desire to keep firefighters away from snags as much as possible. On the other hand, stobs have not been attributed to many injuries and are often seen as more of a nuisance to firefighters. They are difficult to cut due to lack of weight, and often require much more time and energy to fall. What we do know is that even though a stob may lack the height of a snag, they are still a hazard and should not be discounted as a threat to injury. This incident brings to light that while all hazards on the fireline are not equal, they all do require a high level of situational awareness and firefighters need to treat every hazard with the same level of concern.
