INVESTIGATIVE REPORT DADDY RIDGE FIRE

Daddy Ridge Fire

NOVEMBER 10, 2001

**TENNESSEE DEPARTMENT OF AGRICULTURE
DIVISION OF FORESTRY**

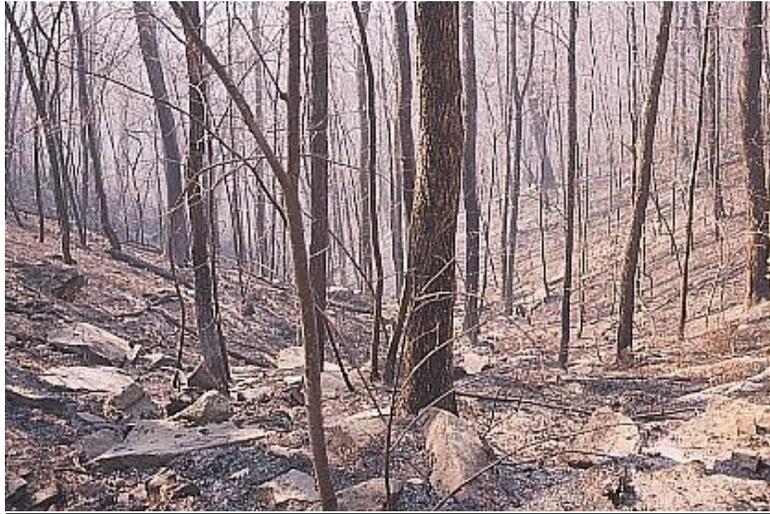
View from Head of the Hollow

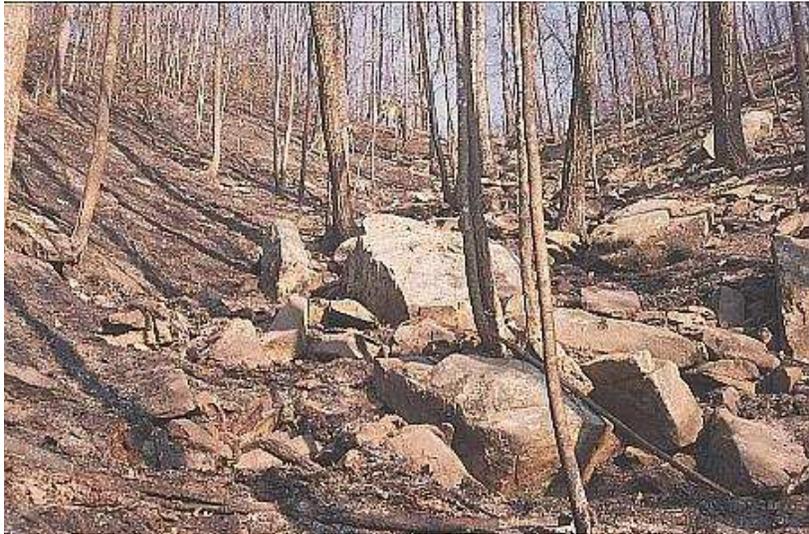
View up the hollow from the fatality site.

Before the blowup those observing the fire burning into the drain described it as very slowly backing down the north side of the drain. Flame length was not over 1 foot. Scorch patterns and witnesses indicate the fire was burning from near the point the dozer line ended, downhill on an angle to within 15 feet of the middle of the drain near where the entrapment occurred. The line of fire then curved to the north and down into Katy Hollow.

Scorch patterns and witnesses indicate a spot fire started in the center of the drain near the base of the steepest part. When first seen by the hand crew the spot fire was about 4 feet wide. A moment later the fire began an intense run up the drain. It is likely that rolling debris from the north side slope fell into the

At the time the blowup occurred most of the north side of the drain had been burned, but none of the steeper south side. It is estimated that a length of 200 feet of the steep ravine was engulfed in about 45 seconds. Scorch indicates flame height to generally have been 3 to 10 feet, and flame lengths 10 to 25 feet. Witnesses described the flames as "laying down low" and spreading very rapidly on the steeper south side of the drain and the fire in the center of the drain as "rolling". The typical loud "freight train" roar of the fire was also heard. One of the witnesses in the drain described how it became difficult to breathe just before the blowup.

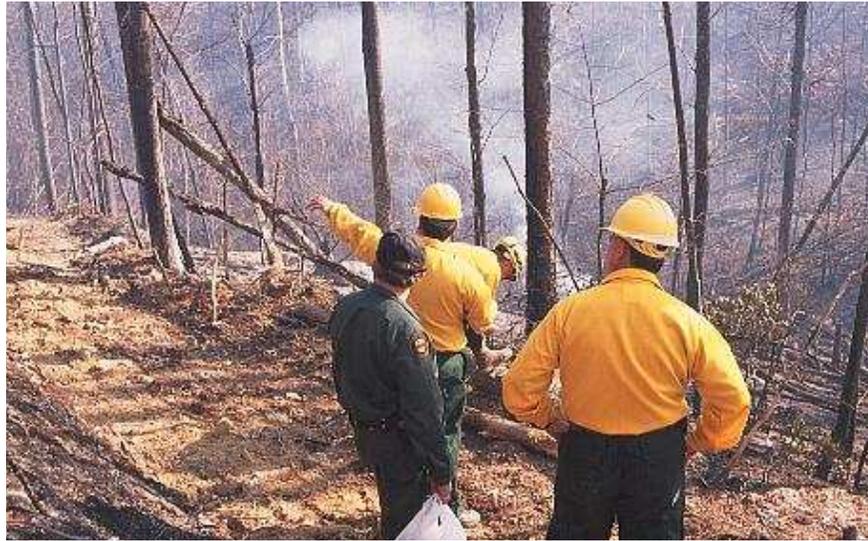
The Investigation Team visits the site of where the dozer line was constructed
