Informational Summary Report of Serious CAL FIRE Injuries, Illnesses, Accidents and Near-Miss Incidents

Debris Fire – Near Miss

July 1, 2011

“E” St Incident

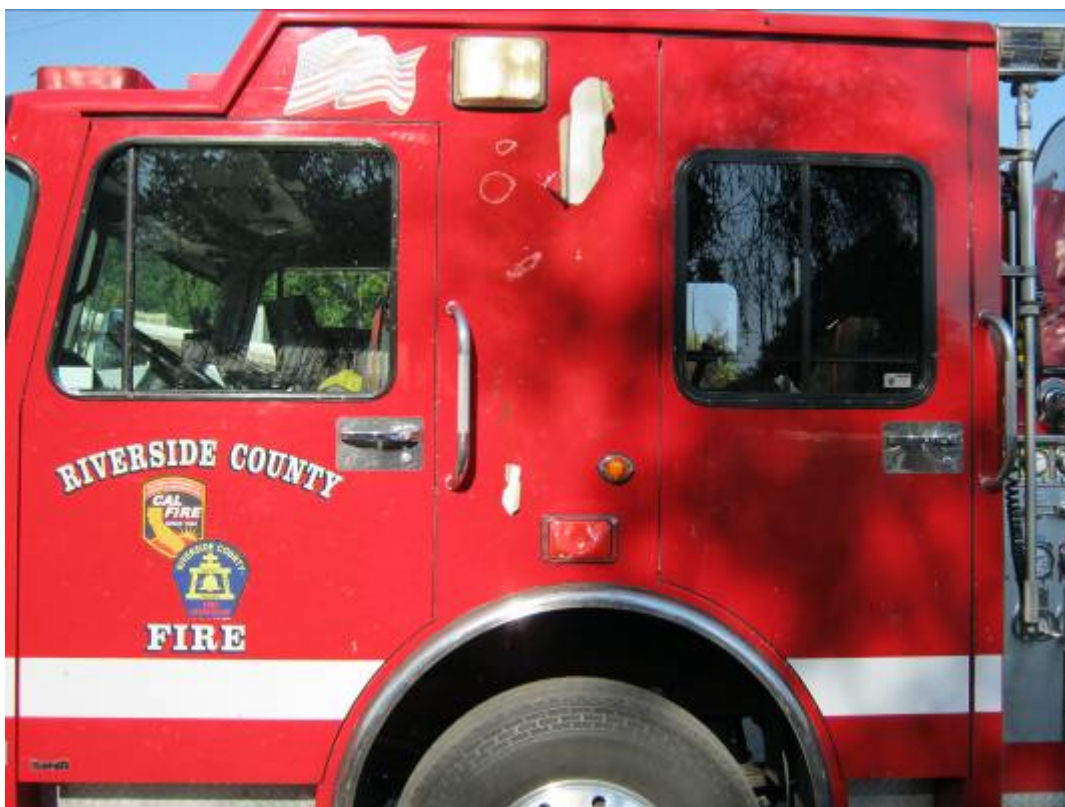
RVC E-26 (E-272) Received damage to multiple lighting lenses and pump panel gauges. Paint was scorched on the left side of the vehicle and an axle seal was melted.

Figure 2: Radiant heat damage to E-26

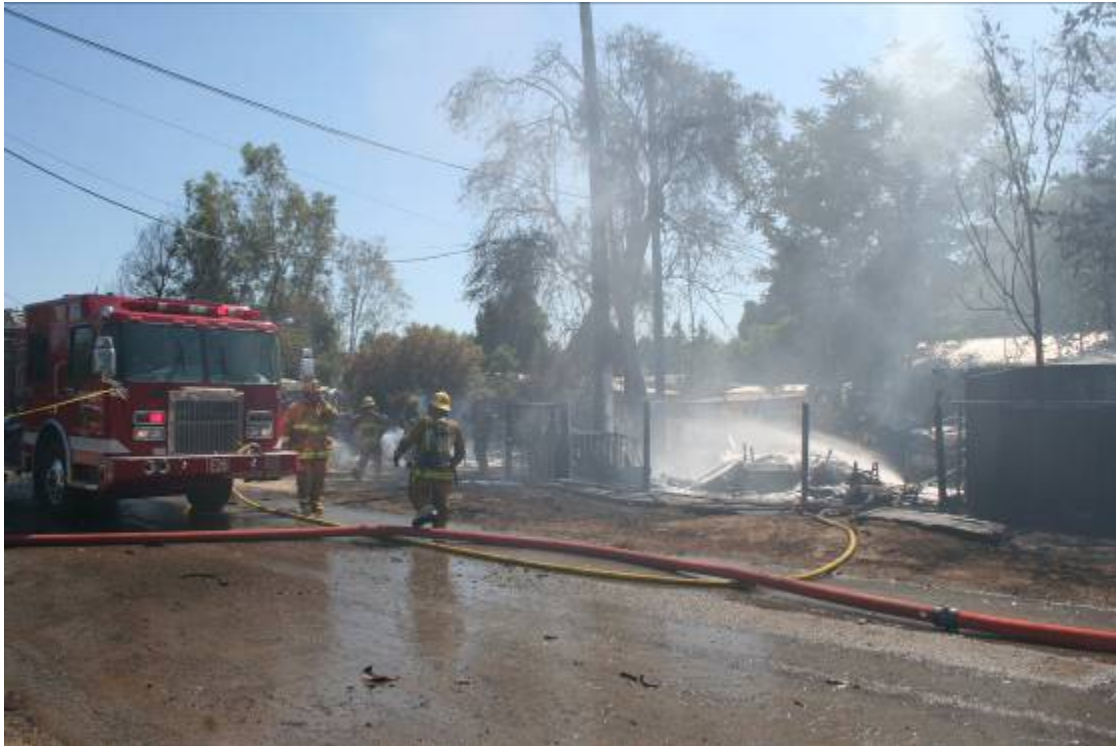
the cab he noticed a power line directly over the engine. The officer made a decision to not move E-26 based on the fact the firefighters already had hose on the ground.

As the officer proceeded to the pump panel to engage the pump, a palm tree and debris next to the engine ignited. The radiant heat drove the officer from the pump panel to the passenger side of the vehicle. The operator was wearing a T-shirt and structure pants. The officer does not drive with a turnout coat donned and keeps his safety gear in the brass box. The officer made a second attempt to get to the pump panel and was again driven away by radiant heat. The officer on E-72 was alerted to the situation and preceded to the pump panel of E-26. The officer on E-72 was wearing full structural PPE. The officer stated the pump panel was so hot he needed to put his structural gloves on to engage the pump. As fire attack was initiated, the officer from E-72 returned to his engine. At the same time of the fire flare up, two sets of overhead wires burned through, one dropped to the ground on both sides of E-26 and the other laid across the first arriving engine company. It was determined that the set of wires across the engine were phone and cable TV wires. The second set of wires was an energized electrical service drop which broke in half, missed hitting E-26 and landed on the ground igniting a second fire in vegetation on the opposite side of the road. The hazard of the energized electrical wires was communicated to all personnel on the scene and isolated until the wires could be secured by the utility companies.

Figure 3: Spotting Location E-26

- Ensure all personnel are in proper personal protective equipment (PPE).
- Base all actions on current and expected fire behavior.
- Apparatus must be spotted based on actual and predicted fire behavior.
- Look up, look down, look around.
- Fires can spread quickly in light flashy fuels.
- Seasonal weather and fuel conditions have transitioned to hot and dry; the fuels are mostly dried and cured and are readily available for burning at all hours of the day or night.
