Deer Park Wildfire

Firefighter Injury and Helicopter Incident- August 10, 2010

Facilitated Learning Analysis

USDA Forest Service, Eastern Great Basin Region,

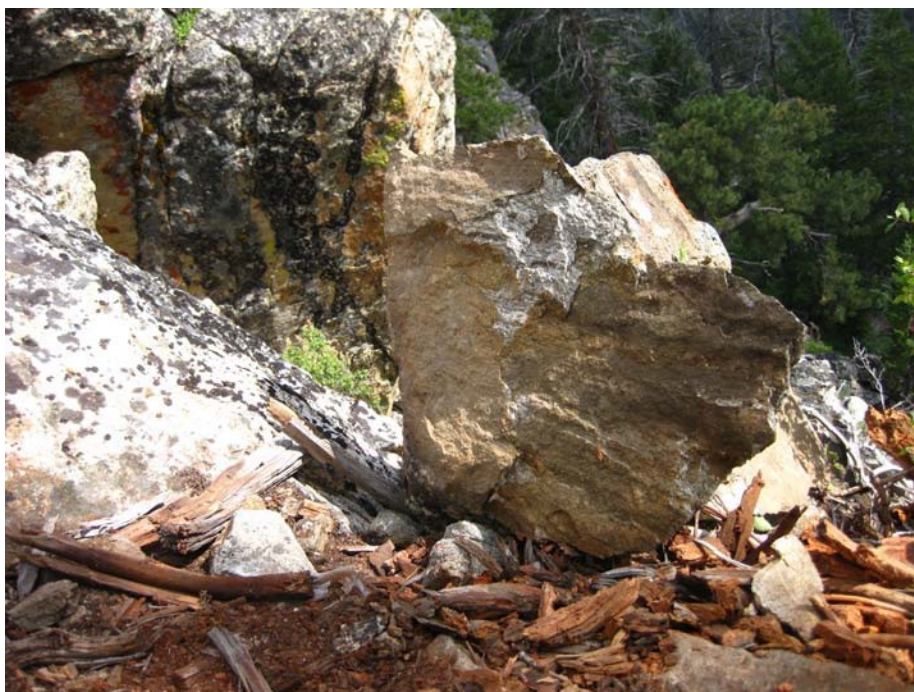
While walking up the ridgeline on roughly a 35% slope, the lookout stumbled and reached towards the rocks to steady his balance. This caused an approximately 200 pound boulder to slide free which rolled and pinned the lookout against other rocks. The lookout radioed back to the crew that he had sustained a possible femur fracture.

The rock that was dislodged by the patient and striking the patient causing a left femur fracture.

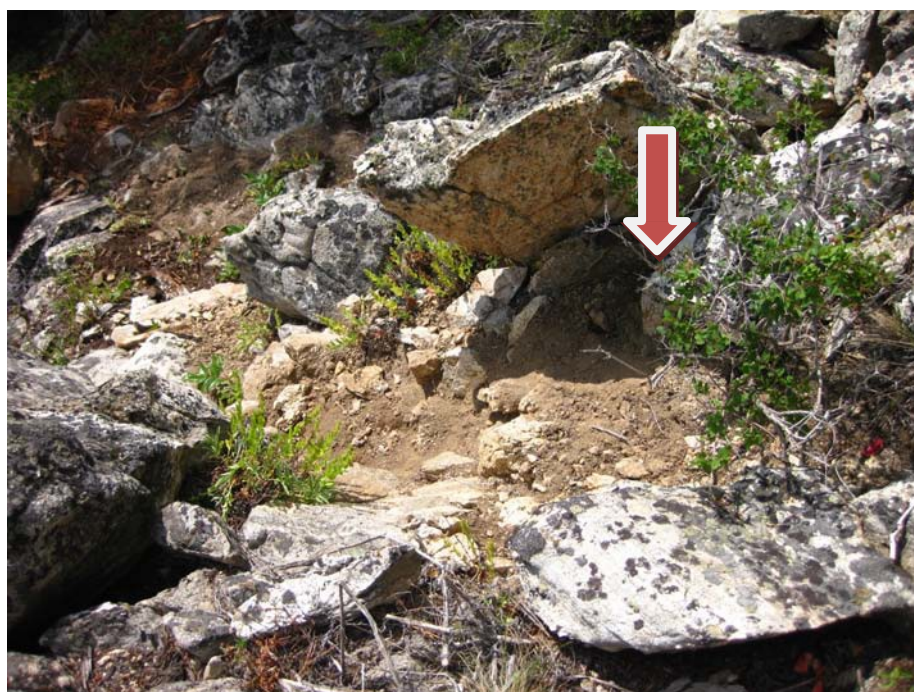
Injury site. Arrow indicates where the rock was dislodged from.

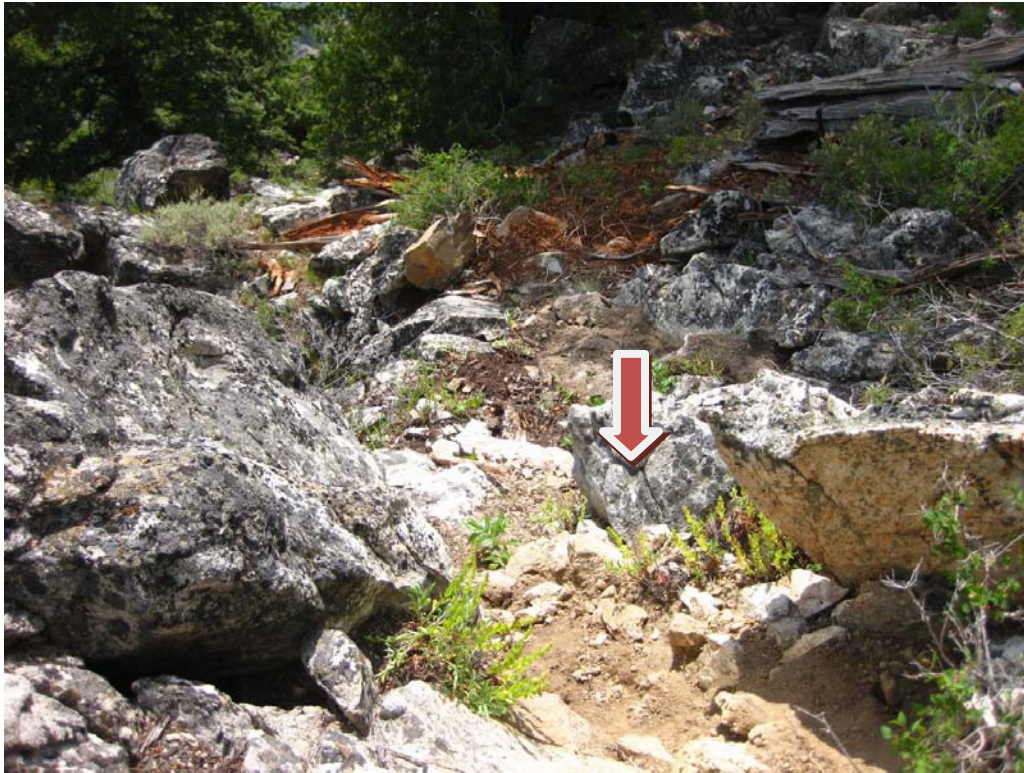
Injury site. Looking from top down slope. Arrow indicates location where patient is stuck by the rock and pinned against another rock.

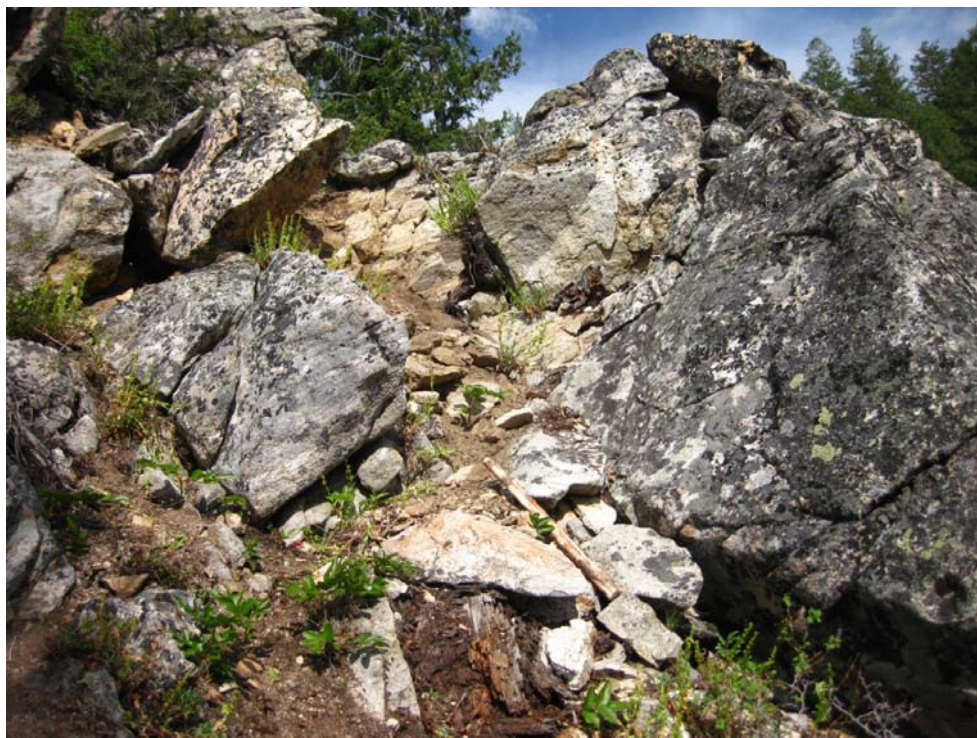
Injury site. Photo looking up slope from the final resting point of the dislodged rock.

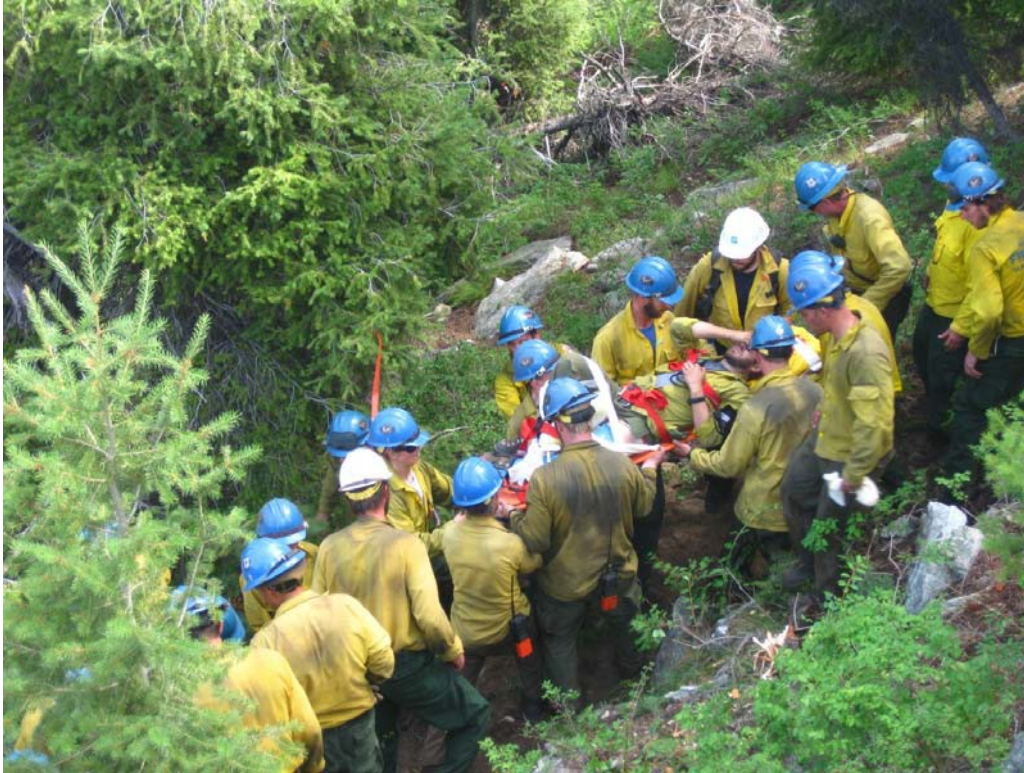
Patient being “Conveyer Belt” transported by Flathead IHC and Texas Canyon IHC from injury site towards Medivac spot #1.

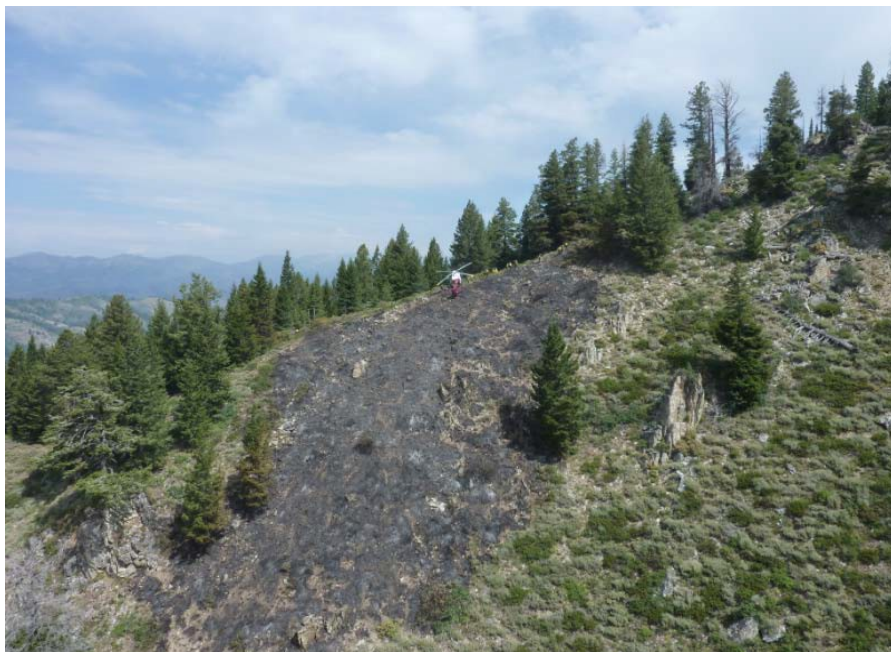
1140- Lifeflight A shuts down power. As helicopter is spooling down it tips backwards and comes to rest on the bottom of its internal fan tail rotor. Pilot exits helicopter safely.

Lifeflight A at Medivac Spot #1 after settling on tail boom, photo taken from Helicopter#352 looking north.

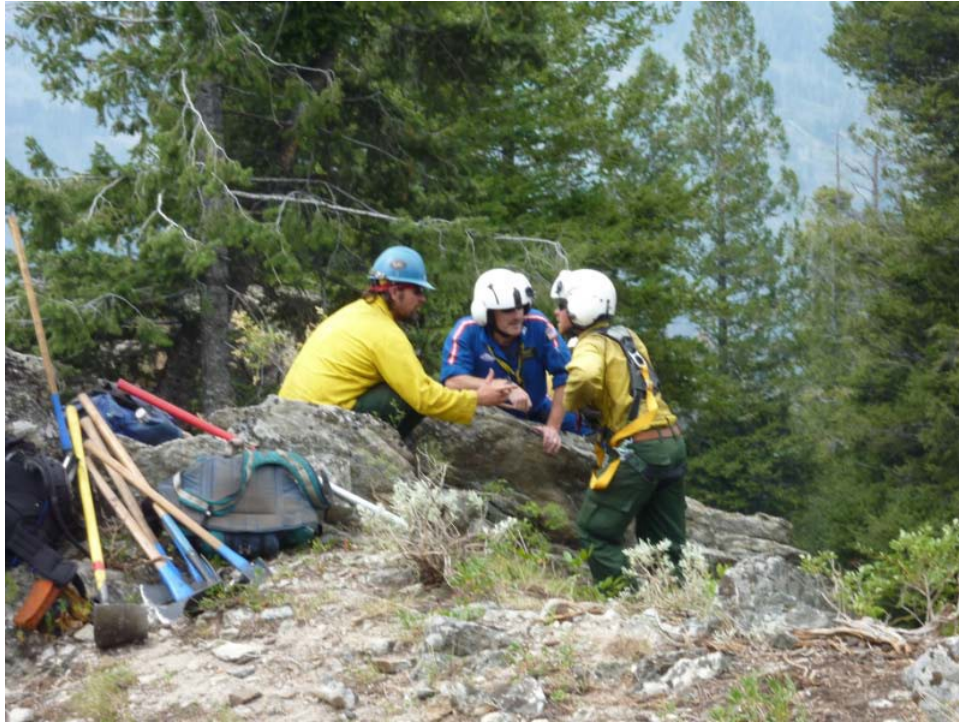
Briefing on the loading of patient into Helicopter 352 between Flathead IHC, Lifeflight Nurse and Sawtooth Helitack Paramedic.

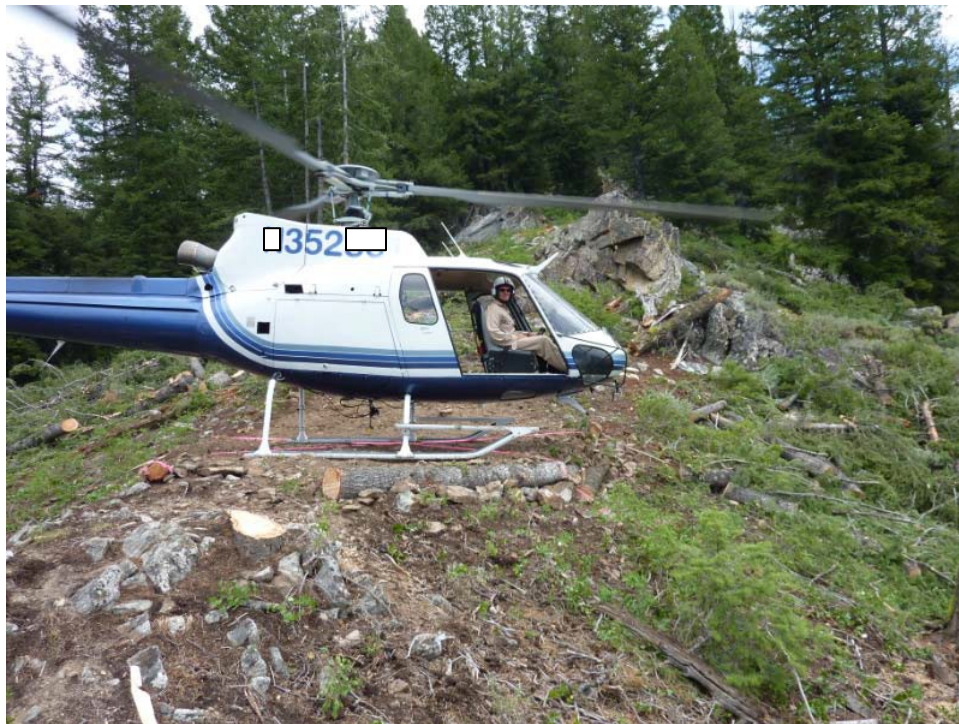
Helicopter 352 at Medivac Spot #2.

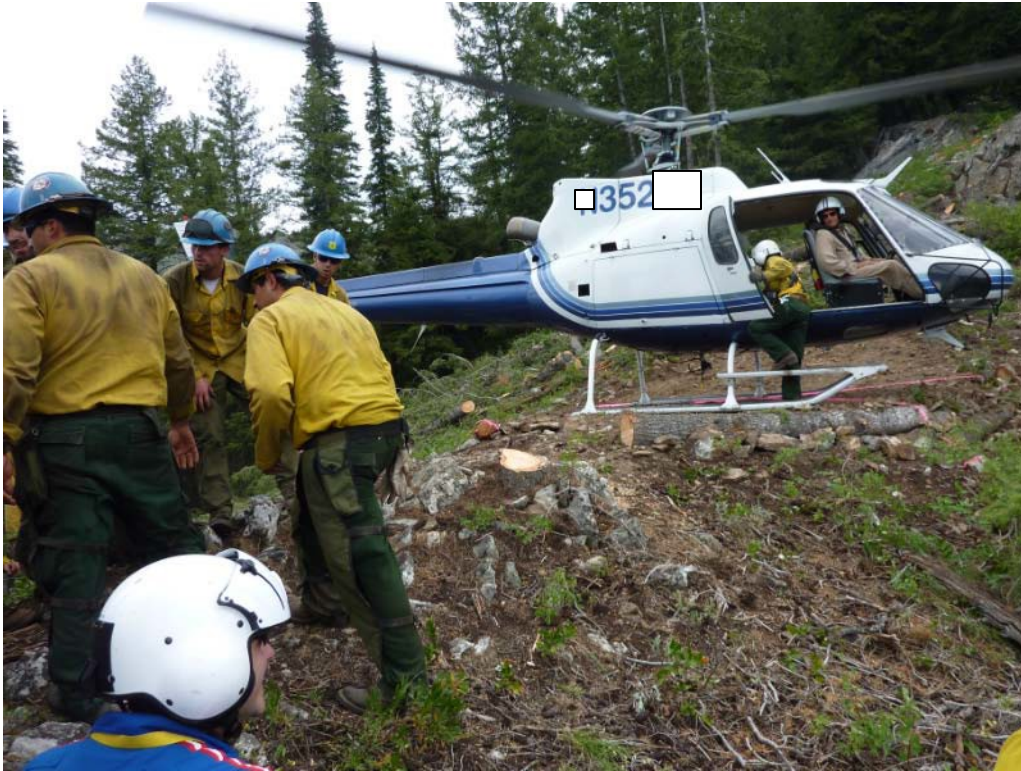
Flathead and Texas Canyon IHC “conveyor belting” patient towards Helicopter 352 at Medivac Spot #2.

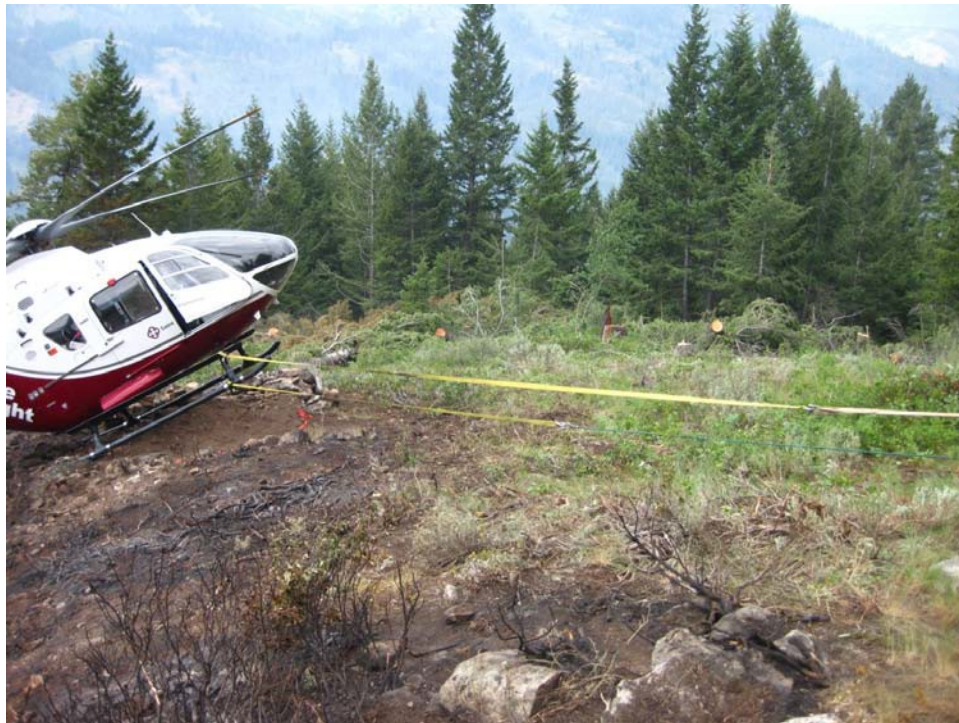
Lifelight A secured to trees using long lines, tow straps and come-a-longs.

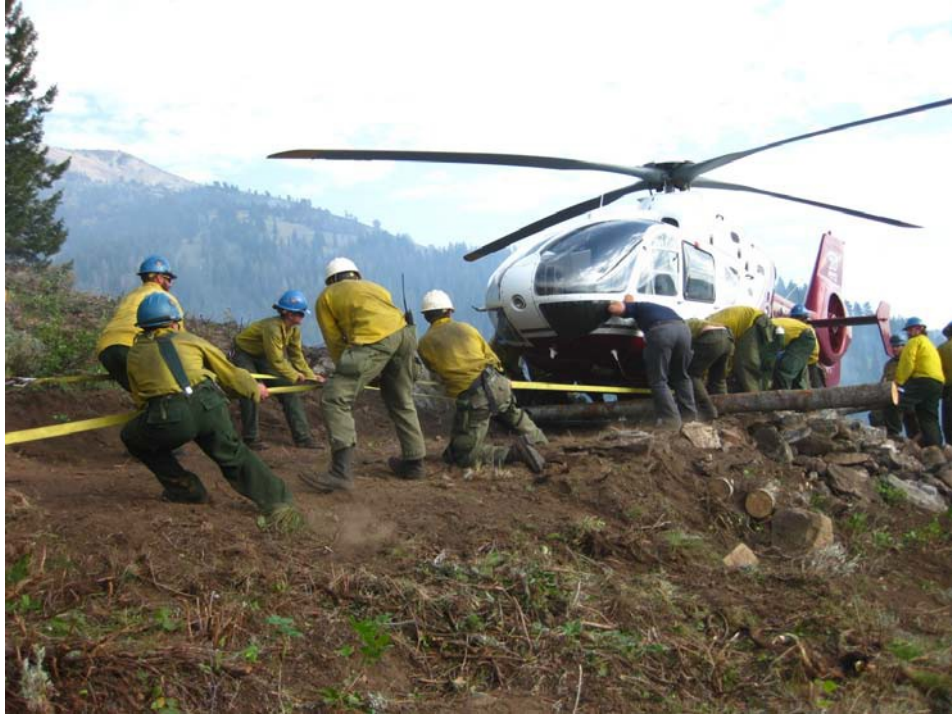
Smokeyjumpers, Flathead IHC and Texas Canyon IHC using pure horse power and ingenuity to get Lifeflight A leveled and back on the pad at medivac spot #1.

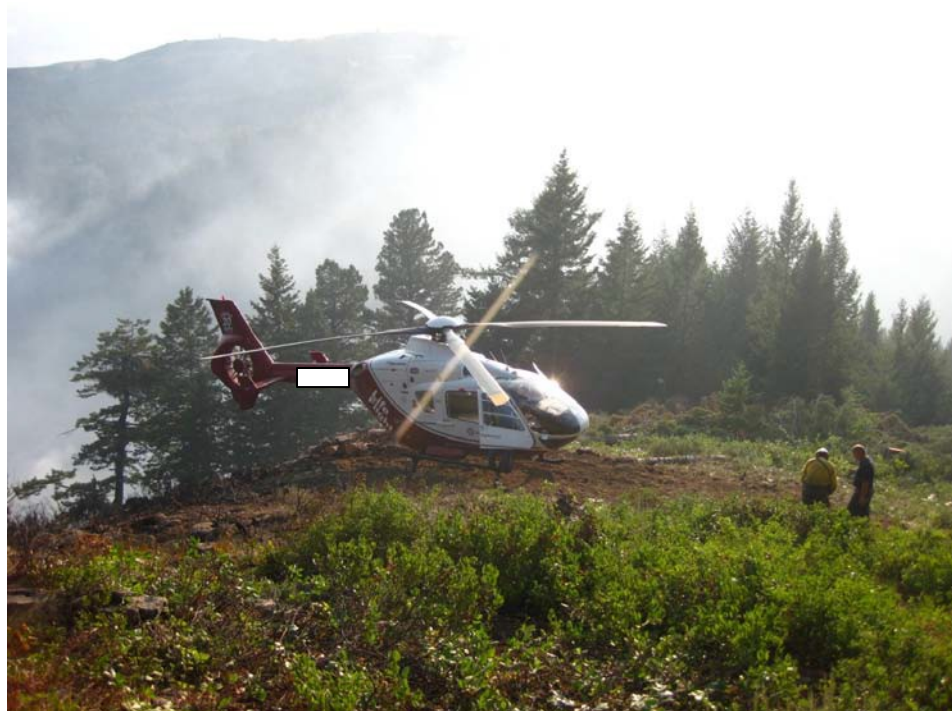
Lifeflight A back to a level position getting ready to perform run ups and system checks.
