Rapid Lesson Sharing

Event Type: John Deere J Series Dozer Overheating

Overheating Problem – and the Fix

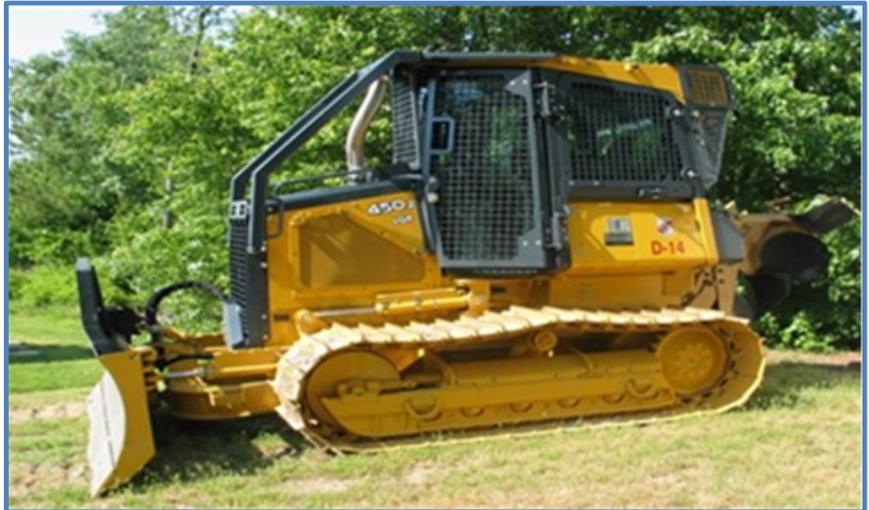
The John Deere J Series Dozer has overheated during fire operations. When the engine overheats it goes into a limp mode, limiting the dozer's speed and effectiveness. Because the dozer could go into this limp mode during critical times of fire operations, this situation represents a key safety concern. Multiple federal and state land management agencies have worked together with the manufacturer to remedy this problem. After various modifications to the engine cooling system, a design has been developed that fixes this overheating dilemma.

Installation, testing, and further design enhancements of the retrofitted cooling system have now been completed. The current retrofit design increases the heat rejection capacity of the engine cooler by 17% for Tier 2 dozers and 11% for Tier 3 dozers. This was accomplished by increasing the thickness and width of the engine radiators while retaining the Original Equipment Manufacturer (OEM) capacity of the hydrostatic cooler.

On the retrofit design, the number of radiator fins was reduced from the OEM fin design of 10.35 fins per square inch to 6 fins per square inch. The fin design was also changed from a V fin shape to a U shape to allow debris to pass through the radiators more easily and reduce the clogging potential—which has been an issue with the OEM design. Additionally, the thickness of the fins was increased to limit damage caused by restricted air flow.
