**Accident Investigation  
Factual Report**

**Engine 3144 Rollover  
Bakersfield Field Office  
September 19, 2007**

**ACCIDENT INVESTIGATION FACTUAL REPORT**

**Accident:** Engine 3144 Rollover

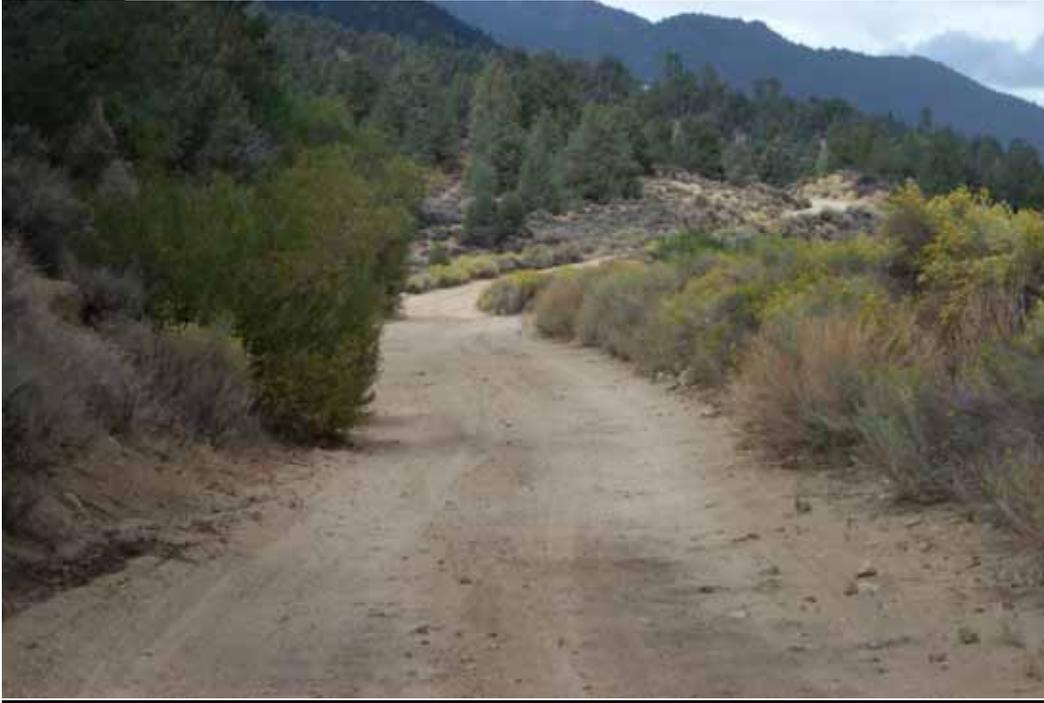
**Picture 1**

Evidence indicates Engine 3144 had been sliding on previous curves.

The Engine was traveling at an excessive rate of speed for safe operations of the Engine for road conditions. Reflected in photo points 1-8.

Photo Date	Photo ID Number	Name of Photographer	Description of Photograph
9/23/2007	1	Tom Sherman	Tire Tracks, 50 yards north of site
9/23/2007	2	Tom Sherman	Tire Tracks, 100 yards north of site
9/23/2007	3	Tom Sherman	Tire Tracks, north of site
9/23/2007	4	Tom Sherman	Tire Tracks edge of road
9/23/2007	5	Tom Sherman	Tire Tracks edge of road
9/23/2007	6	Tom Sherman	Tire Tracks edge of road
9/23/2007	7	Tom Sherman	Tire Tracks, south side of the road

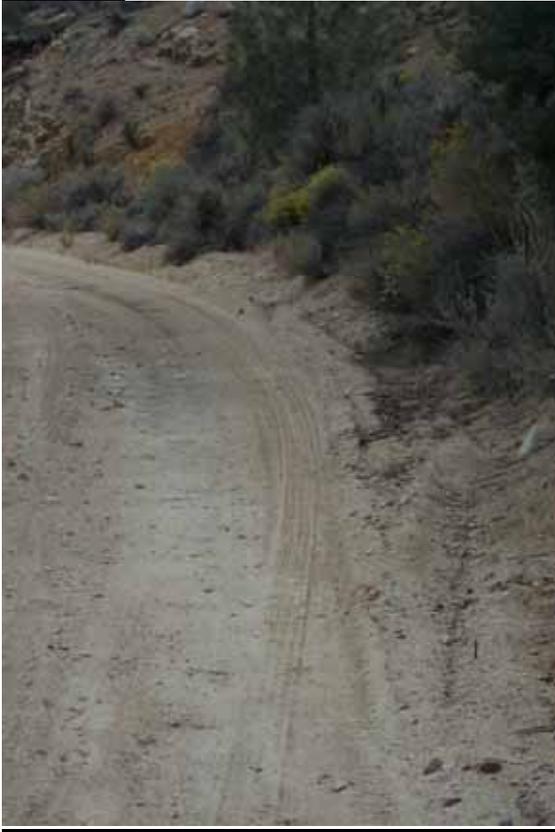
**Picture 8**

<b>Photo Date</b>	<b>Photo ID Number</b>	<b>Name of Photographer</b>	<b>Description of Photograph</b>
9/23/2007	8	Tom Sherman	Tire Tracks edge of road
9/23/2007	9	Tom Sherman	Tire Tracks edge of road
9/23/2007	10	Tom Sherman	Showing Skid mark on rock dislodged
9/23/2007	11	Tom Sherman	Showing Skid mark on rock dislodged
9/23/2007	12	Tom Sherman	Long range view of rocks
9/23/2007	13	Tom Sherman	Showing Skid mark on rock dislodged
9/23/2007	14	Tom Sherman	Showing Skid mark on rock dislodged
9/23/2007	15	Tom Sherman	Tire Tracks edge of road. Sandy Ditch
9/23/2007	16	Tom Sherman	Large Rock at roll over site,
