# Rapid Lesson Sharing

Montana Department of Natural Resources & Conservation

Liberty Fire Suppression Repair

2 October 2017

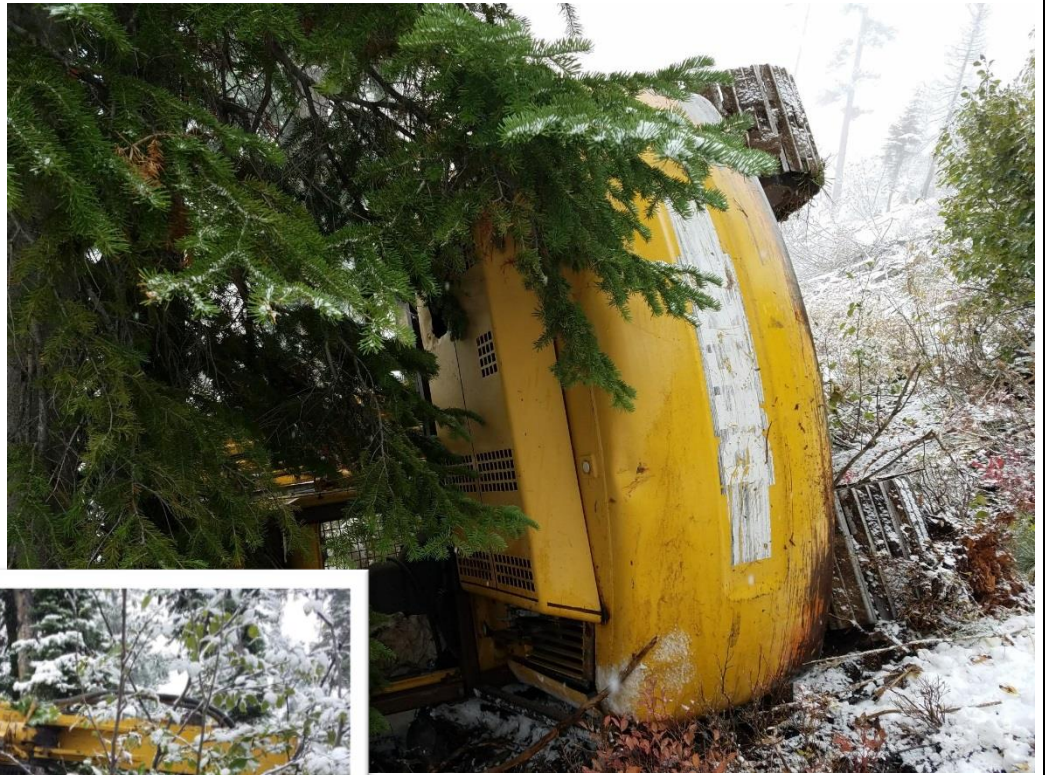
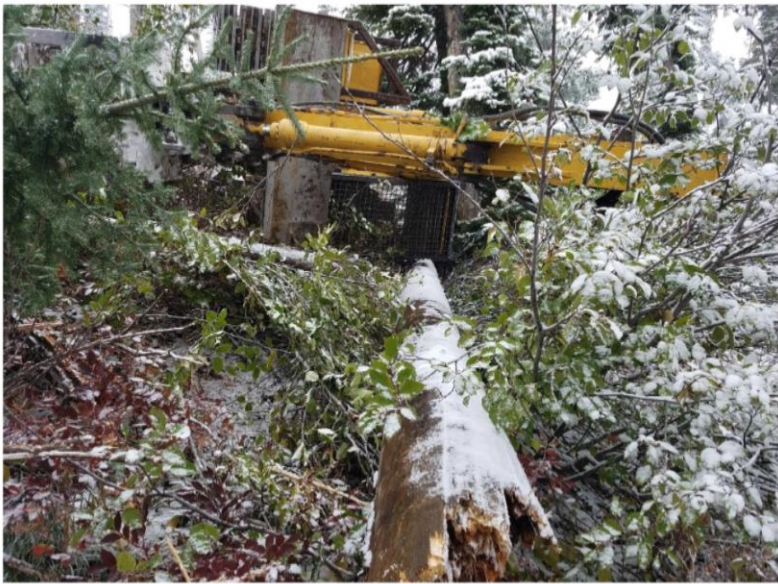
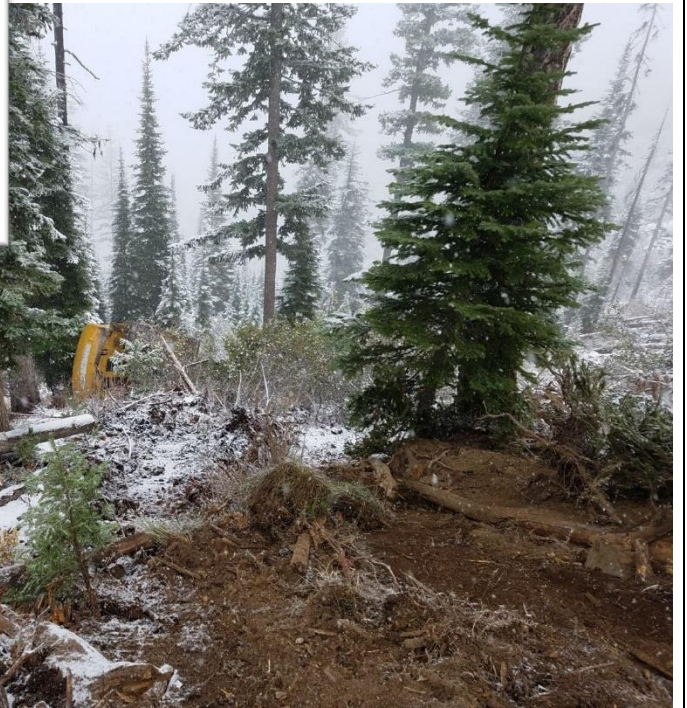
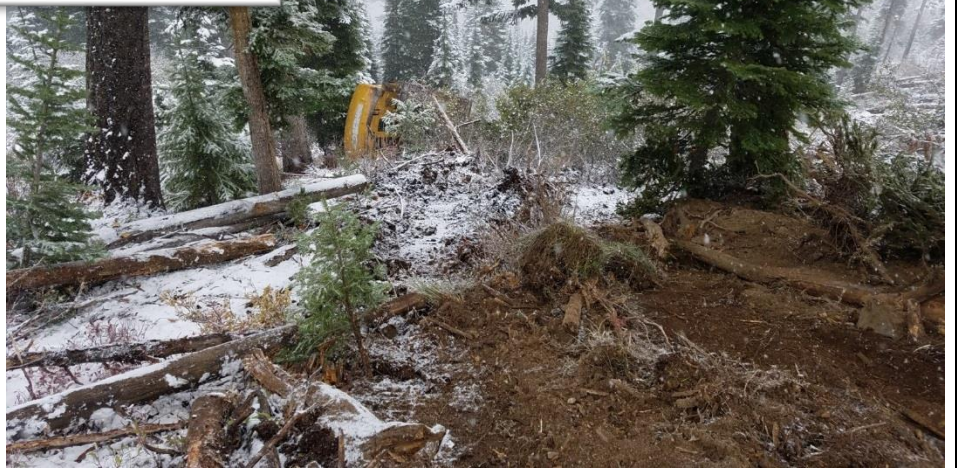
*See Photos  
of this Excavator Tip Over  
on Page 2*

The excavator worked the dozer line successfully. However, while making his way back down the slope, he lost traction and started to slide. The Operator attempted to stop the slide by setting his boom on the ground—but forward momentum carried him over his bucket and the thumb of his bucket got stuck under the excavator blade. This resulted in the machine tipping over on its side and trapping the operator inside the cab. The operator radioed the TFLD. The SOFR(T) answered the call and provided a radio relay. The Operator stated that he had tipped over the excavator and was trapped inside the cab—but was unharmed. While the SOFR(T) was relaying information on the radio, the Operator removed the back window of the excavator and carried it up the steep slope to the road where the SOFR(T) was parked. The ICT3, EMT, and the SOFR traveled to the incident where the EMT checked on the Operator and determined he was unharmed and did not need any additional evaluations. The IC took a tactical pause with all operations while they developed a plan to rescue the tipped over machinery using another excavator. They successfully had the excavator upright and back on its tracks by mid-afternoon.

- Placement of dozer line in steep treacherous terrain made repair work challenging, increasing risk to operators.
- Deficient in qualified HEQB available for shoulder season work.
- Inclement weather made operations challenging.

- Reevaluate tactics after changes in weather and site conditions.
- Provide more HEQB classes and trainee opportunities.
- Generate a contingency plan for egress before engaging resources.
