Accident Investigation: Factual Report

Pine Fire Dozer Entrapment

Descanso Ranger District
Cleveland National Forest
Pacific Southwest Region

Wednesday, September 12, 2007

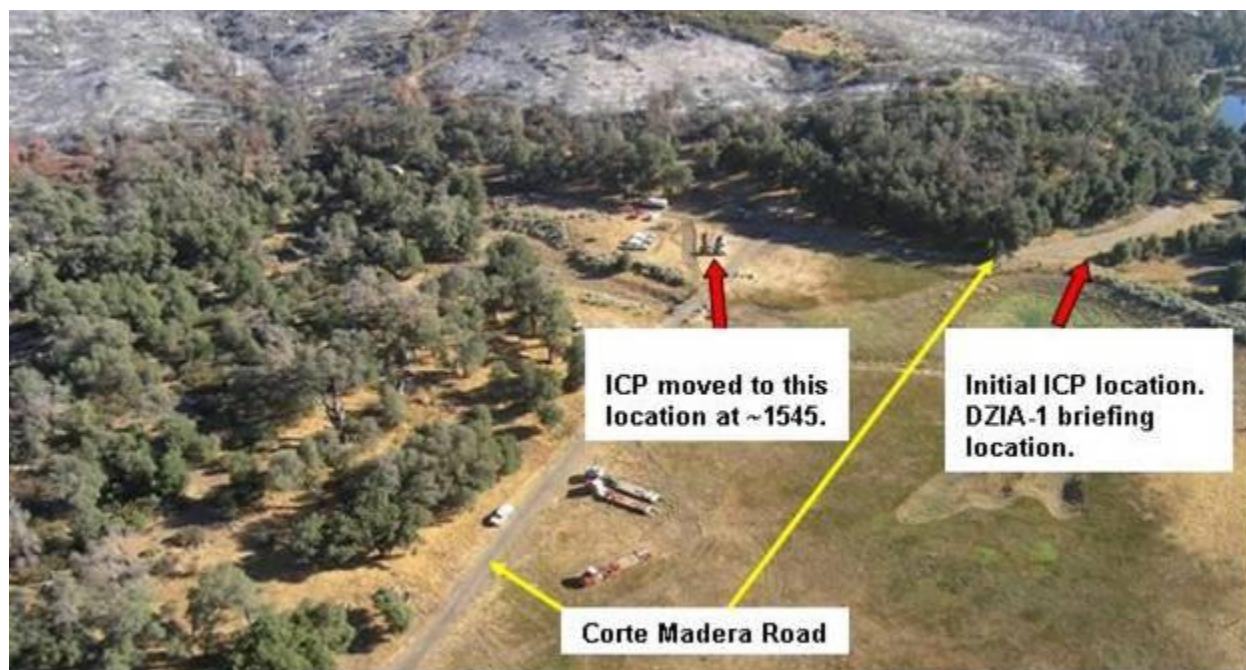
Photo 1 – Incident Command Post locations.

The Incident Command Post (ICP) was established on Corte Madera Road in Oak Valley just north of the left flank of the fire (photo 1).

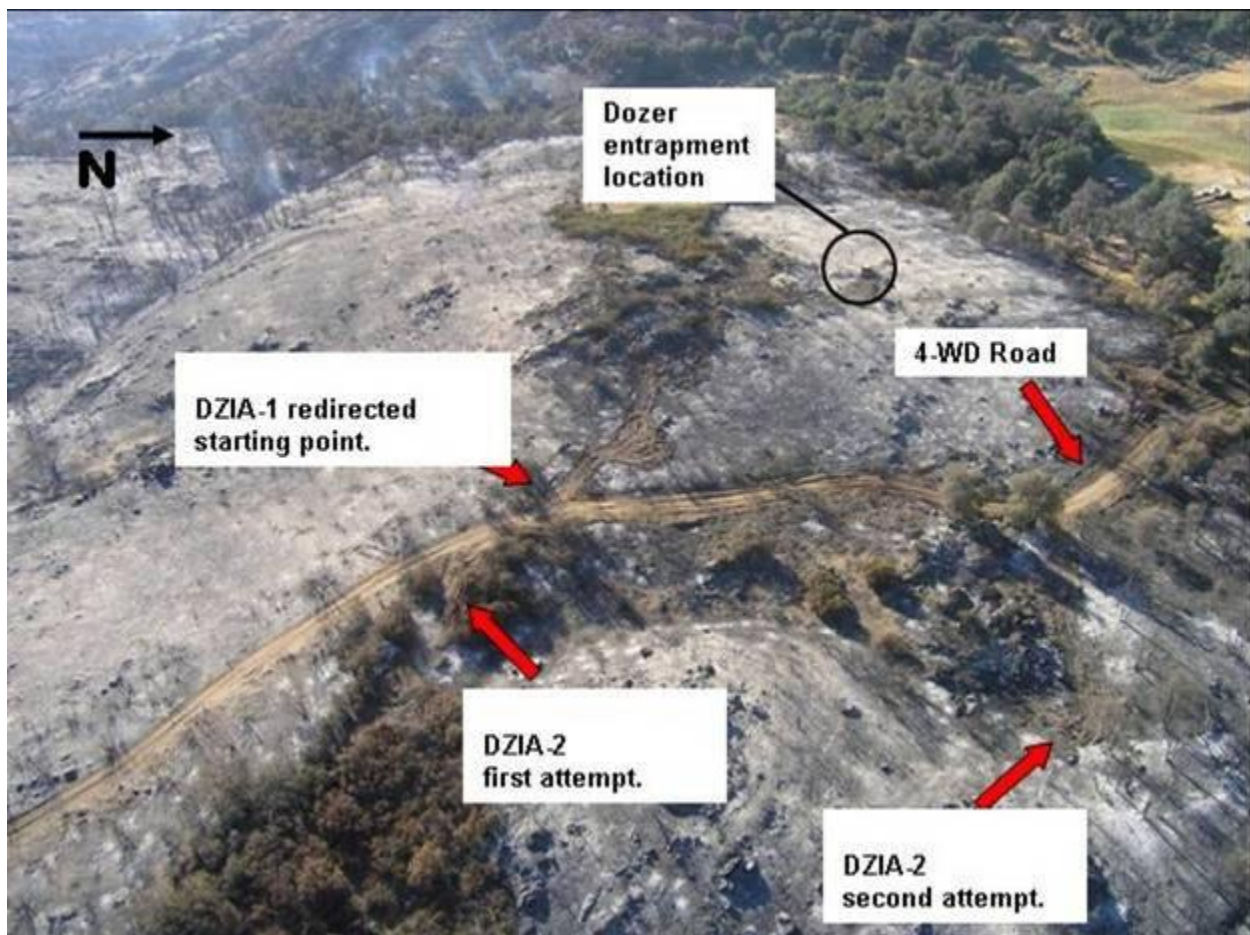
DOZB-1 directed DZIA-1 to anchor on Corte Madera Road and construct line toward the east. The dozer wasn't able to get to that area because of congestion on the road. At 1420 hours, after doing a reconnaissance of the fire area and adjusting dozer priorities, DOZB-1 found DZIA-1 working his way toward the left flank. DOZB-1 redirected DZIA-1 to an area east, and then south on a 4-WD road leading away from the ICP, and toward the center of the left flank of the fire. After going approximately 1/2 mile, DOZB-1 instructed DZIA-1 to begin constructing a direct line west, along the left flank, towards the heel of the fire at 1430 hours (photo 2).

Photo 2 – DZIA-1 and DZIA-2 work off 4-WD Road. View is looking west.

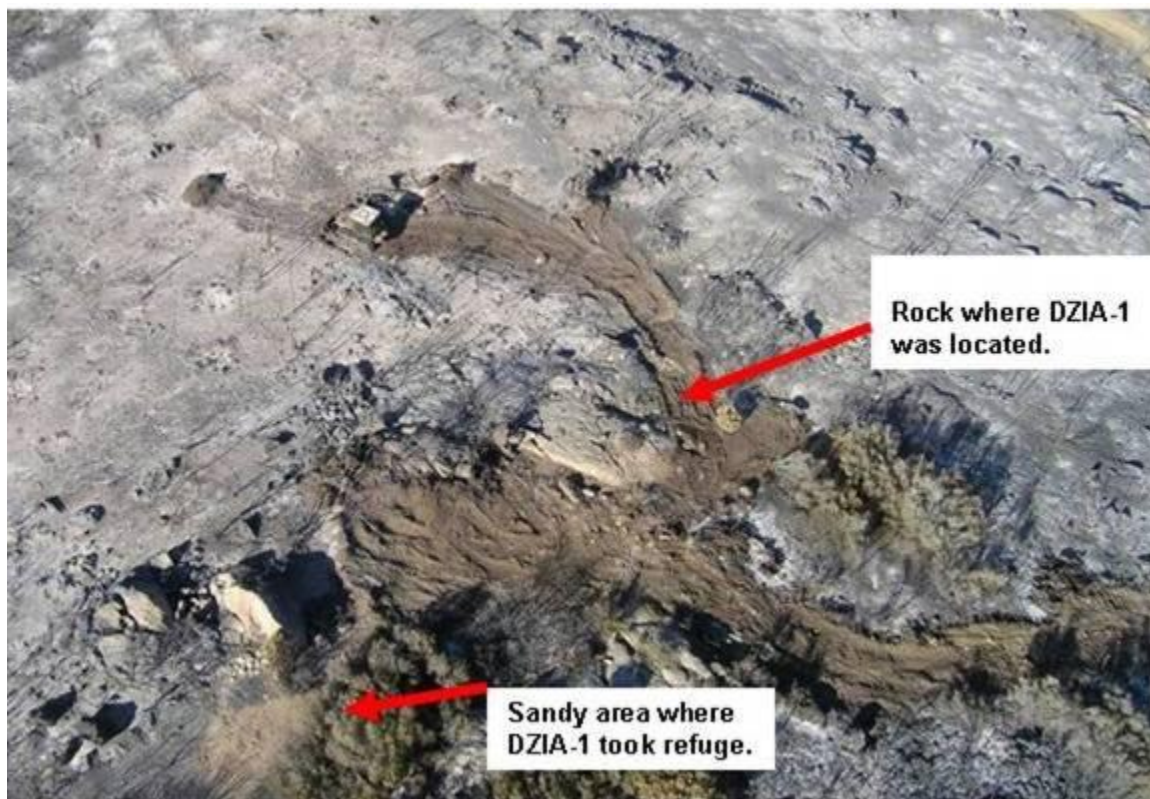
As DZIA-1 was widening the initial single pass line, brush that was piled near the left side of the dozer caught fire. Piled brush in front of the blade also ignited. Fire then began to spot to the right side of the dozer. DZIA-1 tried to reverse up his line but was unable to do so, as the engine stalled during the backing attempt after backing approximately 40 feet (photo 3).

Photo 3 – DZIA-1 was widening the initial line when the dozer stalled.

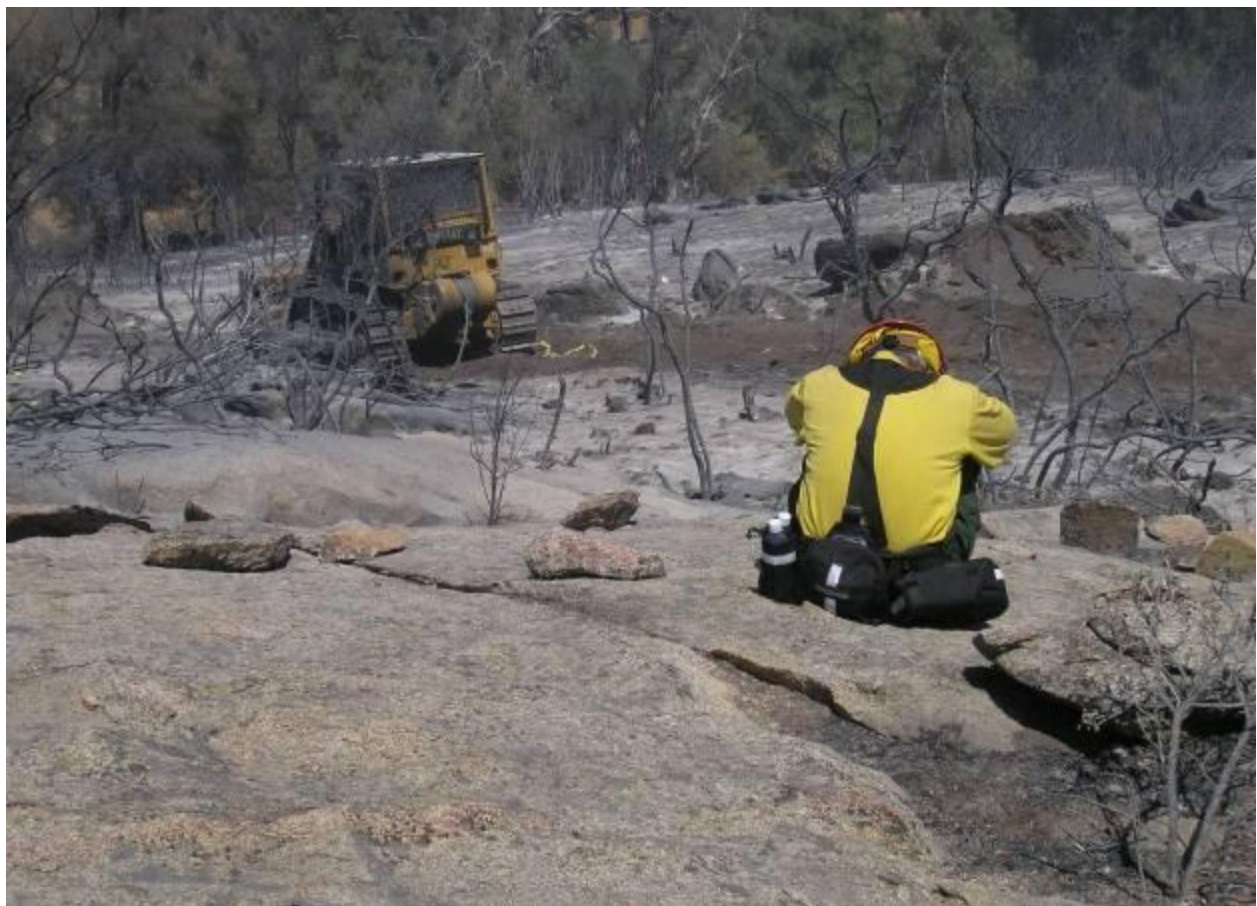
DOZB-1 and the SOFR walked south of the ICP into the burned area. At 1610 hours DOZB-1 spotted the burned over dozer, and the SOFR spotted DZIA-1 sitting on a rock approximately 80' from the dozer (photo 3, photo 4).

Photo 4 – Location, and position, that DZIA-1 was found in (re-creation).

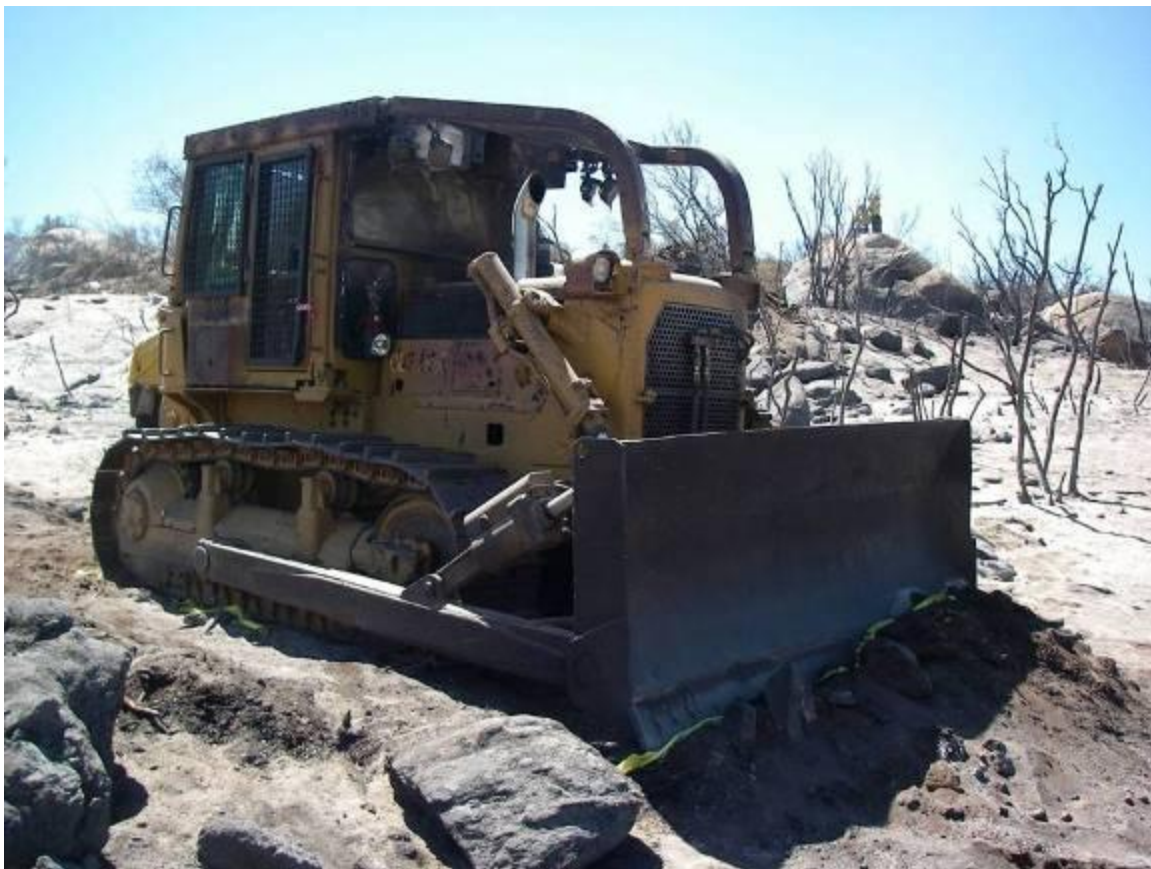
The Dozer was inspected by Gordon Gholson Cal Fire Southern Fleet Manager and John Dell ‘Orto, Fire Captain, Cal Fire Academy Automotive Battalion. Starting from the right front of the dozer then moved clockwise around to the right side of the dozer, the following are observations made during the inspection. The dozer blade is resting on a small dozer pile; the blade is covered with soot except for a portion that was covered with dirt during the entrapment (Picture 1).

Picture 1 – Right side and front of Dozer

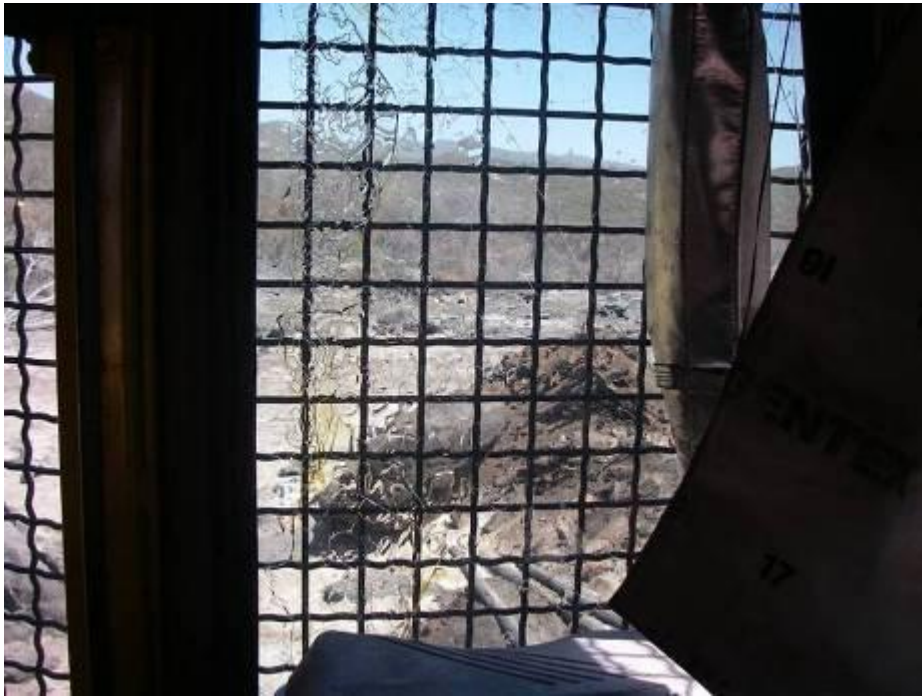
The right rear window had several meandering cracks with the laminate film melted and bubbled (Picture 2).

Picture 2 – Right-rear side window

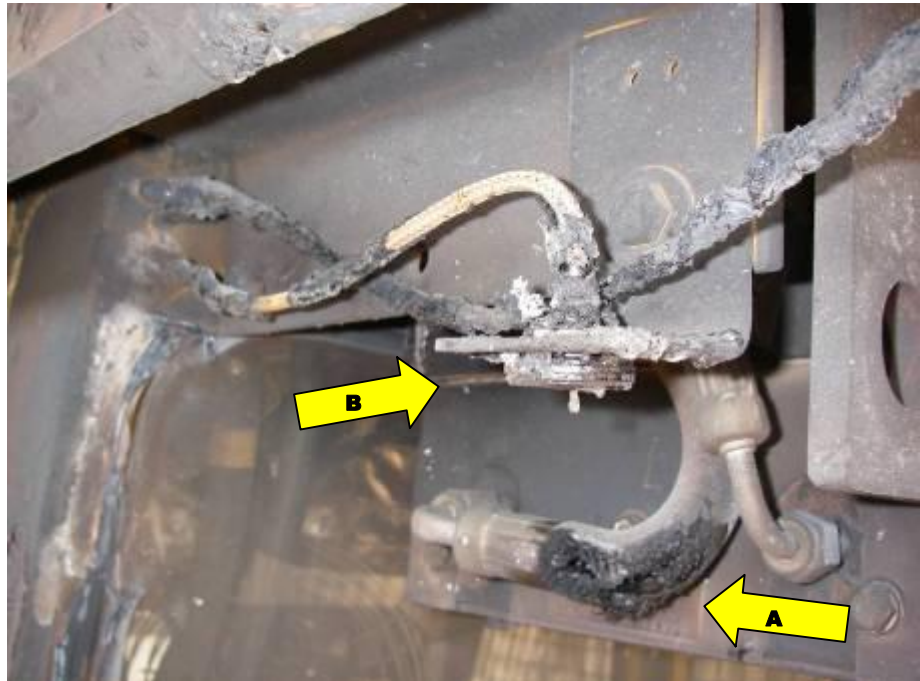
There was extensive burn damage to the air conditioning condenser unit mounted to the under side of the cab roof. One of the air conditioning hoses burned through (arrow A) allowing the coolant to leak out. The communications radio antenna burned off. The antenna was found lying on the ground directly below the antenna mount (arrow B) (Picture 3).

Picture 3 – Antenna mount.

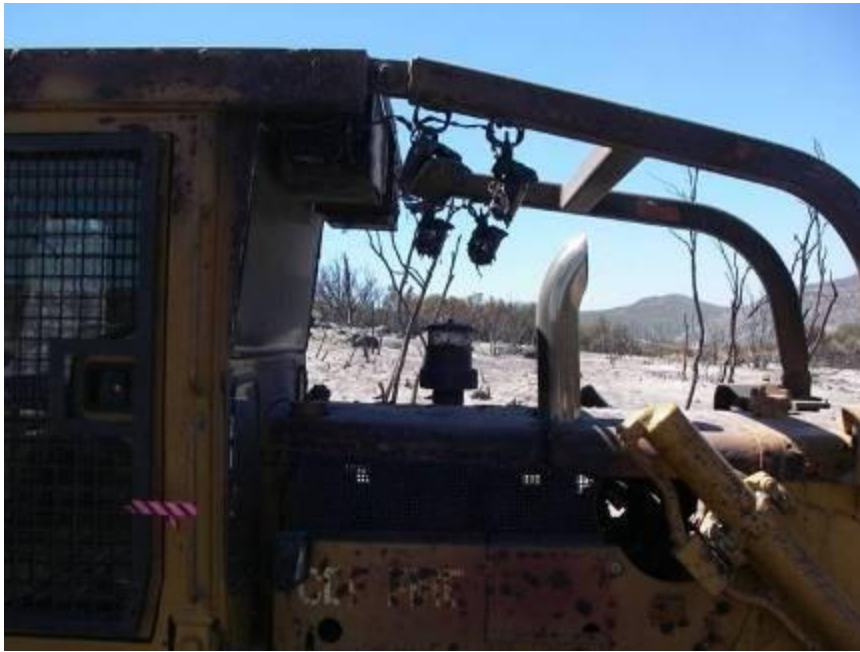
All the plastic light housings were melted (Picture 4a).

Picture 4a – Melted light housings

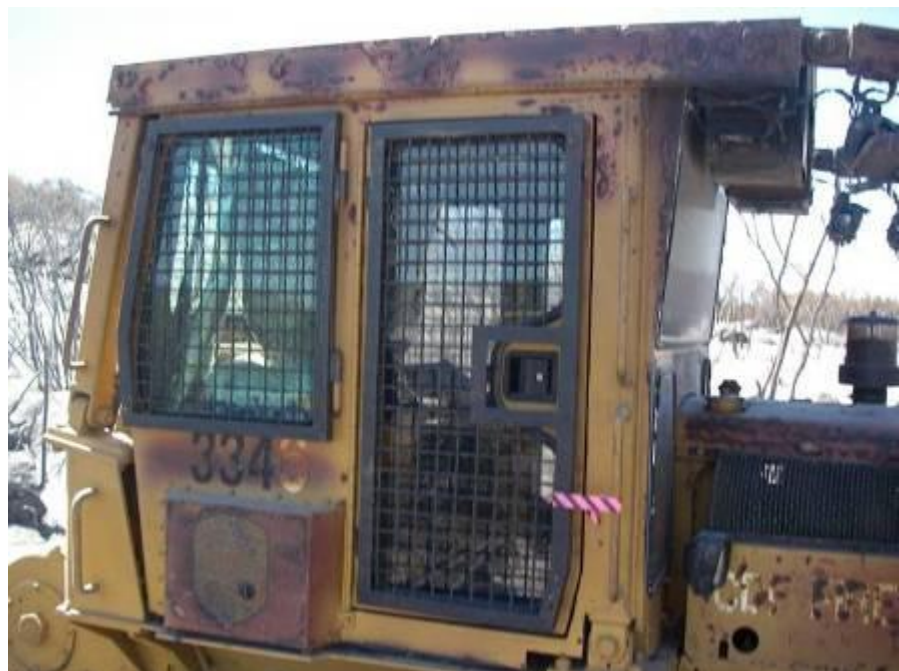
The paint and CDF decals were blistered randomly over the surface of the right side of dozer cab and battery box door (Picture 4b).

Picture 4b - Heat damaged paint and decals

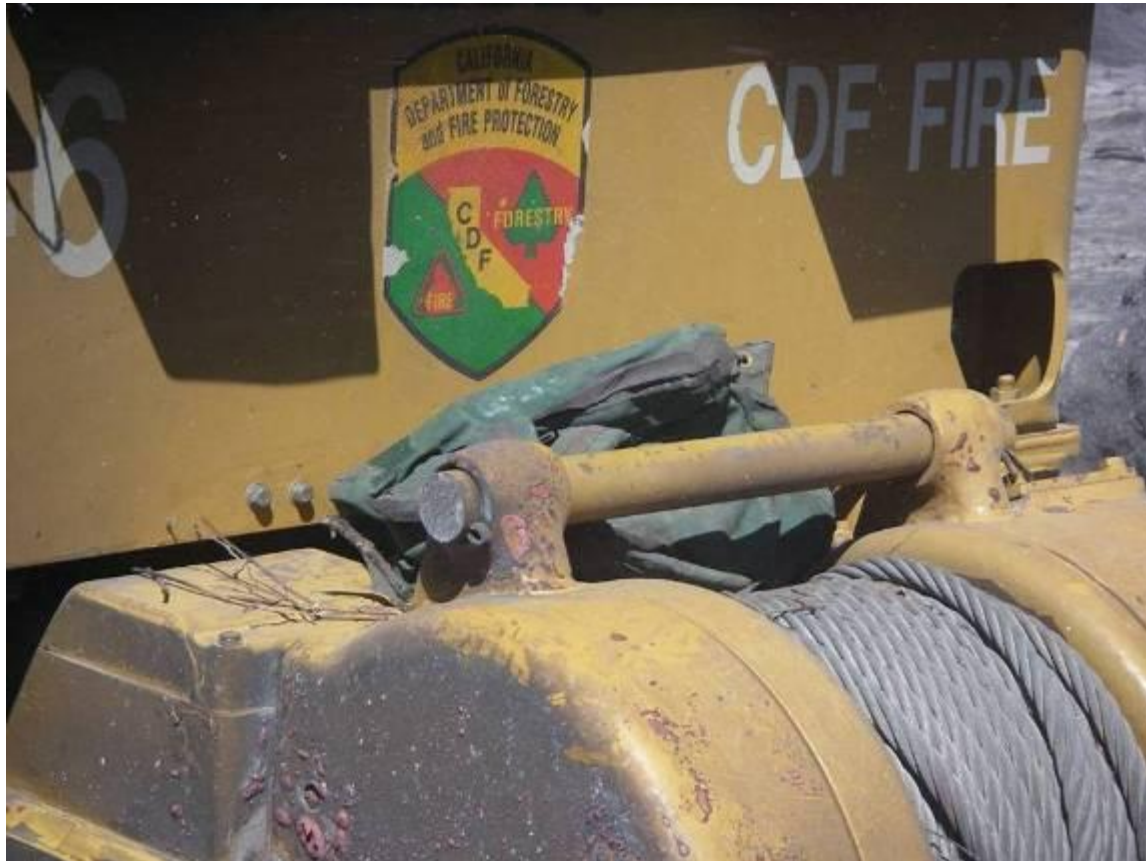
A green USFS knapsack containing fuses was lying on the top of the winch (Picture 5). Very little heat damage to the knapsack was observed.

Picture 5 – Knapsack with fuses.

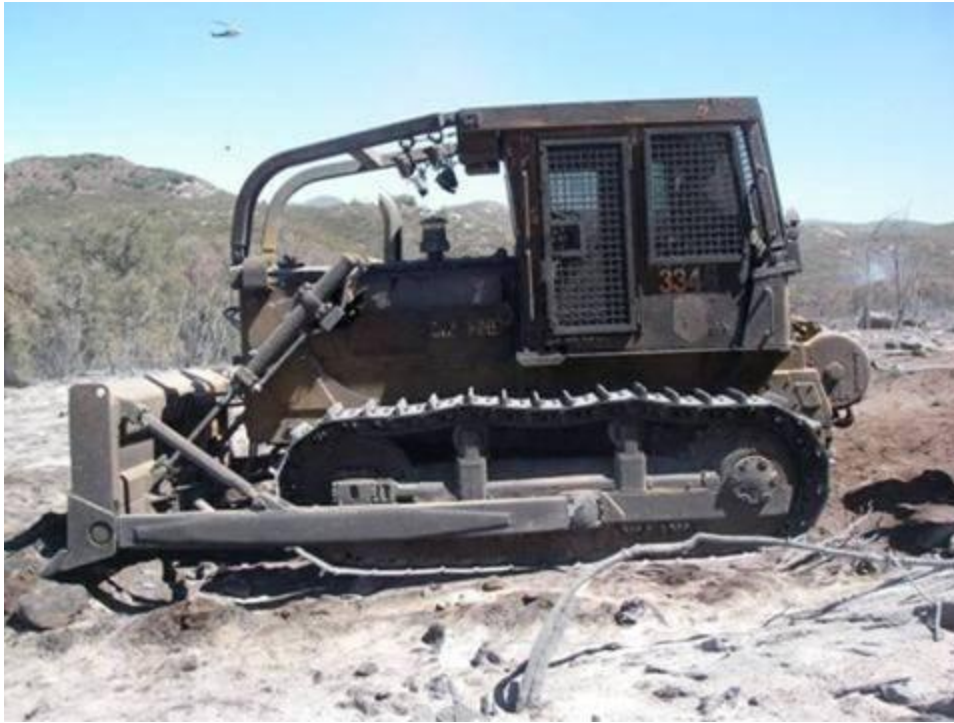
The greatest amount of burn and heat damage was observed on the left side of the dozer. Very little of the yellow paint was visible. (Picture 6)

Picture 6 – Left side of Dozer 3346

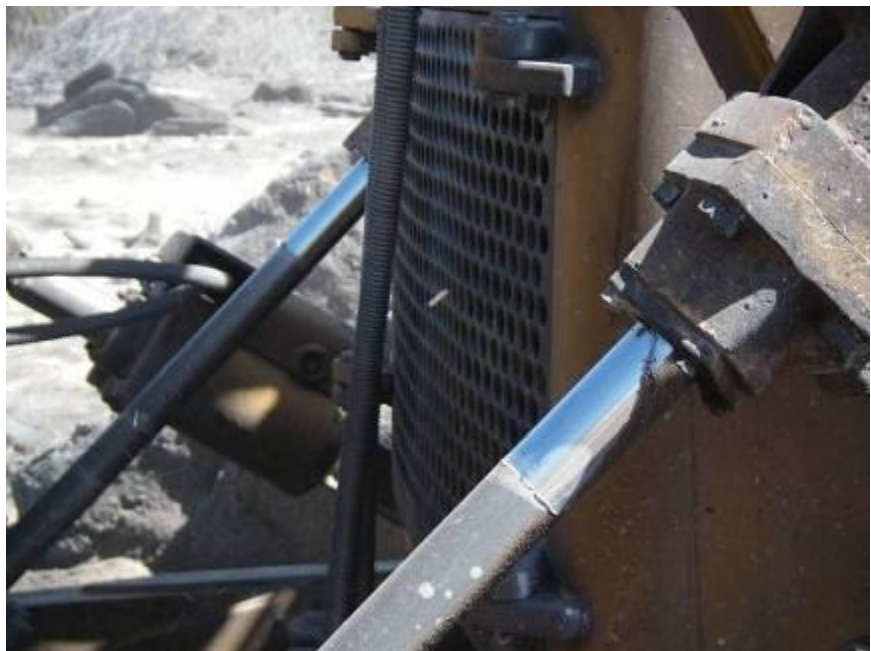
The left and right blade lift rams had an approximately 6 inch section of the ram below the cylinders that were clean indicating that the hydraulics had leaked down over night exposing a section of the ram not exposed during the entrapment.

This would indicate that the blade was not grounded during the entrapment. (Picture 7)

Picture 7 – Blade lift rams indicating bleed-down.

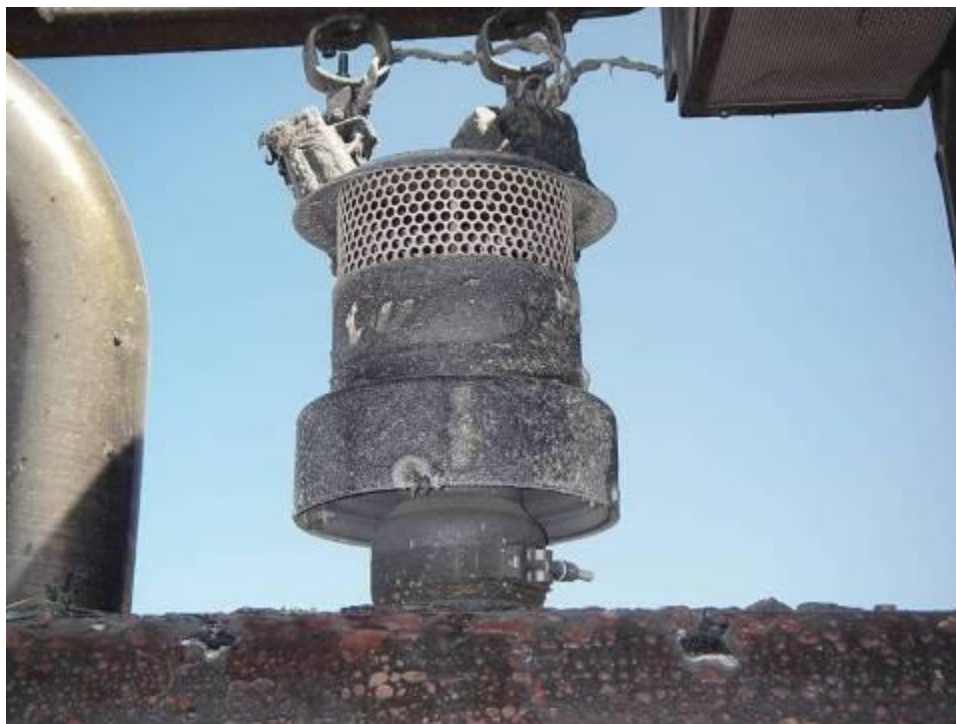
The engine air filter pre-cleaner showed significant burn and heat damage (Pictures 8a and 8b).

Picture 8a – Engine air filter pre-cleaner.

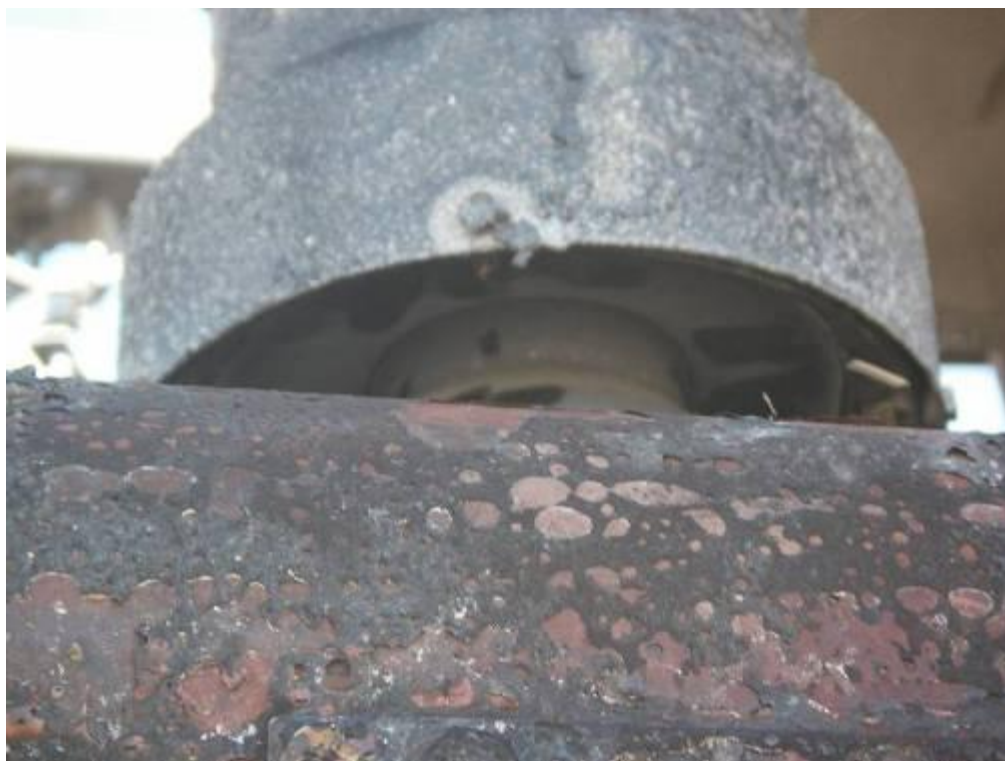
Picture 8b – Engine air filter pre-cleaner. Close-up of reducer mount.

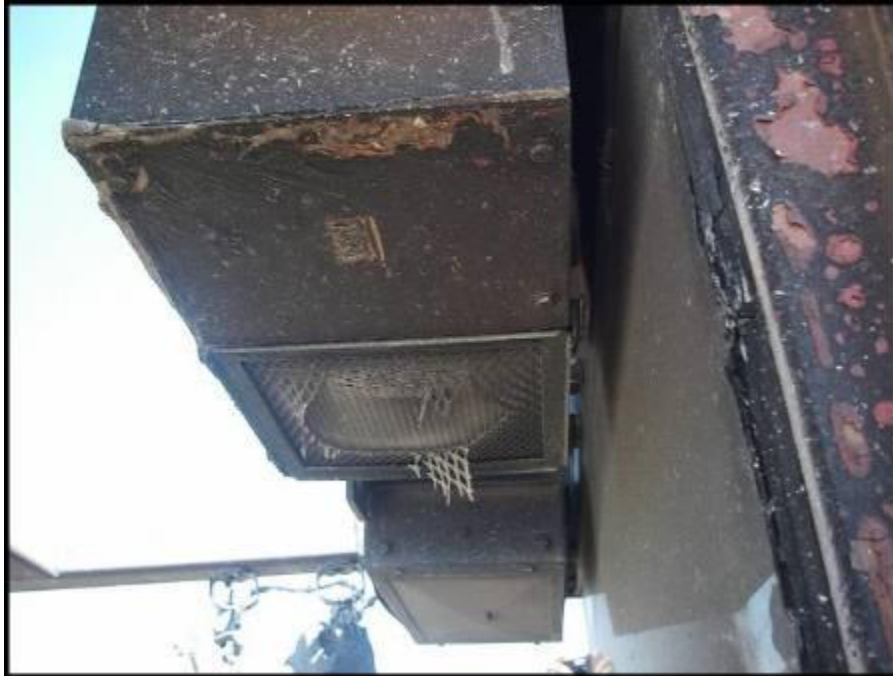
The cab air High Efficiency Particulate Air (HEPA) filter system had received extreme damage to the air intake screen and spark arrester. (Picture 9)

Picture 9 – Cab air intake (HEPA) screen damage.

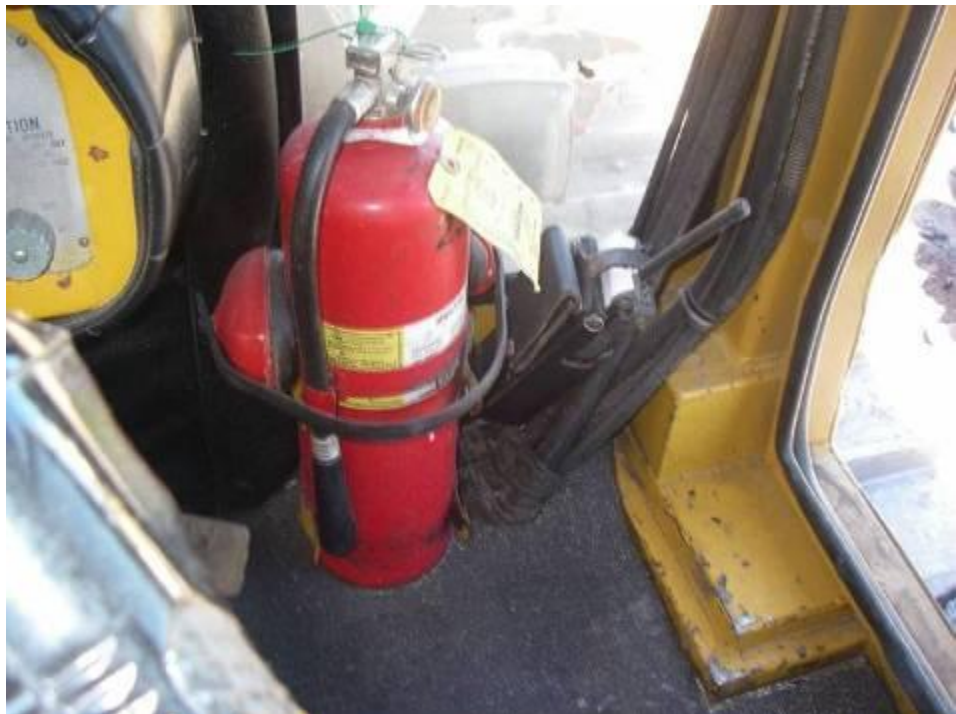
Opening the left and right dozer cabin doors, the neoprene door seals did not show signs of damage from heat or flame. (Picture 10)

Picture 10 – Right door seal and safety equipment (fire extinguisher, ear muffs, portable radio).

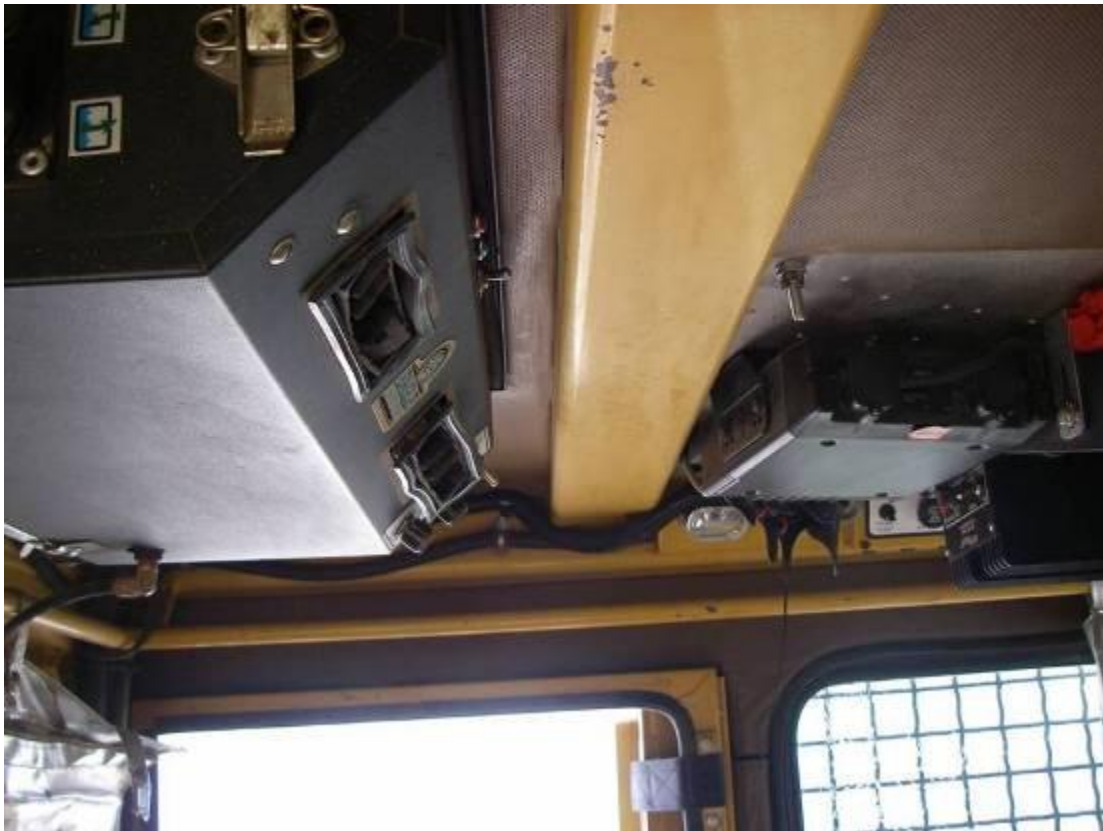
There are several corrugated plastic wire looms, wiring insulation, air conditioning vents and related components that are totally melted or at least warped out of their original shape. (Picture 11).

Picture 11 – Air conditioning vents melted and started to warp. Wire loom was melted.

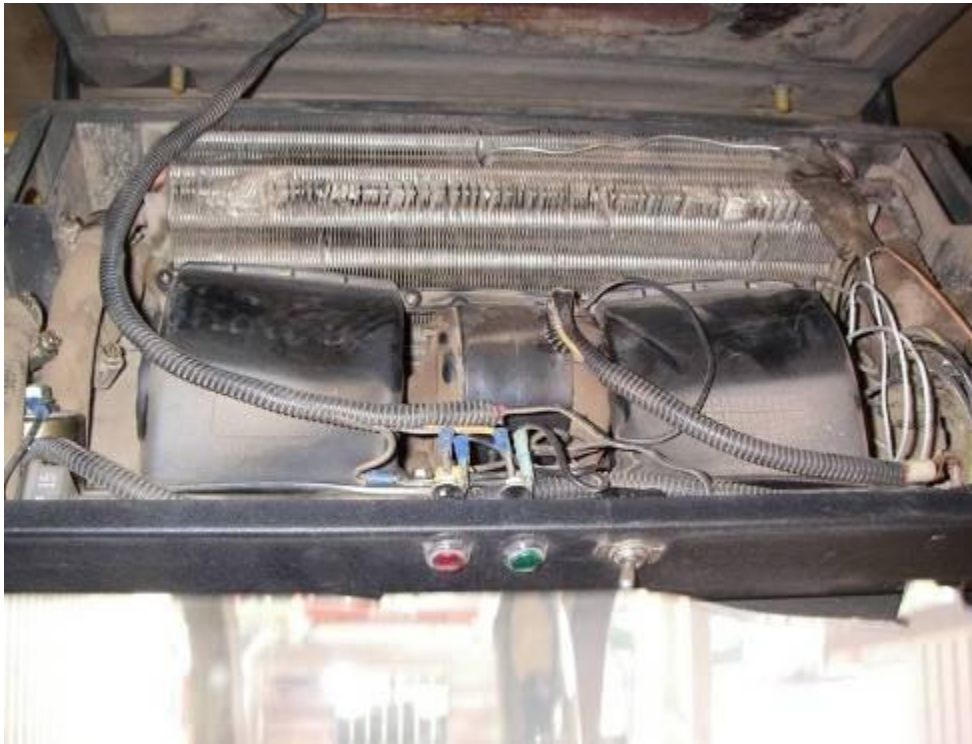
The cabin air intake control switch was in the off position (Pictures 12a and 12b).

Picture 12a – Looking inside cab air intake system.

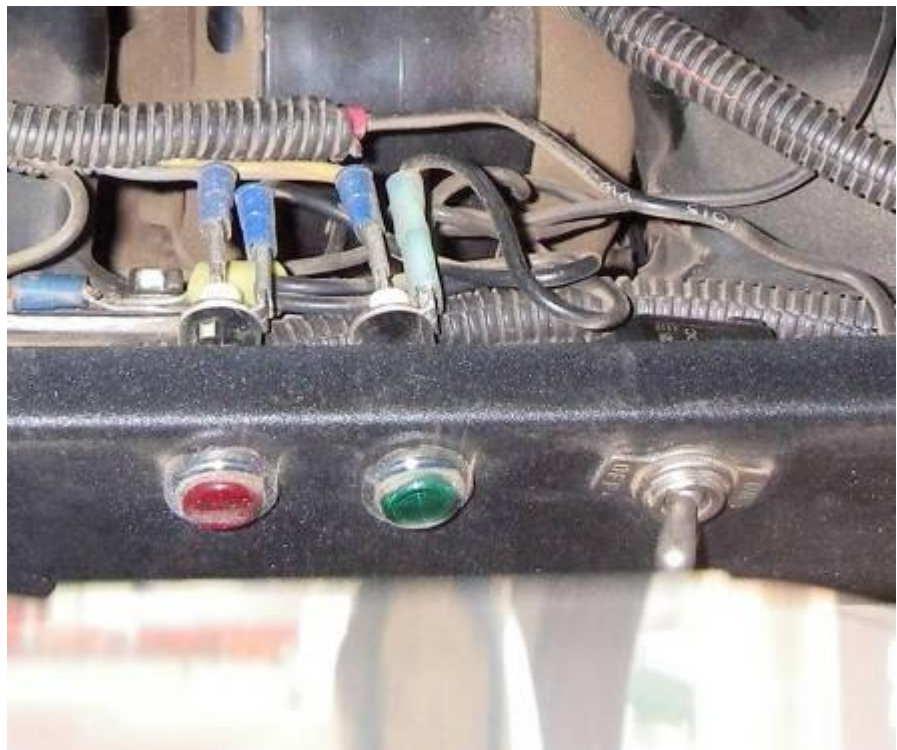
Picture 12b - Cab air intake system switch in "off" position.

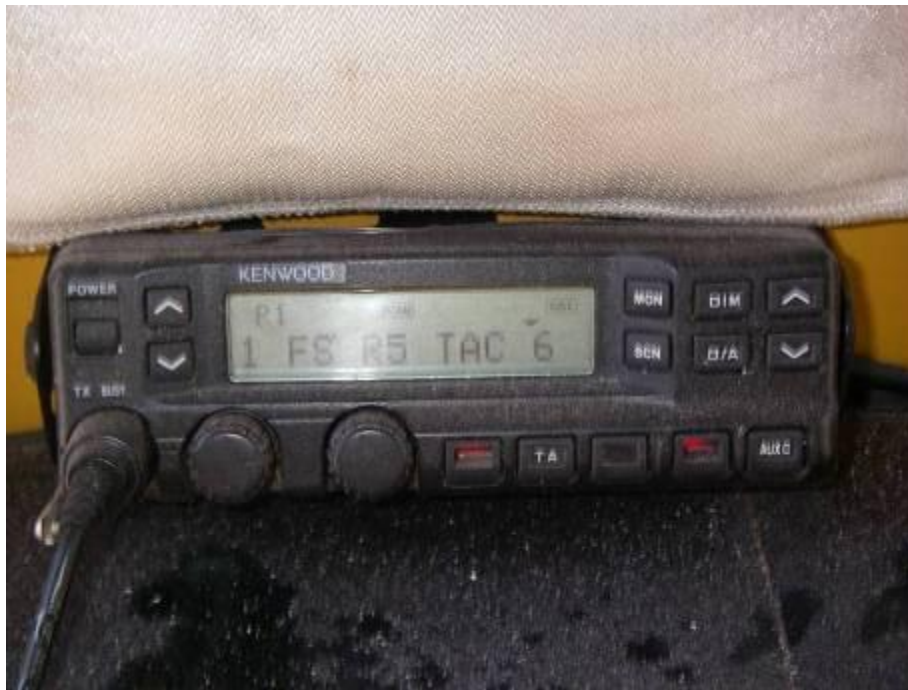
142) The dash-mounted radio was tested by Department of General Services Radio Tech. The microphone was found to be defective. The defect prevented the microphone from transmitting audio. The defect was at the connection to the radio head. The center locating pin on the connector appeared to have been cut or damaged. The microphone could be made to work intermittently if the cord was wiggled during transmission.

The dash-mounted mobile radio powered up. The radio display indicated the radio was set on FS R5 TAC 6. The scan feature was activated and the radio was scanning FS R5 Tac 6, CDF A/G, MVU LOCAL, CDF TAC 5, CDF CMD 1 (Picture 13a.)

Picture 13a – Dash-mounted mobile radio

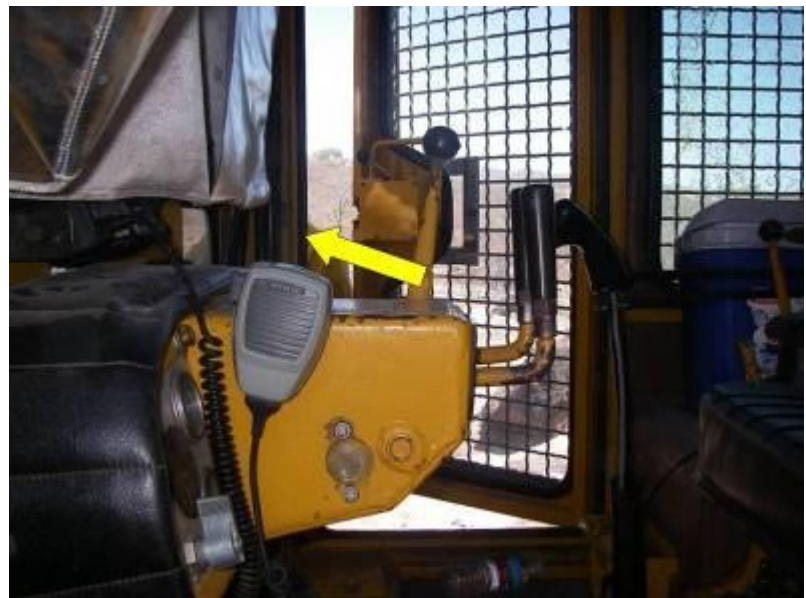
Picture 13b also shows that the front windshield fire curtain was rolled down but the lower front window flaps (see arrow) were still fastened with Velcro® and not dropped down to cover the lower front windows.

The rear fire curtain was also rolled down. Neither side curtains were deployed.
mounting clip

Picture 13b – Mobile radio microphone in

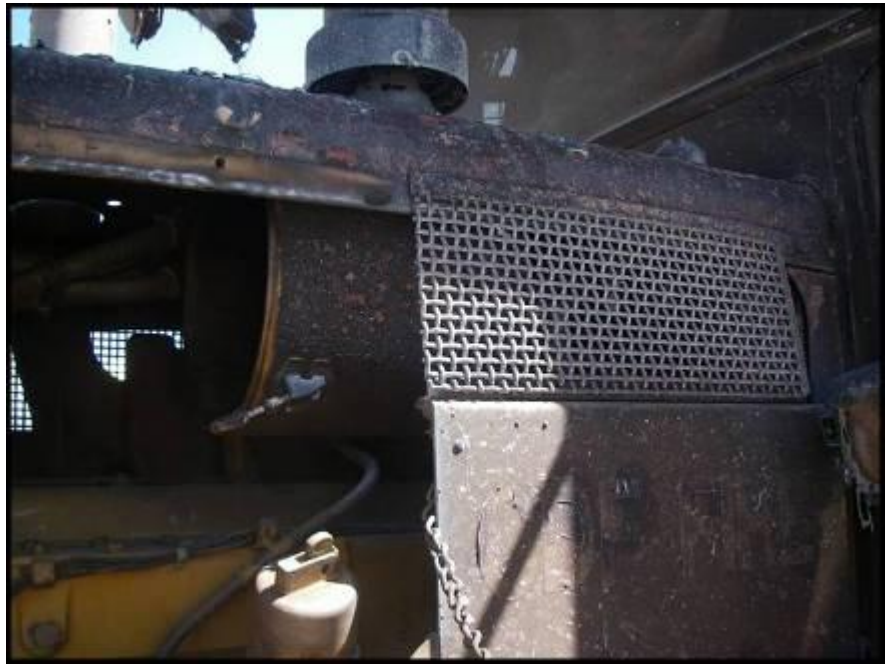
Picture 14 – Left side engine cover removed.

The left engine cover was opened to expose the engine air filter housing. The air filter housing cover was removed to gain access to the air filter elements (Picture 14).

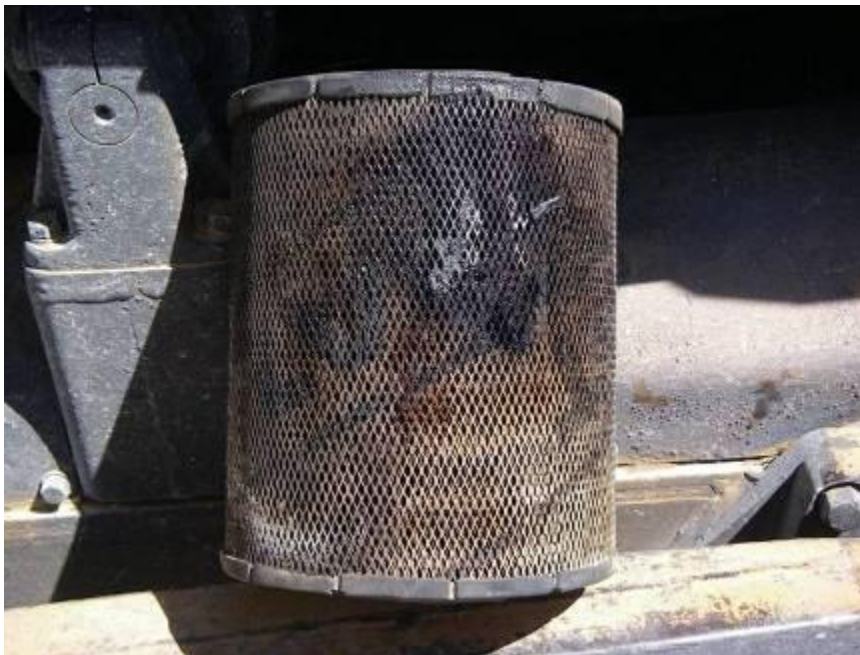
The primary air filter had a large area burned on the side of the filter facing up toward the inlet. (Pictures 15, 16, 17)

Picture 15 – Burned primary engine air filter.

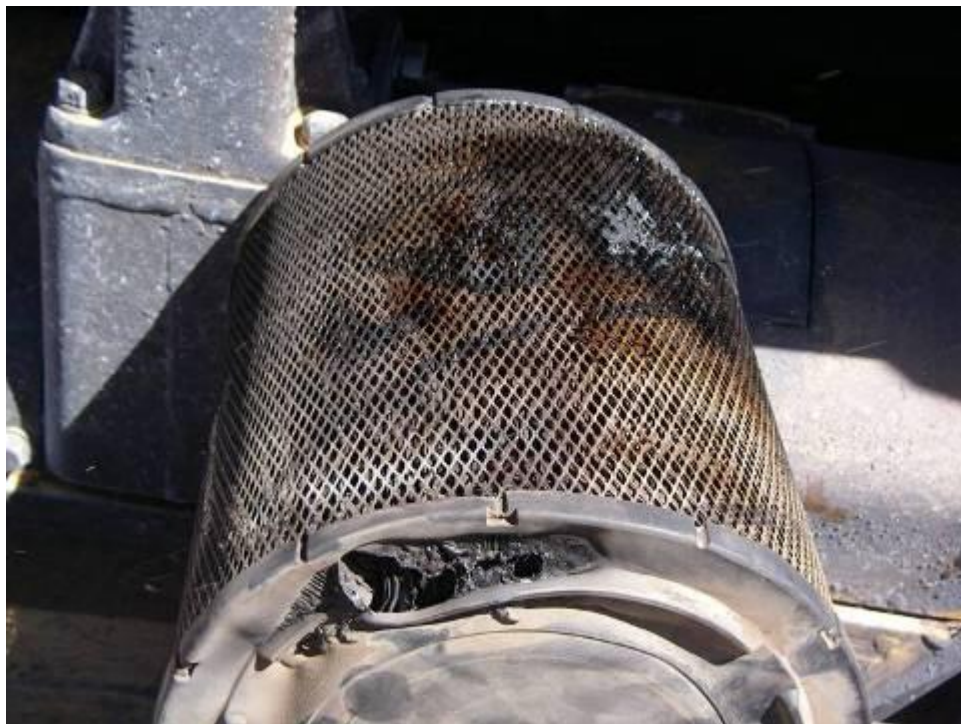
Picture 16 – Primary engine air filter showing burn through on end.

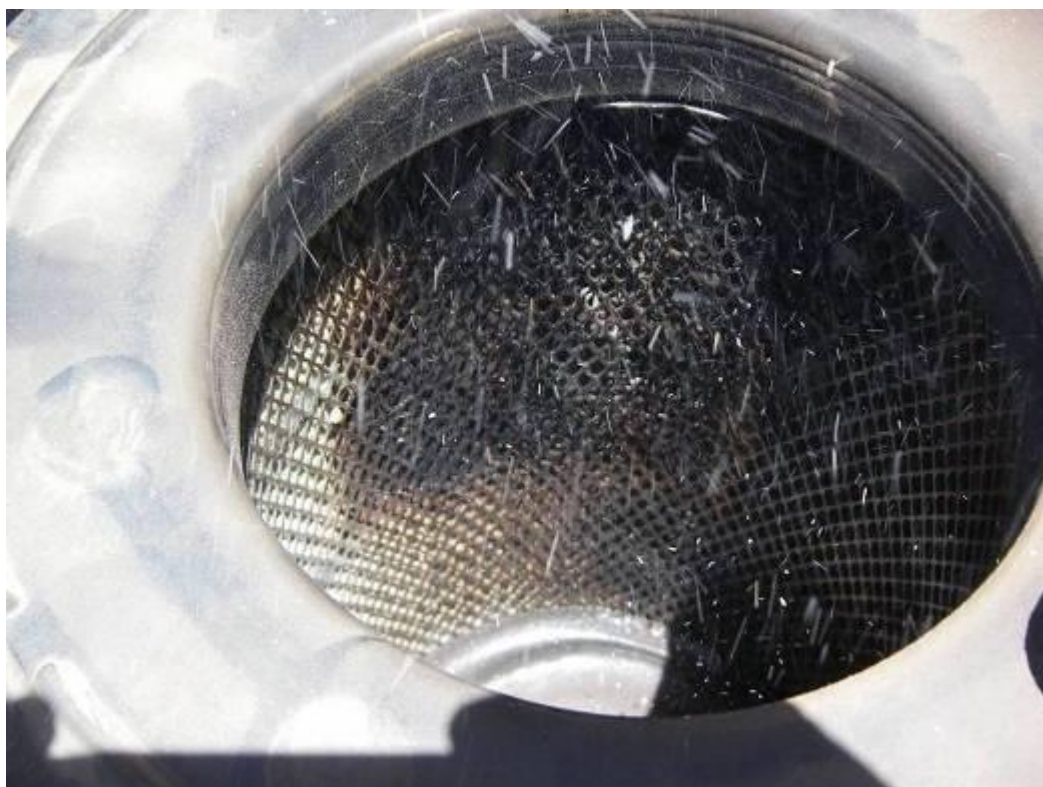
Picture 17 – Primary engine air filter, inside view.

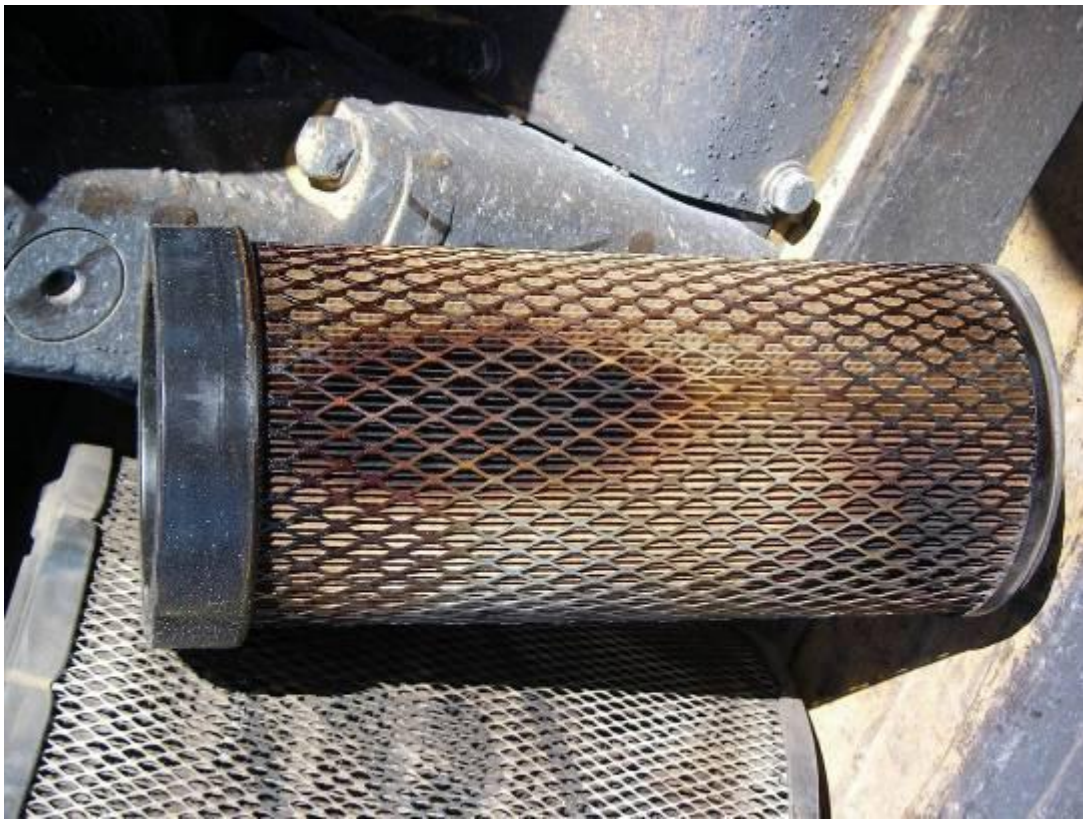
The secondary filter was scorched but had not burned though. (Picture 18)

Picture 18 – Secondary engine air filter.

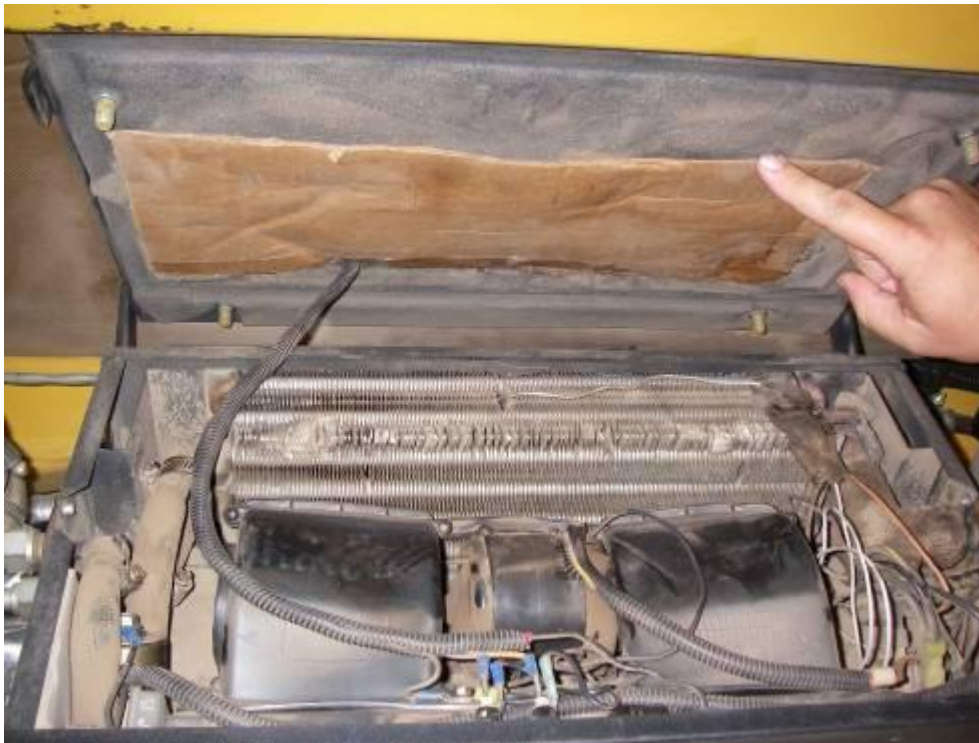
When the system was lowered, a piece of corrugated paper fiber cardboard was found inserted over the fresh air inlet blocking fresh air supply to the air conditioning system and cab. (Pictures 20a and 20b).

Picture 20a – Corrugated paper fiber cardboard blocking fresh air inlet.

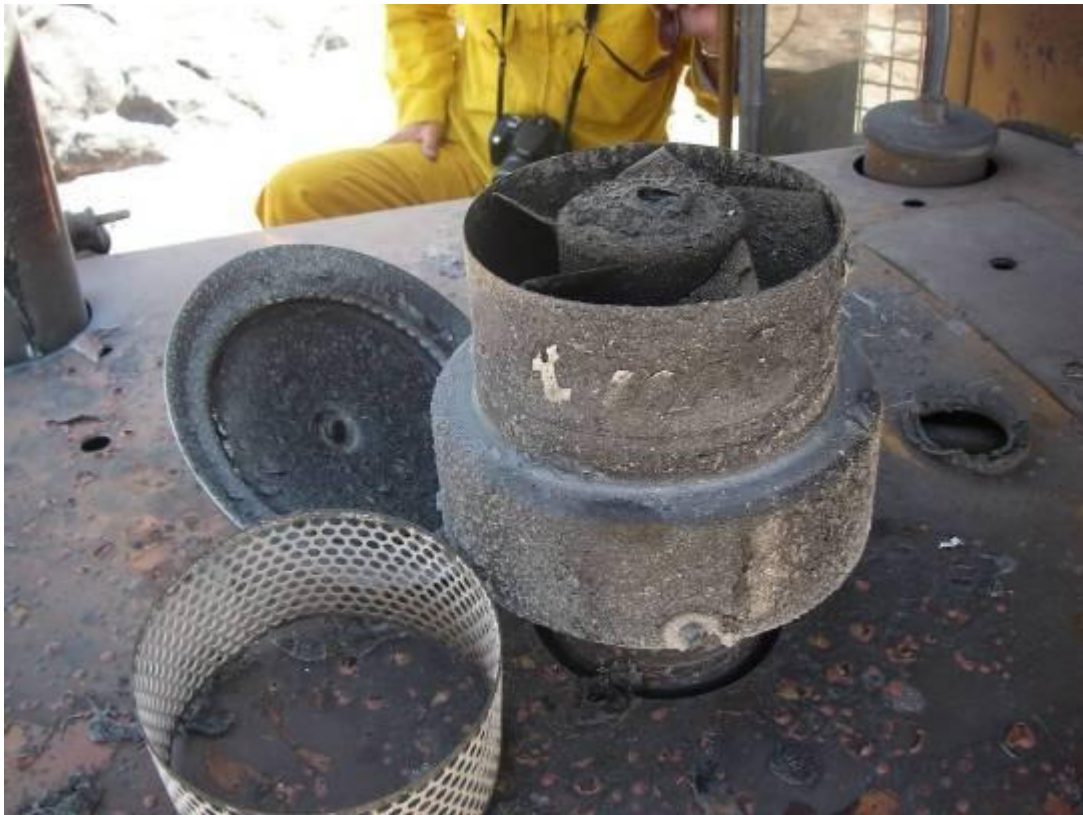
The engine air filter pre-cleaner had been modified from the original equipment to an after-market, Maradyne Corporation, Turbo Pre-cleaner, Turbo II - Model 24 (Picture 21.)

Picture 21 – Engine air pre-cleaner with top cover removed.

After researching the product applications it was discovered that the Turbo II, Model 24 is not the correct unit for Dozer 3346, and could cause the engine to have a significantly restricted engine air supply. The Turbo II - Model 24 is for a 100 to 250 CFM rated engine. Dozer 3346 has a D333C diesel engine requiring 650 cubic feet per minute under maximum load. According to the manufacturers guide the correct model for a Caterpillar D333C diesel engine is a Turbo II - Model 46 pre-cleaner providing up to 650 CFM.
