GREEN SHEET

Informational Summary Report of Serious CAL FIRE Injuries, Illnesses, Accidents, and Near Serious Accidents

Firefighter and Fire Crew Inmate Injuries

Salt

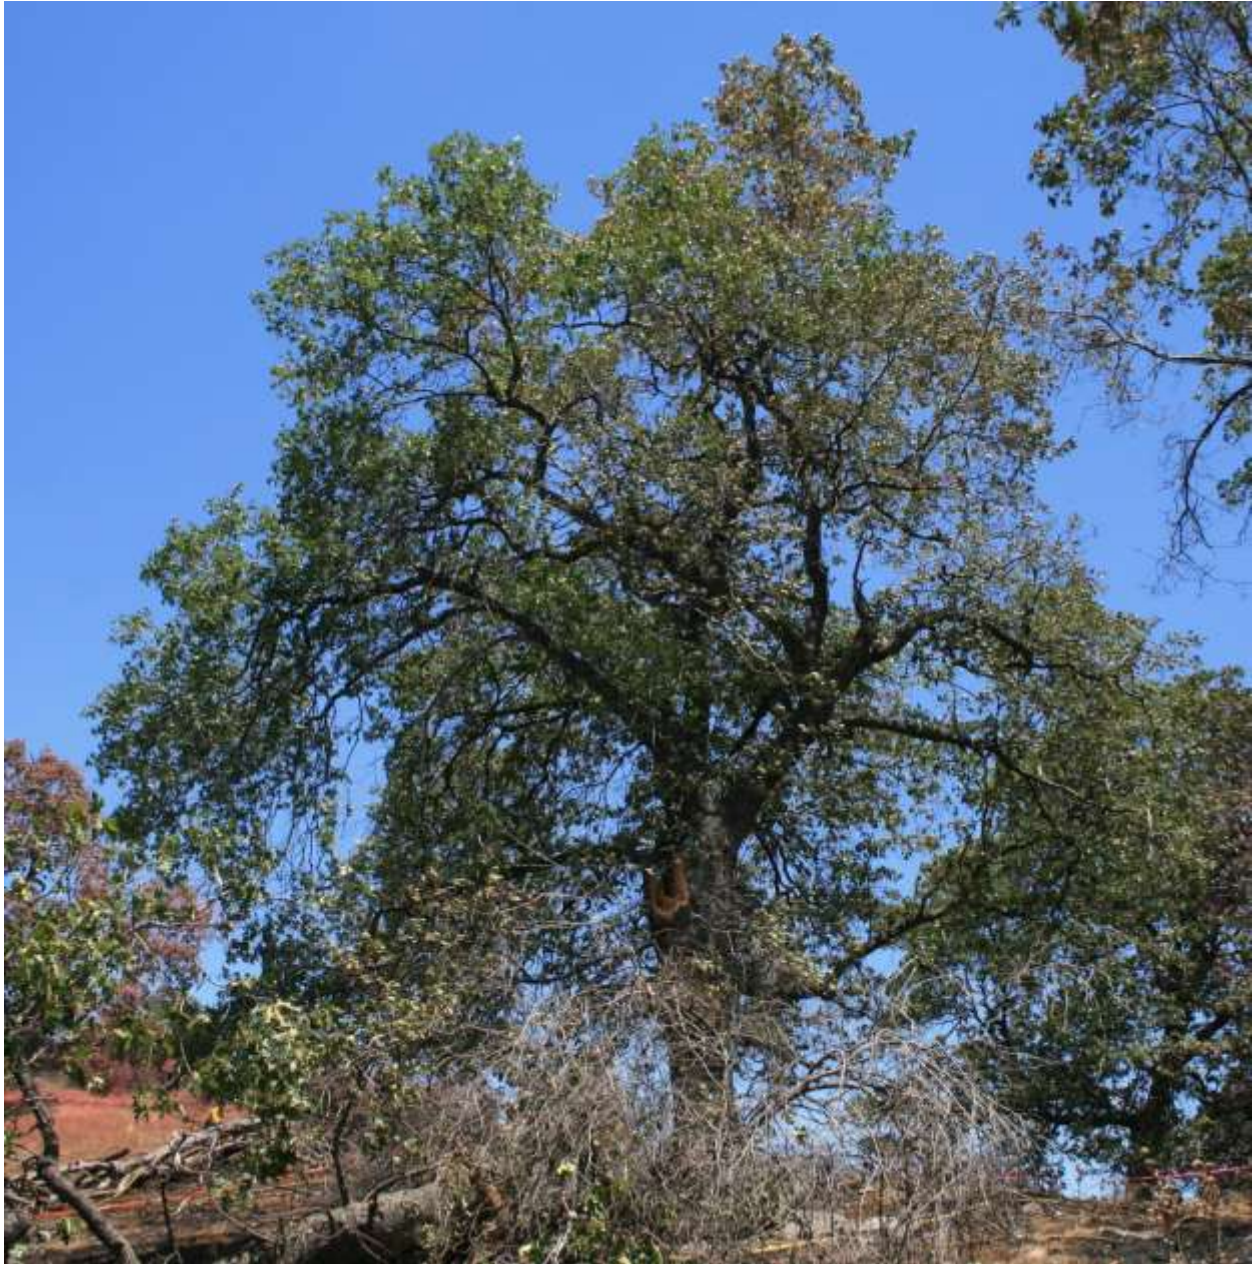
Tree 1 was a California black oak, approximately 46 feet tall, with a 34.2 inch DBH. Tree 1 had a fork approximately 3.9 feet from the ground and split into two limbs. Limb 1 had an 18.8 inch diameter just above the fork. Limb 1 broke at 11.5 feet above the ground. Limb 2 had a 21.2 inch diameter just above the fork. Limb 2 was the main leader and grew near vertical with several limbs branching off of it. Limb 1 had a slope of approximately 70° and leaned to the southwest. Tree 1 appeared to be overall a healthy tree. There was evidence of rot within the tree, which is common for oaks.

Looking north at Tree 1 California Black Oak, approximately 46 foot tall. Notice the broken Limb 1 near the middle of the photo.

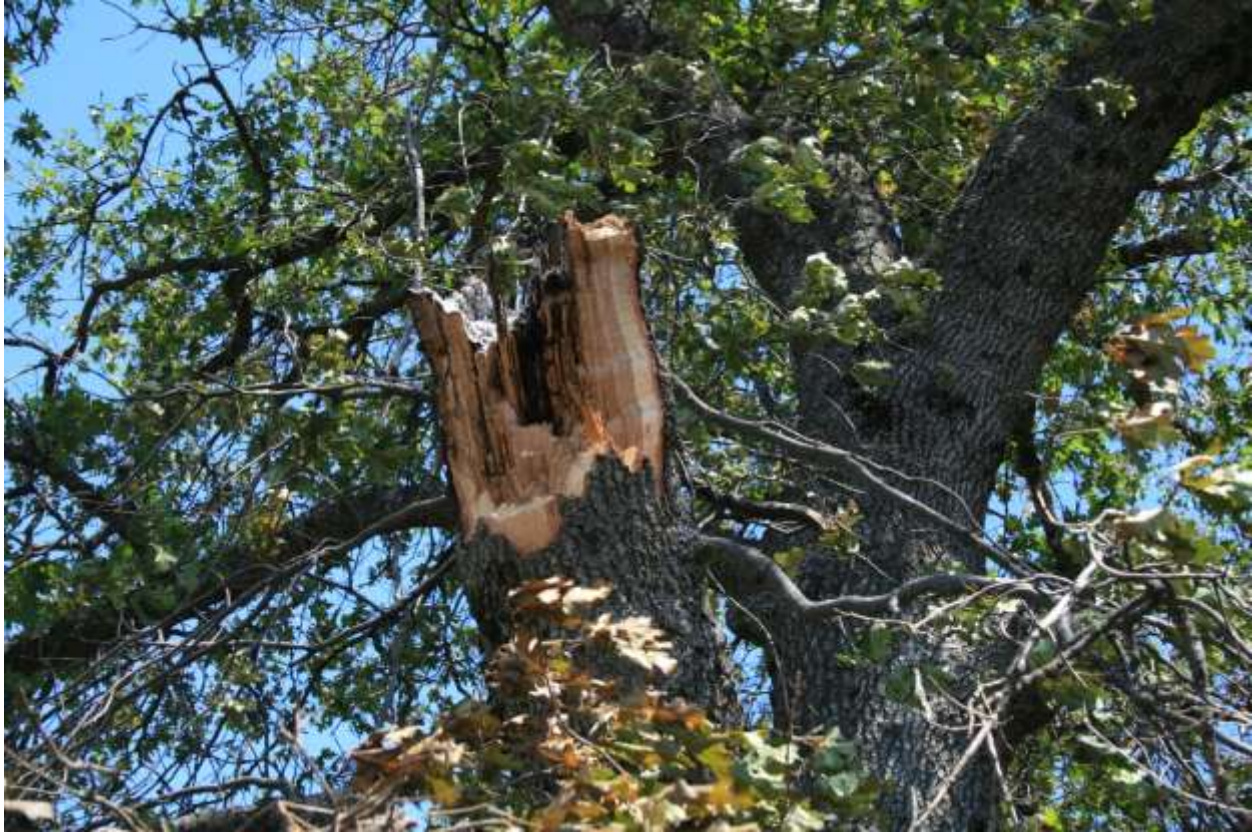
Limb 1 had a diameter of 17.5 inches at the break and was 38 feet long after the break. It was observed that Limb 1 had heart rot. Limb 1 had several loose knots or rotten knots along the limb. These types of knots are potential fuel beds for fire embers. On the back side, where the limb failed, there was evidence of a knot. The knot crevasse was observed to have heat and fire damage. Fire had burned the tension wood, releasing the weight of the limb similar to a chainsaw "back cut." When the tension wood was released, the tree was no longer able to support the weight of the limb and the limb failed and fell to the ground.

View of Tree1 from ground showing Limb 1's break. Notice the charring at the back side.

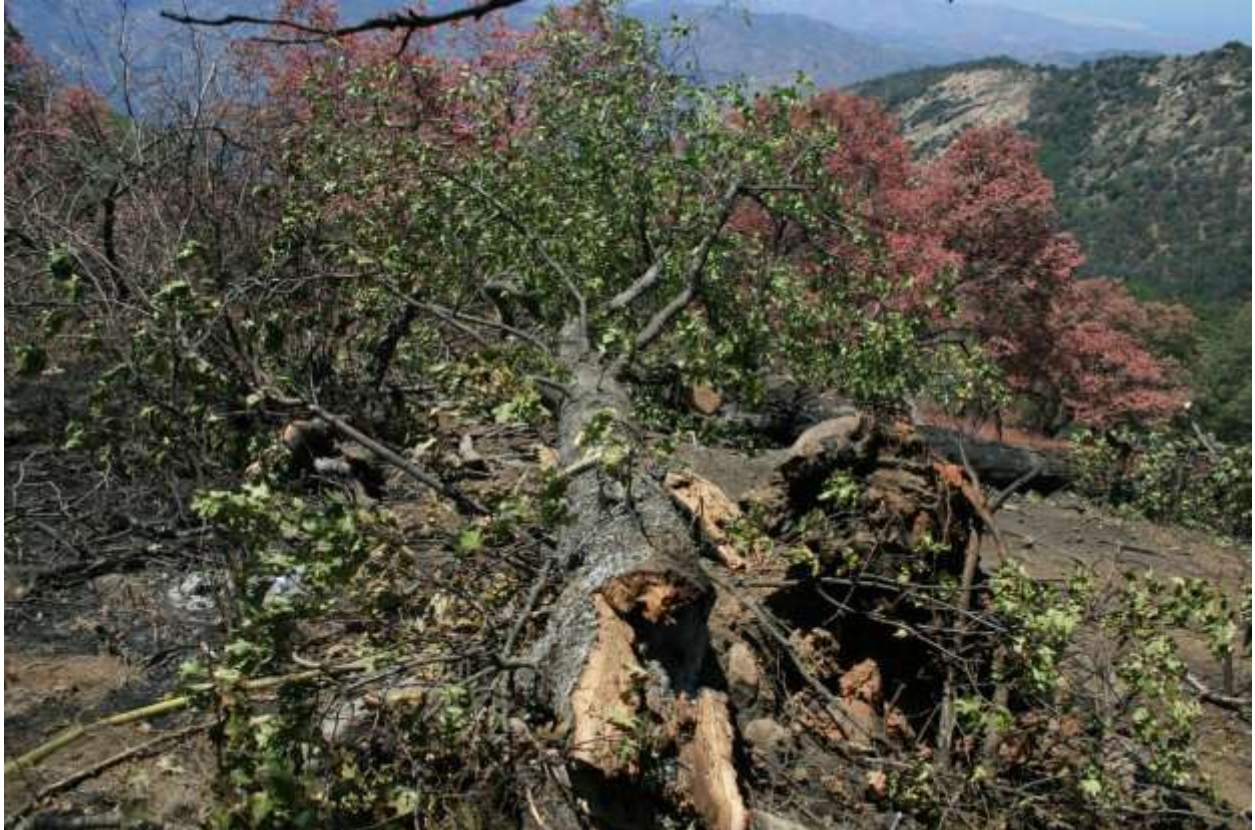
View of the broken portion of Limb 1. Notice the char on what would have been the back side of the branch. To the right is the downed burned tree that FF1 was mopping up at the time of the incident.

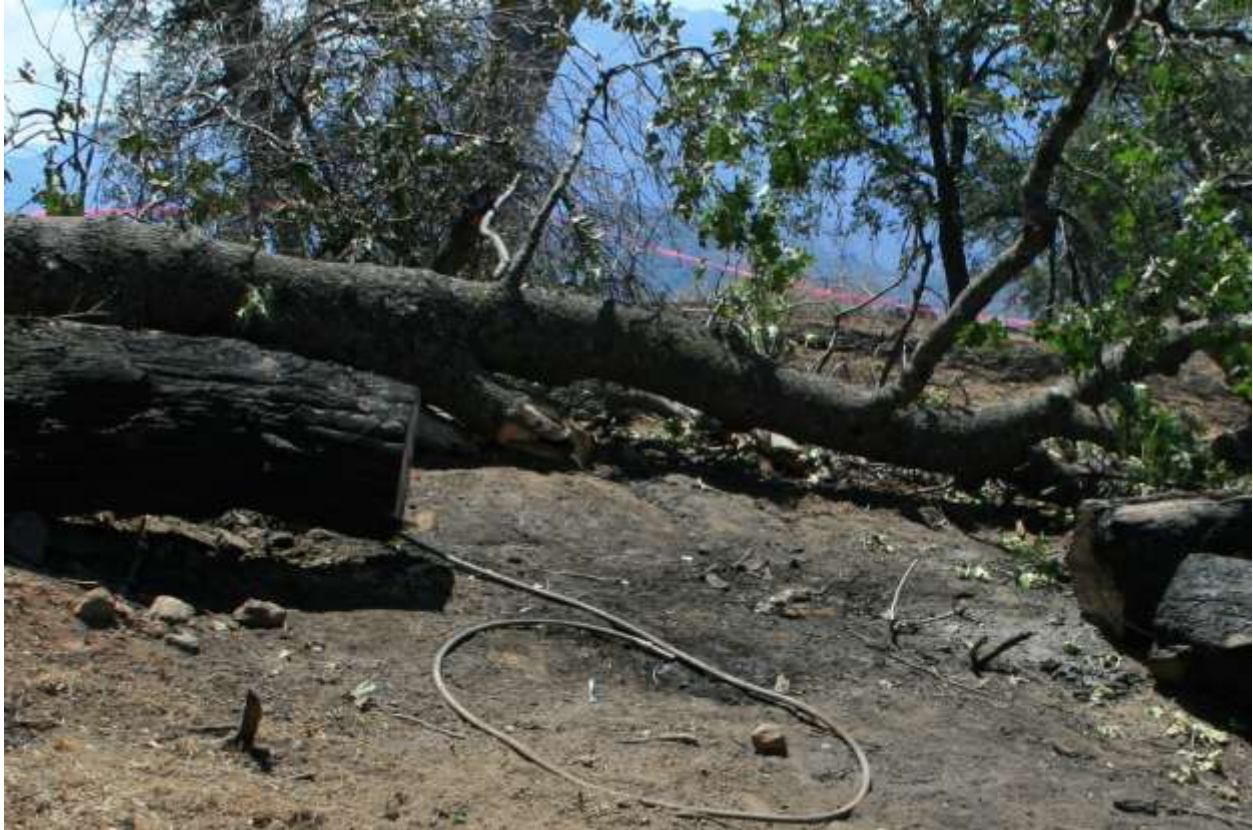
View of where FF1 was working between the fallen Limb 1 and the downed burned tree. FF1 was pinned under fallen Limb 1, showing at the middle of this photo.

1. Always wear full safety gear while actively engaging in firefighting and mop up operations at fire.
2. Beware of drought stressed trees, because they can be more receptive to embers and ignition.
3. Beware of hidden fire in trees and tree branches, watch for signs of smoke.
4. Be aware of where you are walking, standing and what you're working under; look up, look down and look all around.
