FLORIDA DEPARTMENT OF AGRICULTURE & CONSUMER SERVICES

SUBJECT: Donald J. Armstrong Burn Incident Report

GENTILE FIRE REVIEW
Fire Shelter Deployment Incident
Forest Ranger Donald J. Armstrong Burn Injury
Lake County, Florida
May 31, 1989

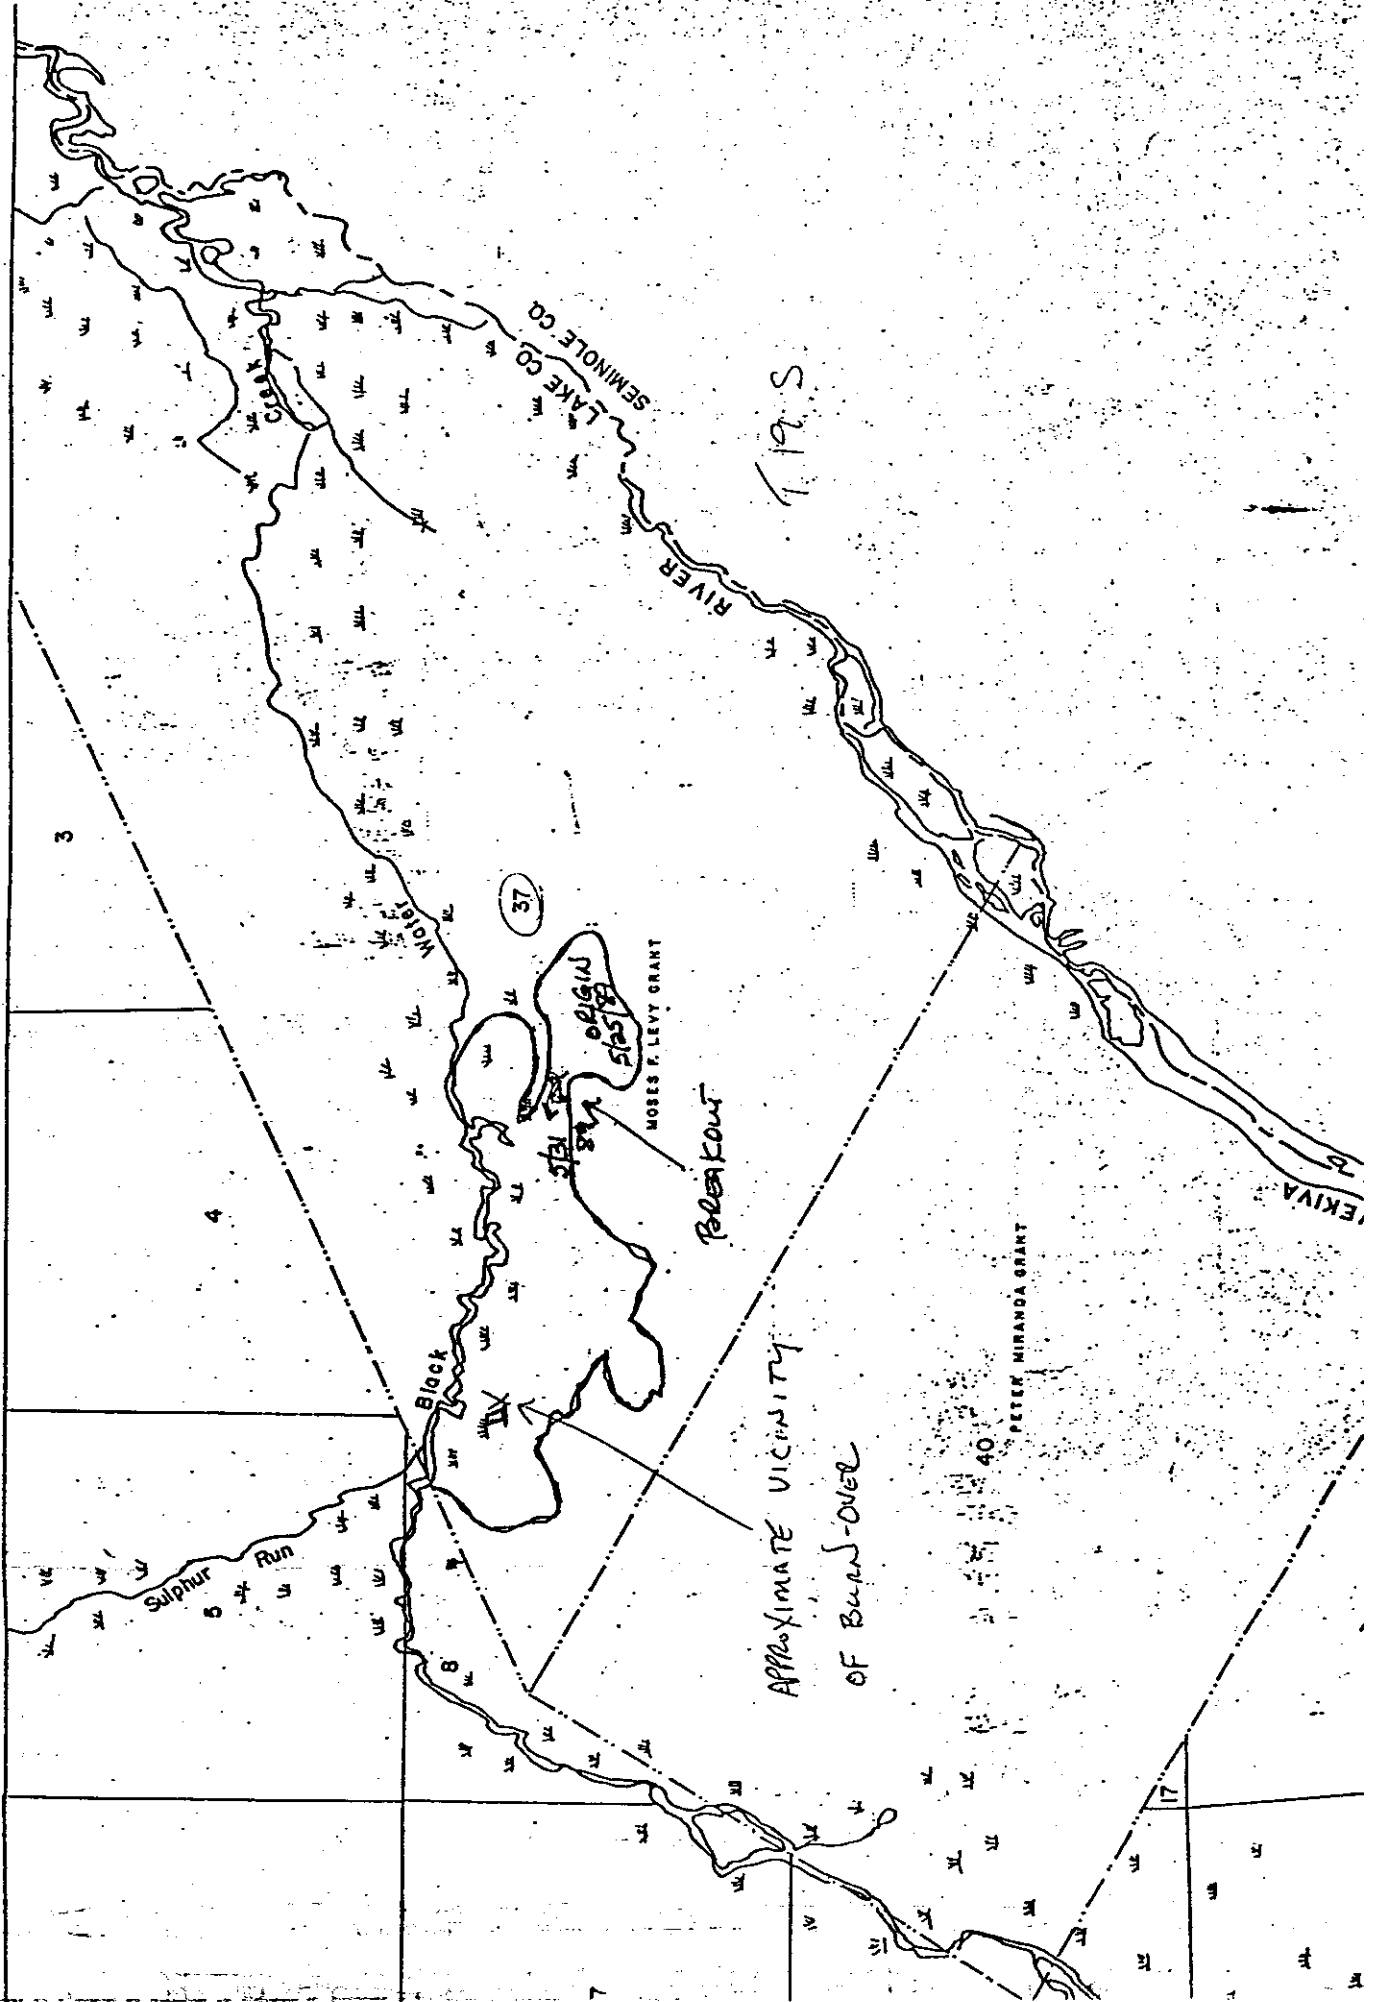
GENERAL OVERVIEW OF
SCENE WHERE RANGER
ARMSTRONG'S INCIDENT
OCCURRED.
