# Informational Summary Report of Serious or Near Serious CAL FIRE Injuries, Illnesses and Accidents

## GREEN SHEET

### Helicopter Wire Strike

Bayliss Incident

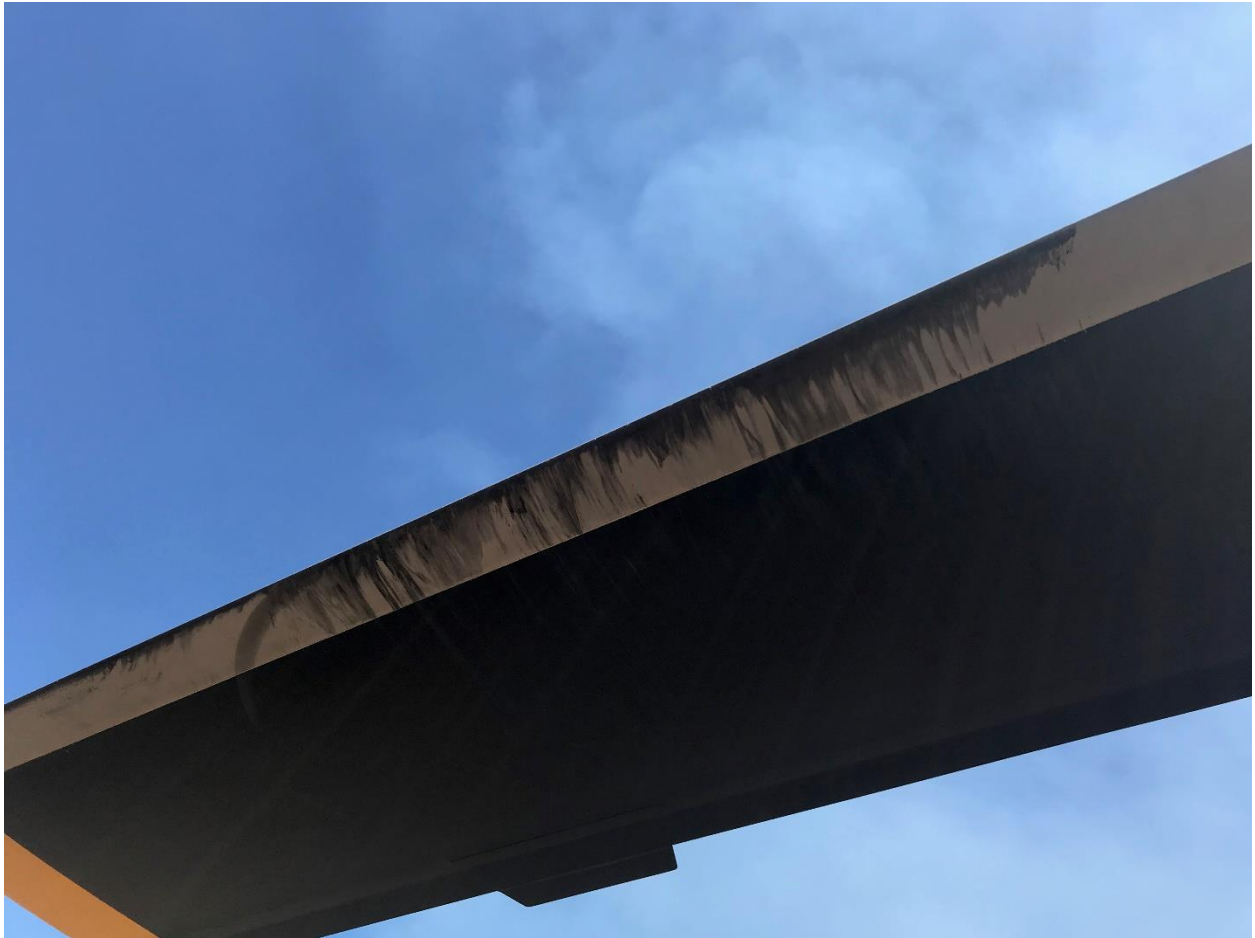
Area where main rotor blade struck the 1/2" fiber optic communication line.

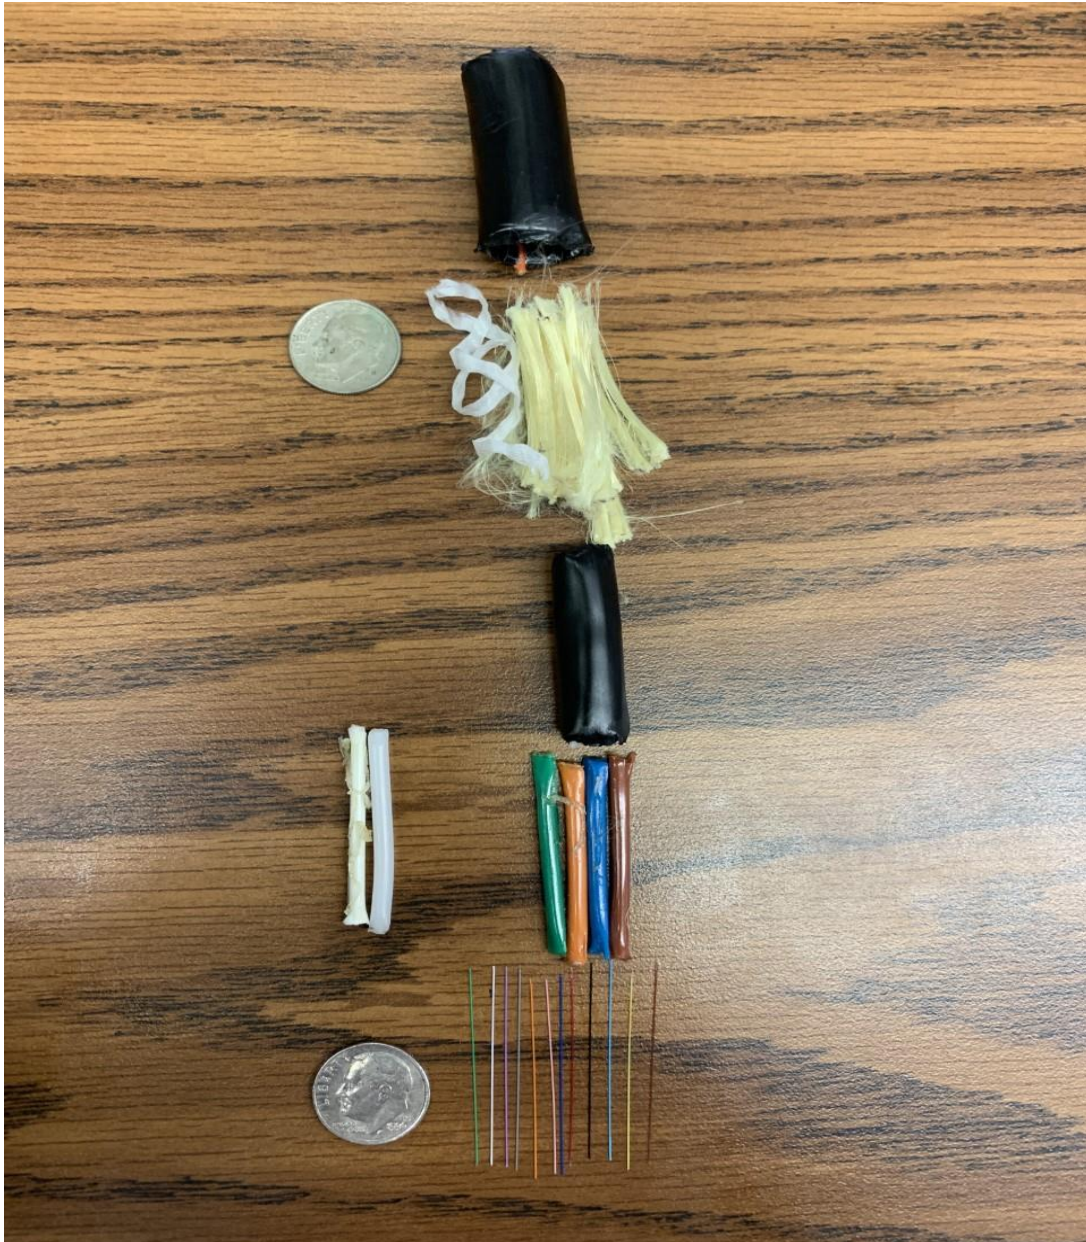
Deconstructed view of the 1/2" fiber optic line.
