# **GREEN SHEET**

**Engine Burn Over**

**July 12, 2016**

**Pacheco Incident**

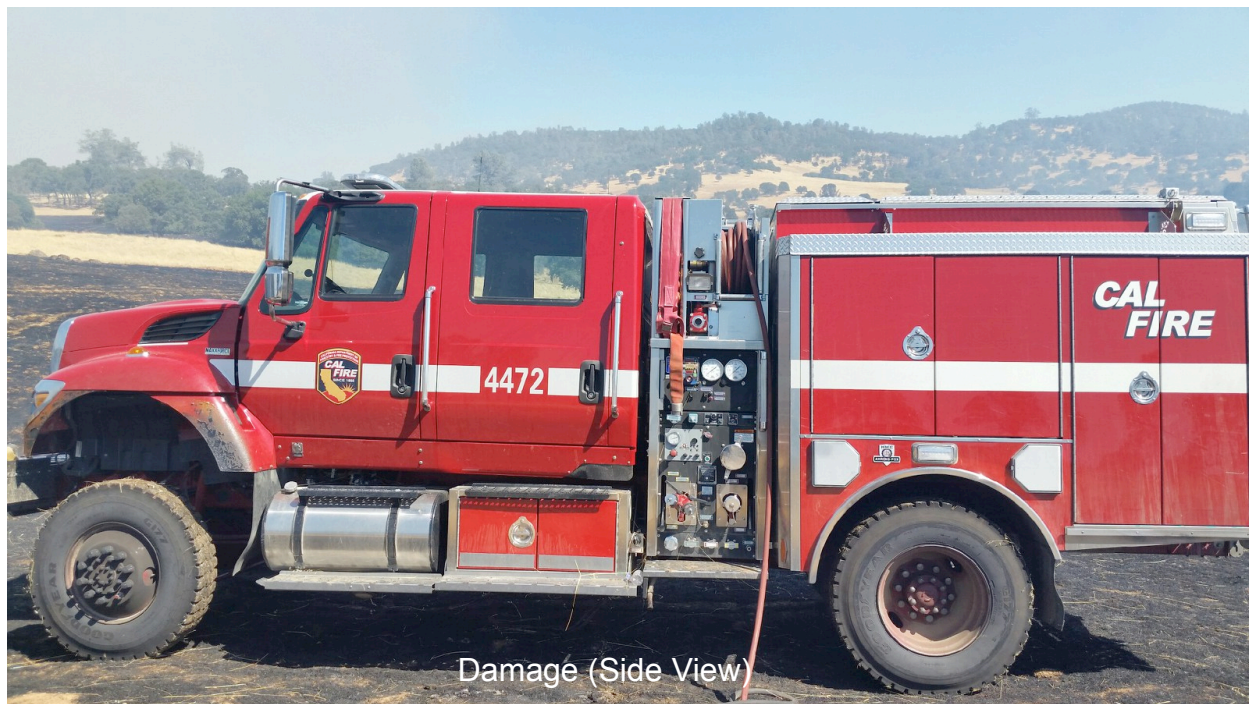
Damage (Side View)

Flame impingement caused the airlines above the frame rails to burst. When the air pressure dropped below 60 psi, FC1 was unable to release the spring brake. FF2 ran back to E1. A helicopter dropped water around E1 while D1 constructed line around a portion of E1 to protect the crew. FC1 notified the Incident Commander that all personnel were accounted for and in a good location.

There were no injuries. E1 sustained heat damage to the tires, fenders, lens covers, air brake lines and pump panel.
