# Informational Summary Report of Serious or Near Serious CAL FIRE Injuries, Illnesses and Accidents

# GREEN SHEET

## Limb Strike

Fork Incident

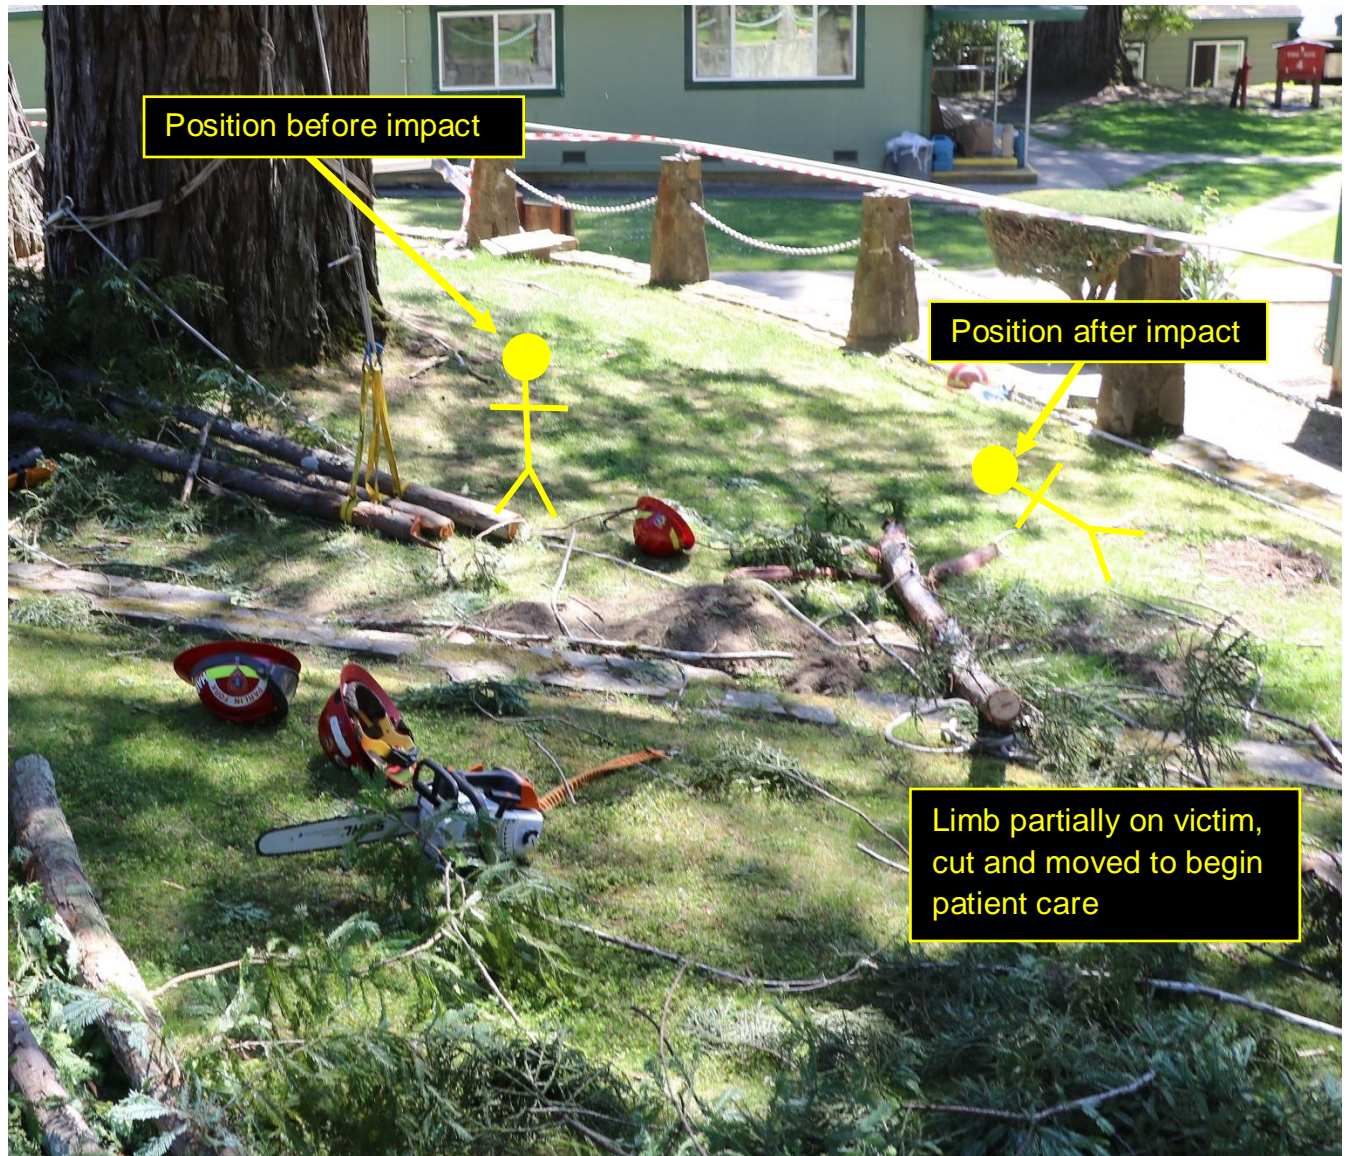
Victim position before and after impact.

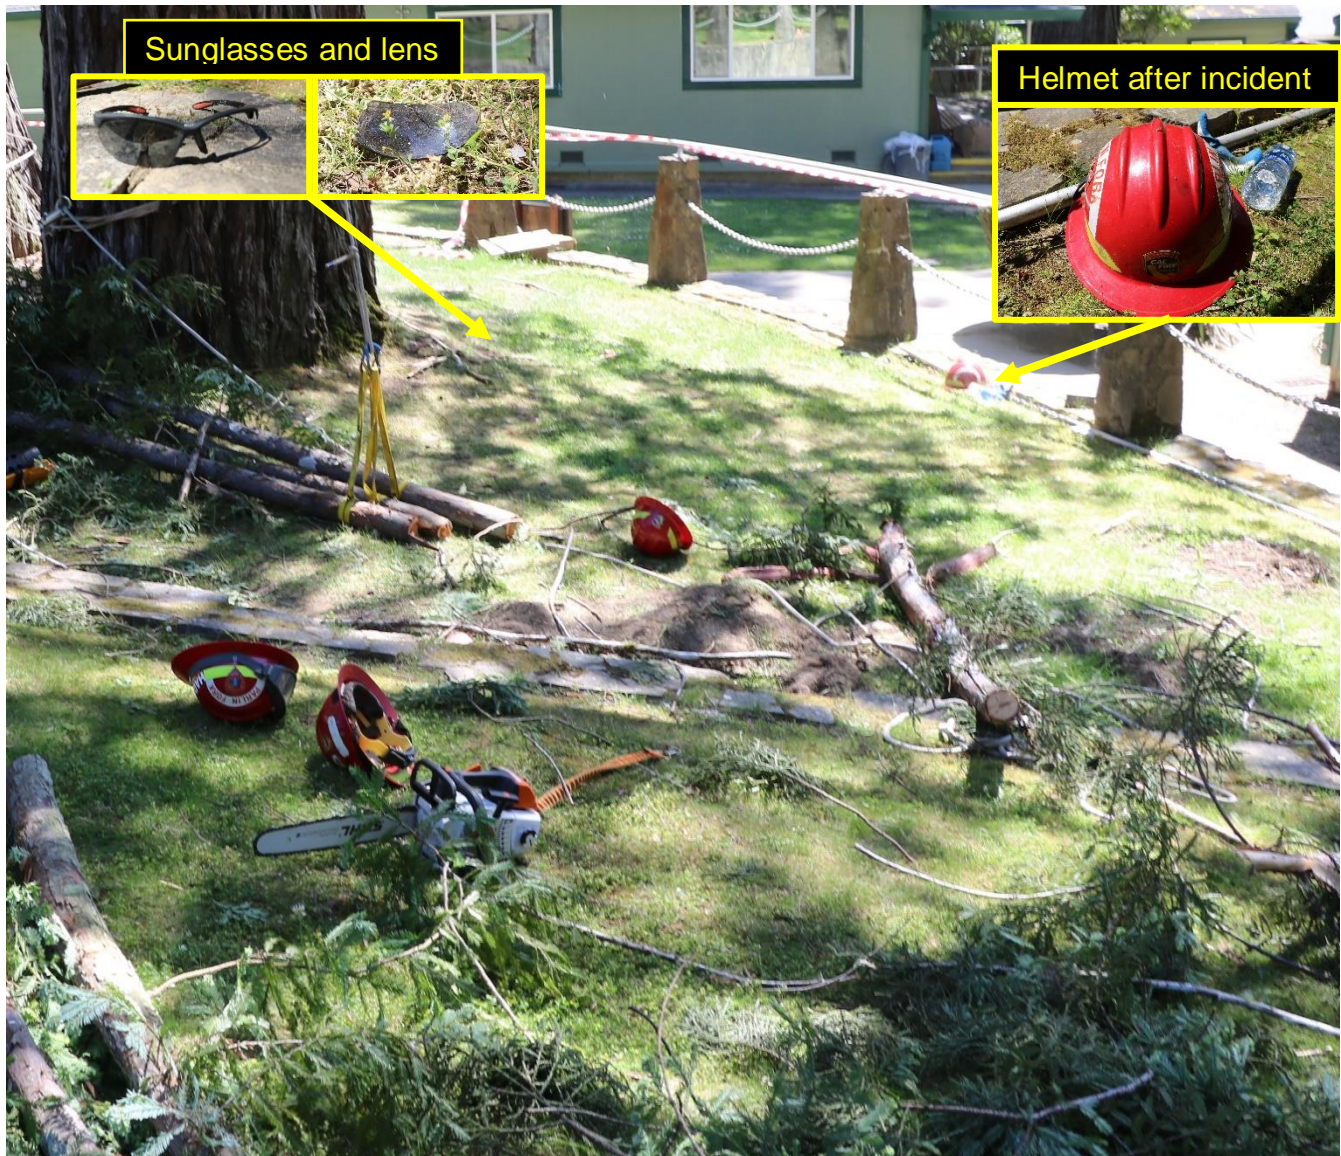
- FC3 was struck in the helmet by the falling limb resulting in injuries affecting the spine, chest, shoulder, and head.
- After a thorough review and examination of the helmet, no structural damage was noted.
- The chinstrap was secured behind the brim of the helmet, indicating it was not in place at the time of the impact.
- No mechanism/correlation could be found between the laceration injuries and the helmet structure.

Glasses and helmet location after impact.

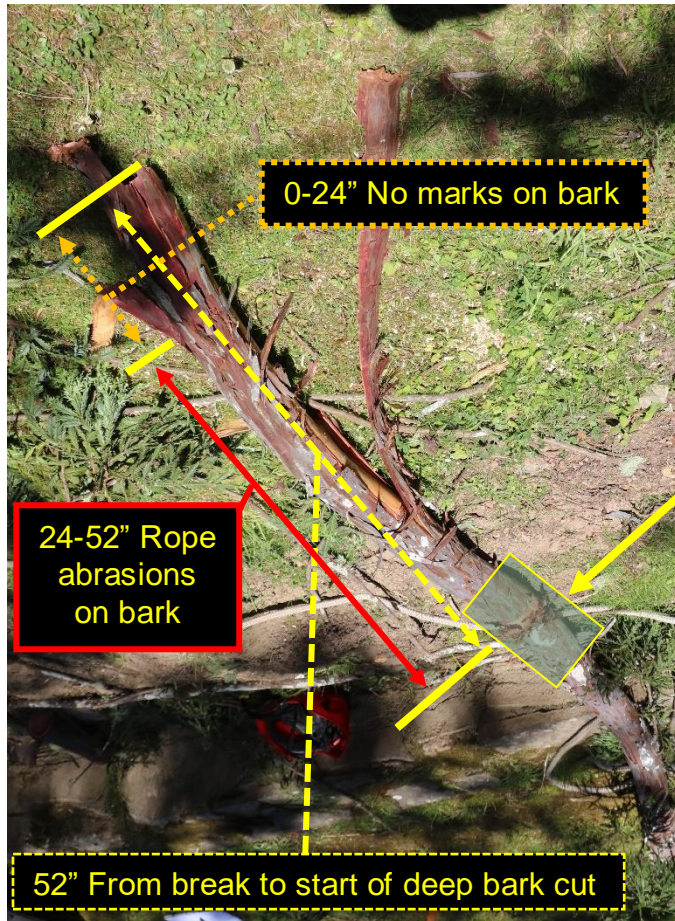
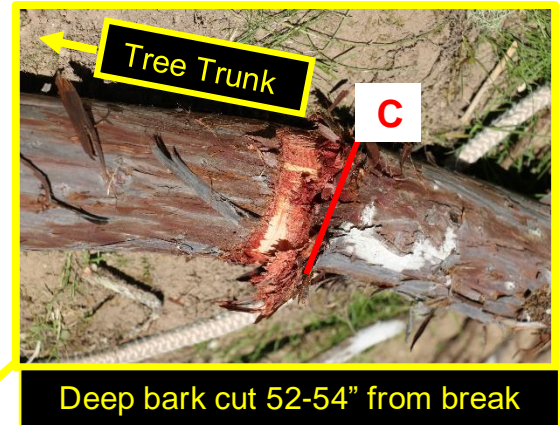
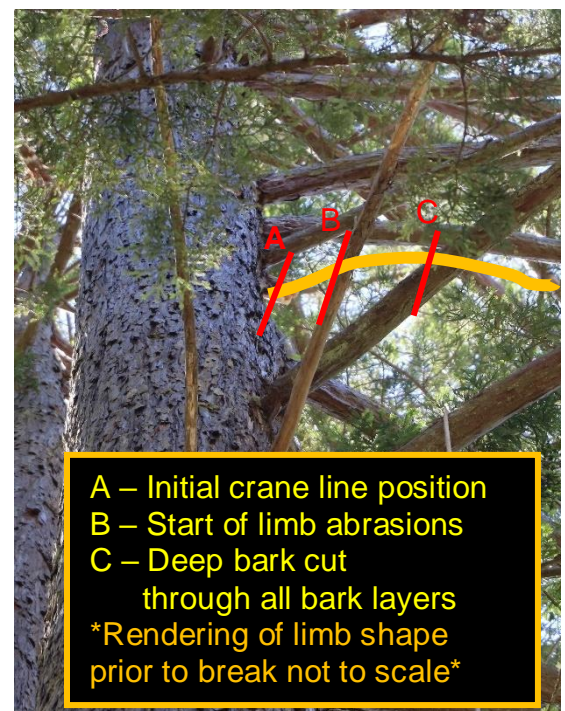
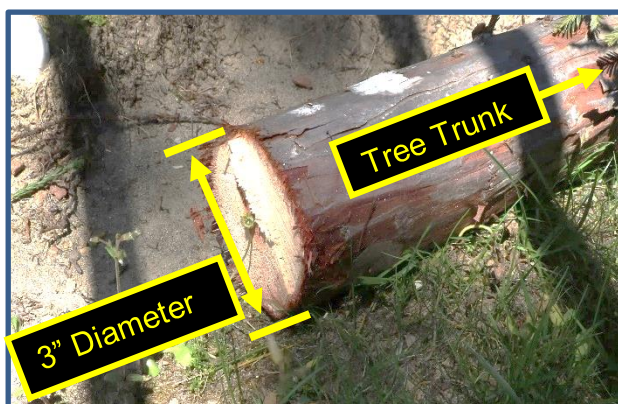
Accident limb details

Branch diameter at the break was 4½" tapering to 3", where a cut was made to remove the log off FC3.

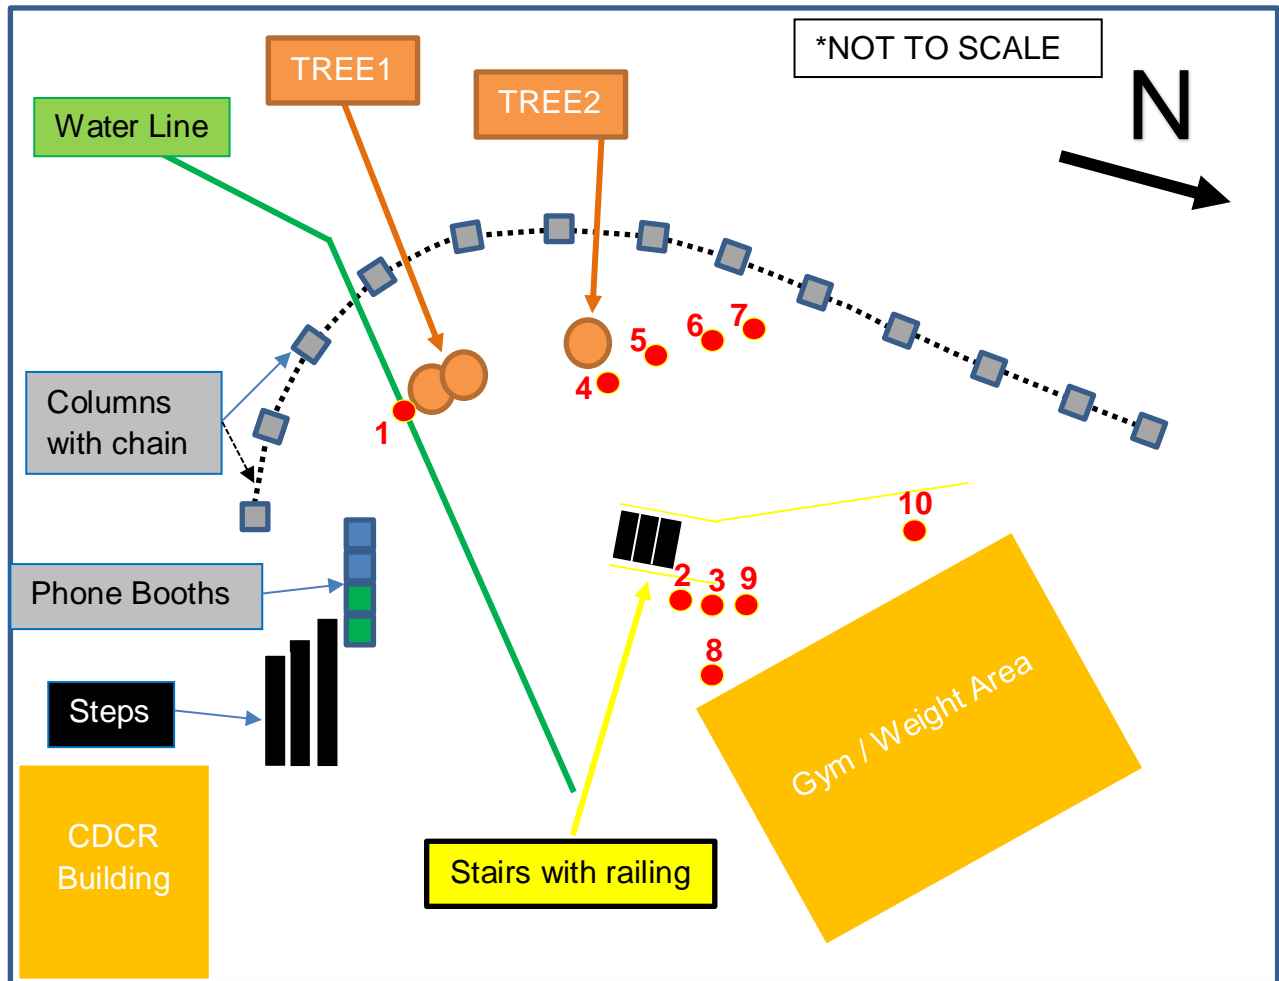
Overhead scene diagram prior to incident.

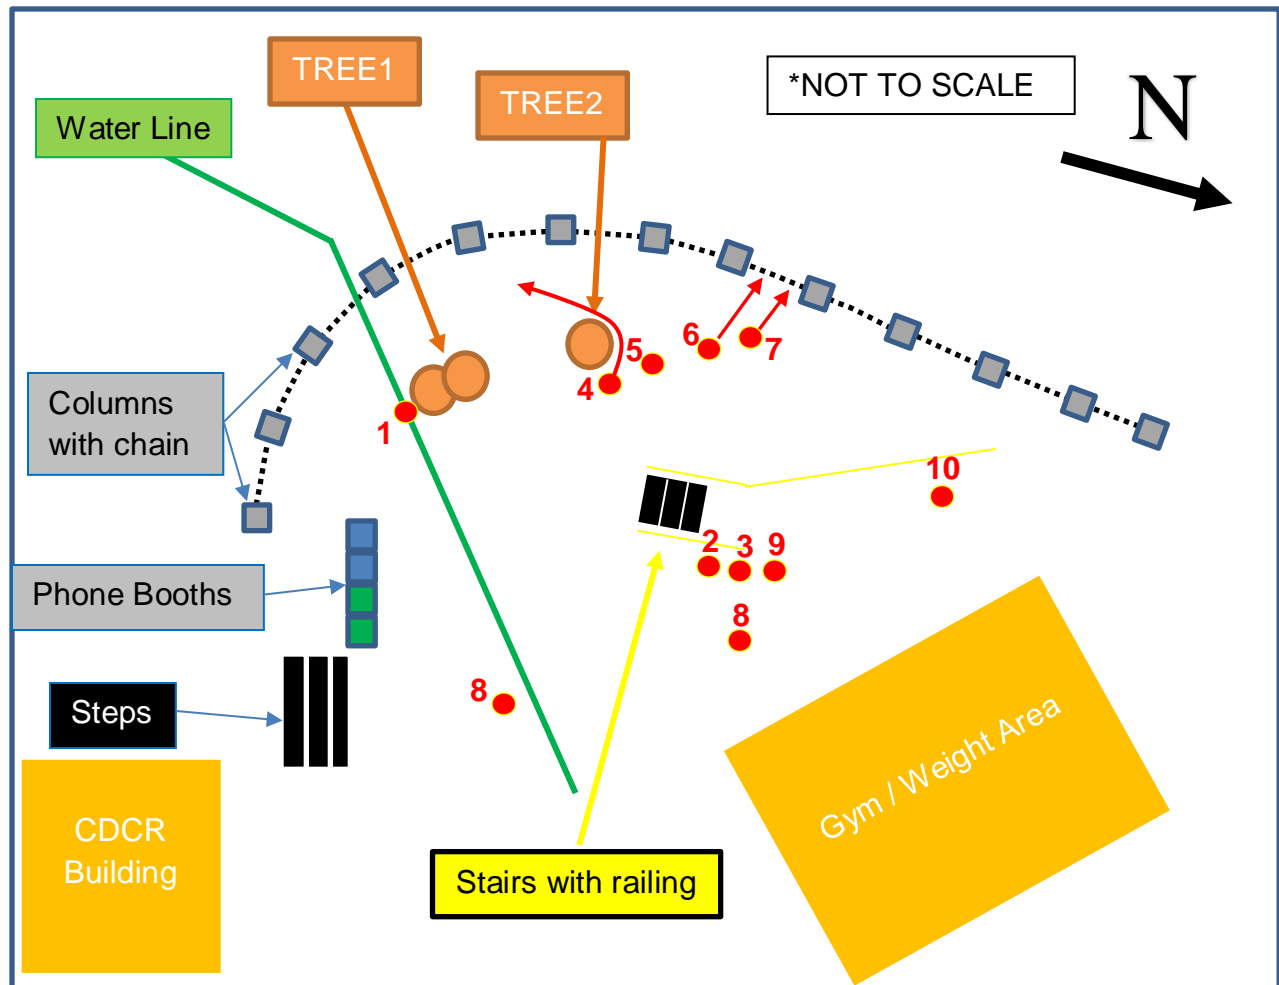
Overhead scene diagram personnel routes of travel.
