SUMMARY REPORT  
BURN INJURIES  
OF  
STEVE FROST, F.A.E.  
AND  
WAYNE WALKER, R.P.T.

JULY 26, 1981

CALIFORNIA DEPARTMENT OF FORESTRY  
LAKE/NAPA RANGER UNIT  
REGION I

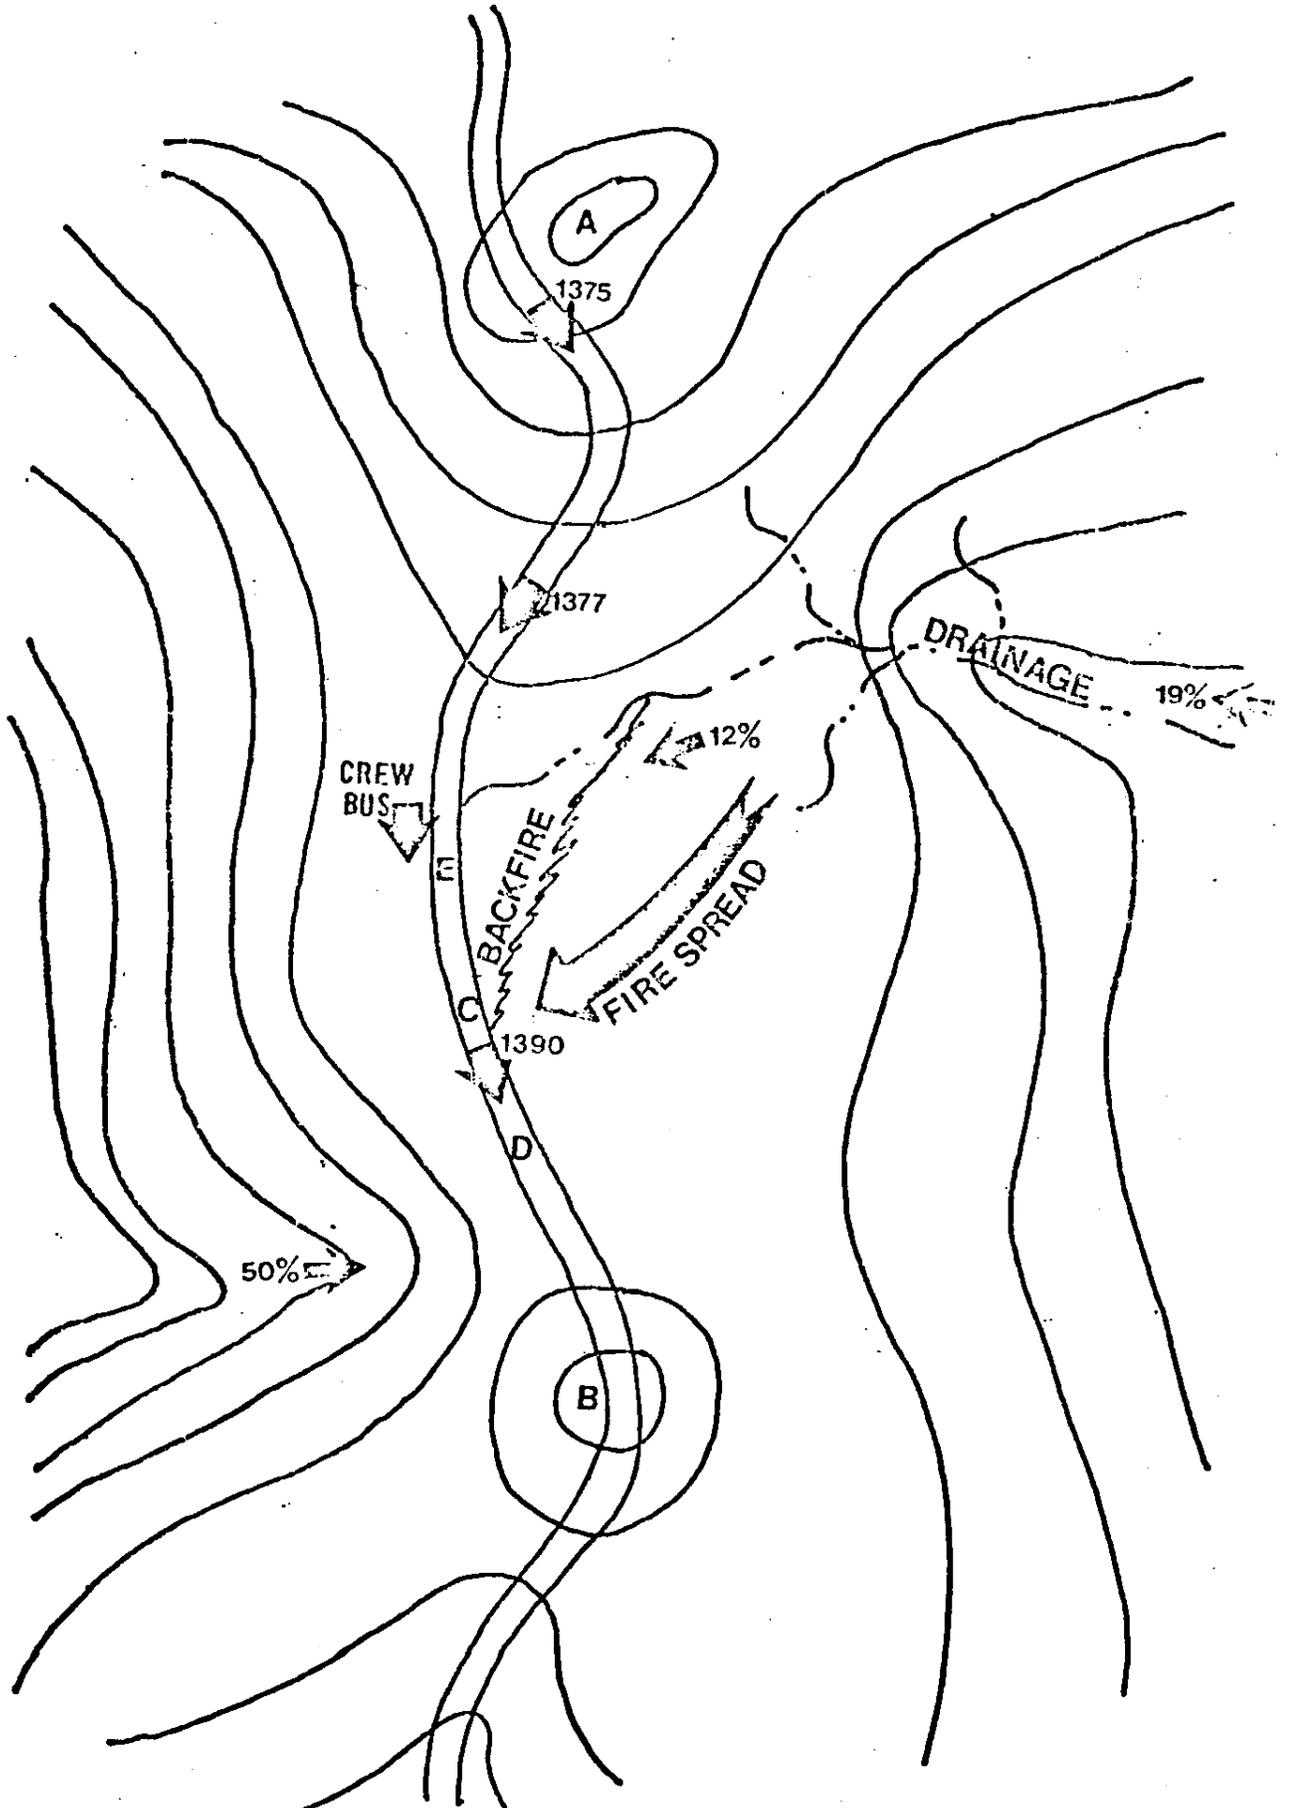
Frost met with the operator of Dozer 1346 at point "E" and discussed the backfiring operation. The dozer moved south along the road, and Frost turned around and moved slowly along the road towards hill "B". His assignment was to watch for spot fires west of the road.

The main fire spread at this time was up the drainage toward the saddle. It had not yet entered the bowl leading to the saddle. The firing crew had worked their way down to the crew bus, but the backfire had spread parallel to the road toward the south to point "C". As Frost and his crew reached point "C", a small spot fire started ahead of the engine in the grass in the middle of the road, at point "D".

Frost accelerated the engine and instructed Walker to extinguish the spot using the 3/4" hard line. After he had accomplished this, Walker walked back to the engine with the hard line. As Walker approached Frost on the driver's side of the engine, the fire suddenly swept up through the saddle to their position. Frost yelled at Walker to get in the cab of the engine. As Frost jumped in the driver's side door, Walker dropped the nozzle and ran around the front of the engine in an attempt to get in the passenger side. As he moved to the right side he was met by a wall of flames on both sides, trapping him in front of the engine. Fire blew under the engine burning his lower extremities.
