FACTUAL REPORT

Facilitated Learning Analysis

ZigZag IHC member hit by falling tree

AK-DOF, Hastings Fire, Fairbanks, Alaska

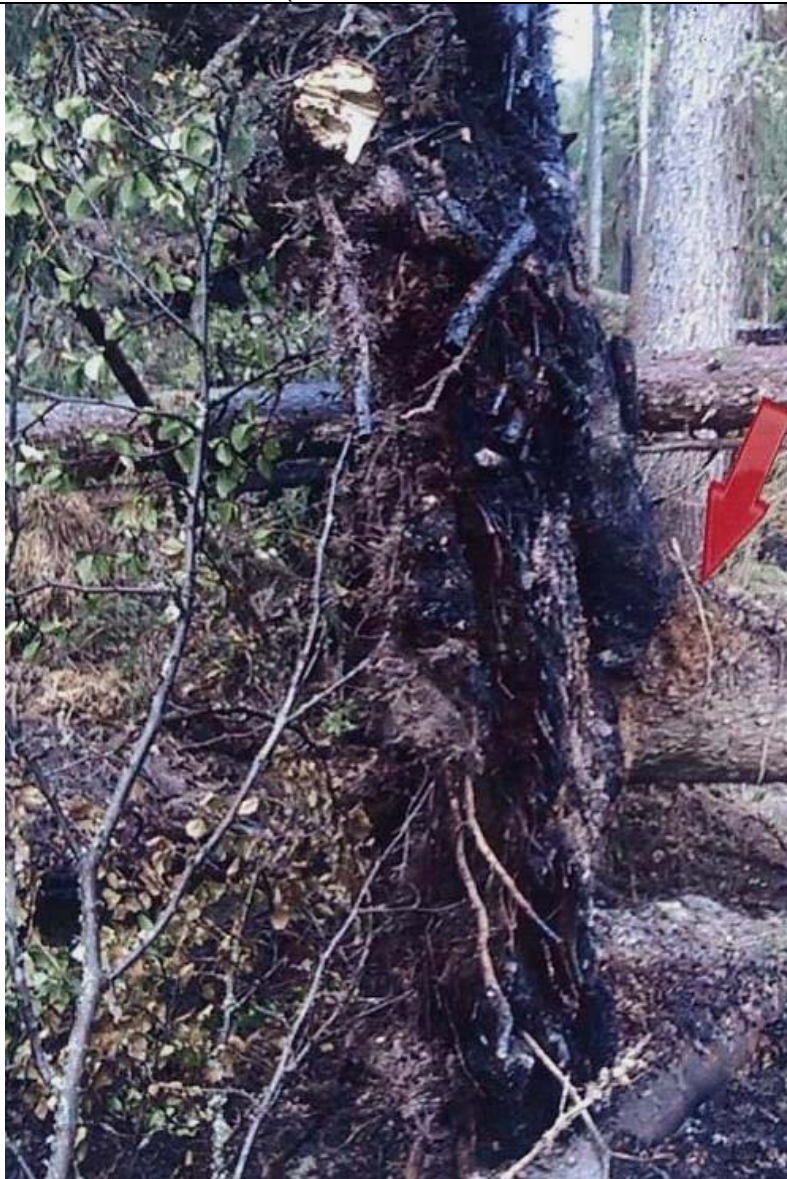
At approximately 1825 hours an “emergency traffic” was announced over the radio for a member of the ZigZag IHC who was assigned to mop-up operations on Division R of the Hastings fire. While working in the area of Sling-13 a tree with a burned out shallow root system fell and made contact with the crew member. A medium helicopter working the fire was quickly loaded with medical personnel, while ZigZag, LaGrande and Rogue River crew personnel worked at

Description of Photograph: Tree & root system

(arrow indicates the tree that hit the crew person)

- Hazard tree identification and hazard mitigations are necessary even if trees are green and appear to be undamaged by fire (ensure L48 crews are well briefed).
- Provide proper maintenance and use of approved PPE (hardhat).
- Adjust Mop-up criteria to suit values at risk and include hazard tree assessment considerations.
- Buddy system – one works & one watches (as practical).
- Risk Management practices which may include alternative mop-up procedures, including area avoidance if necessary.

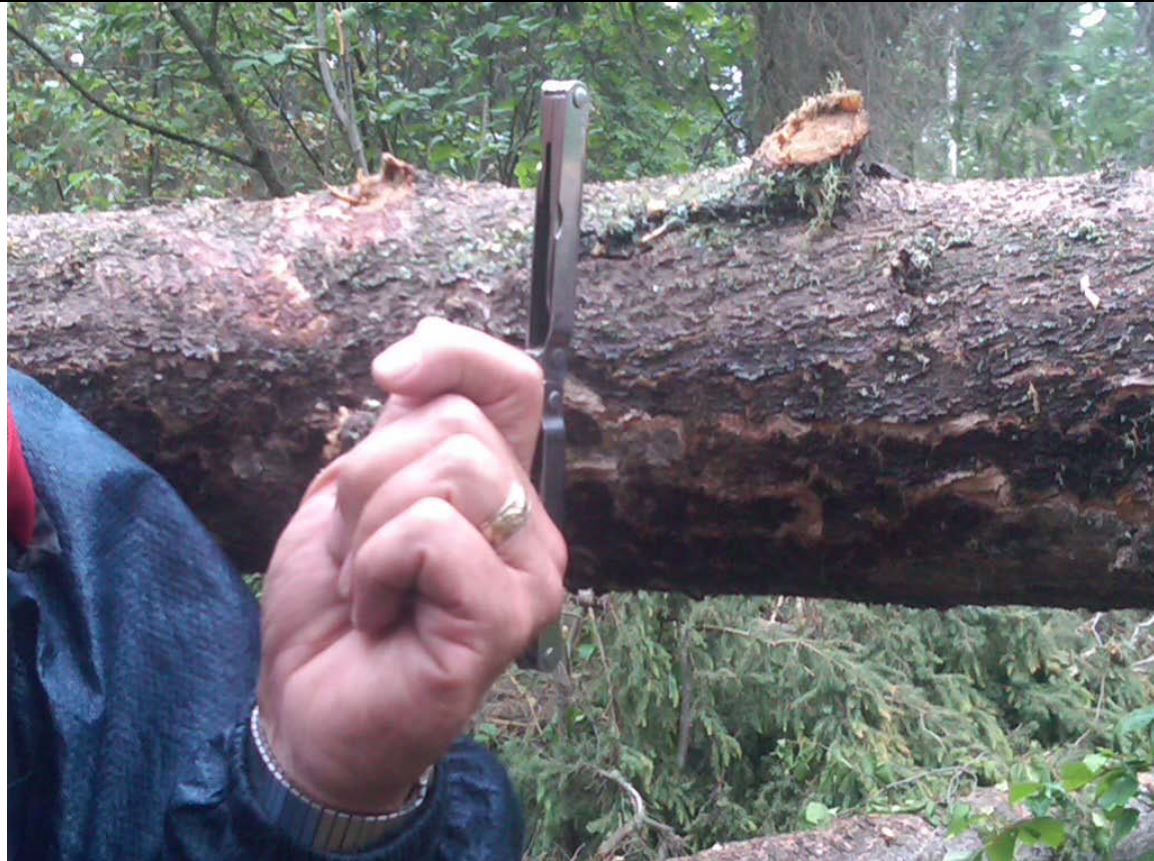
Description of Photograph: Approximately 6 inch diameter at point of impact

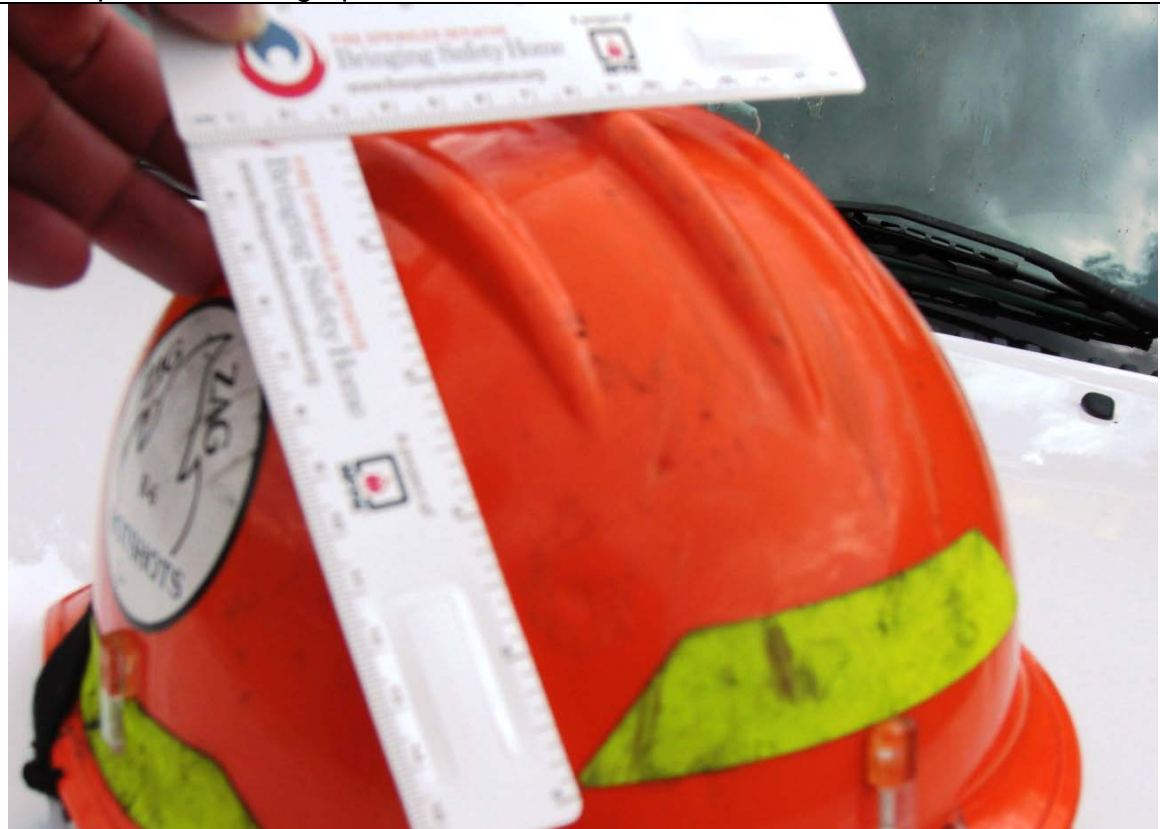
- ✓ Utilize LCES as related to mop-up in timber stands with weakened and shallow root systems.
- ✓ Provide continuous reminders of the hazards associated with shallow and burned root systems in burned areas (Alaska Briefing, IAP, safety messages, crew briefings and etc)
- ✓ Ensure and enforce the proper use of approved PPE (hardhat). In this case the use of an approved hardhat likely saved the crew members life.

Description of Photograph: Exterior of helmet

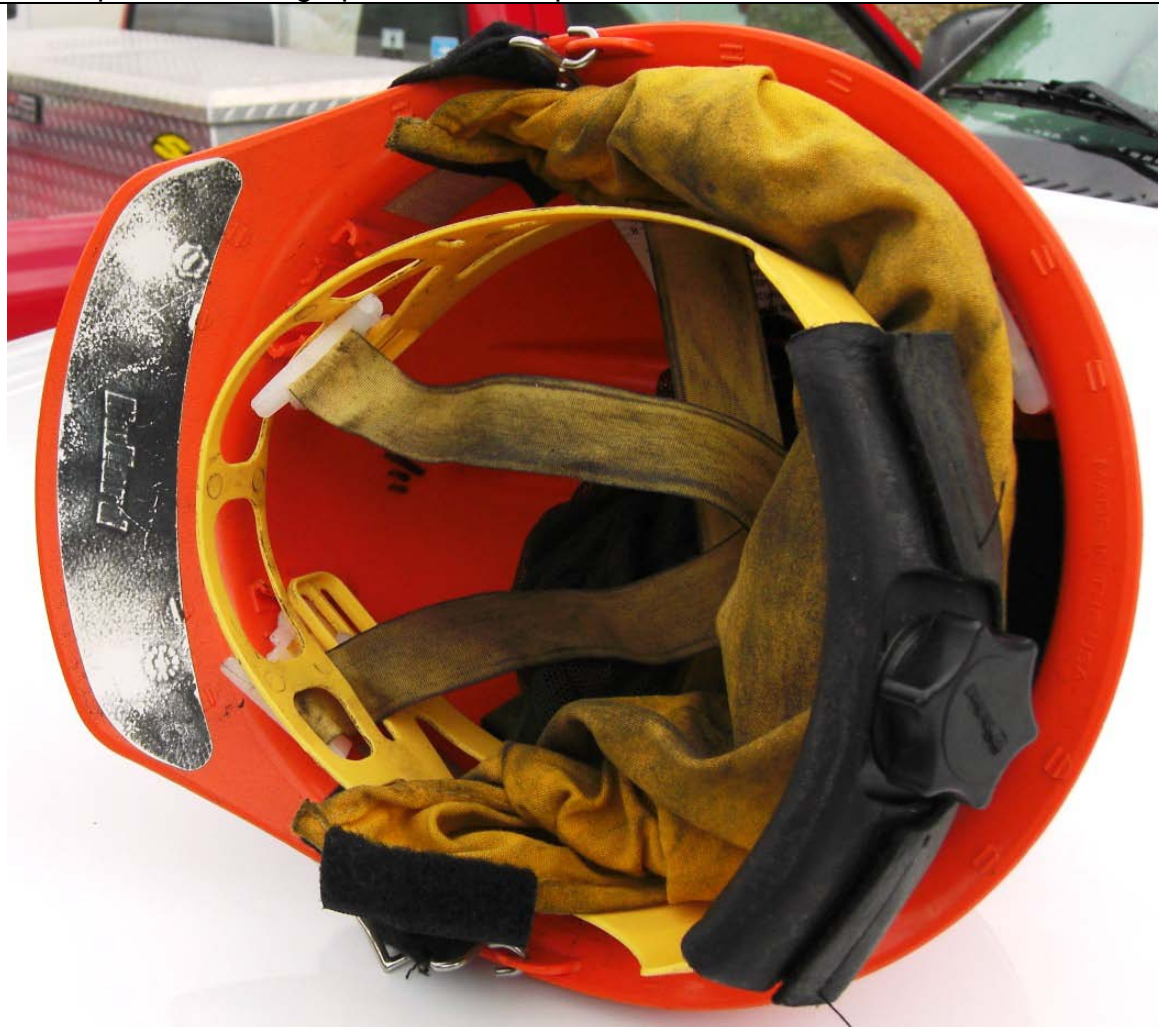
Description of Photograph: Helmet suspension
