Milepost 97 Fire
Object Strikes Crewmember
Rapid Lesson Sharing

July 29, 2019

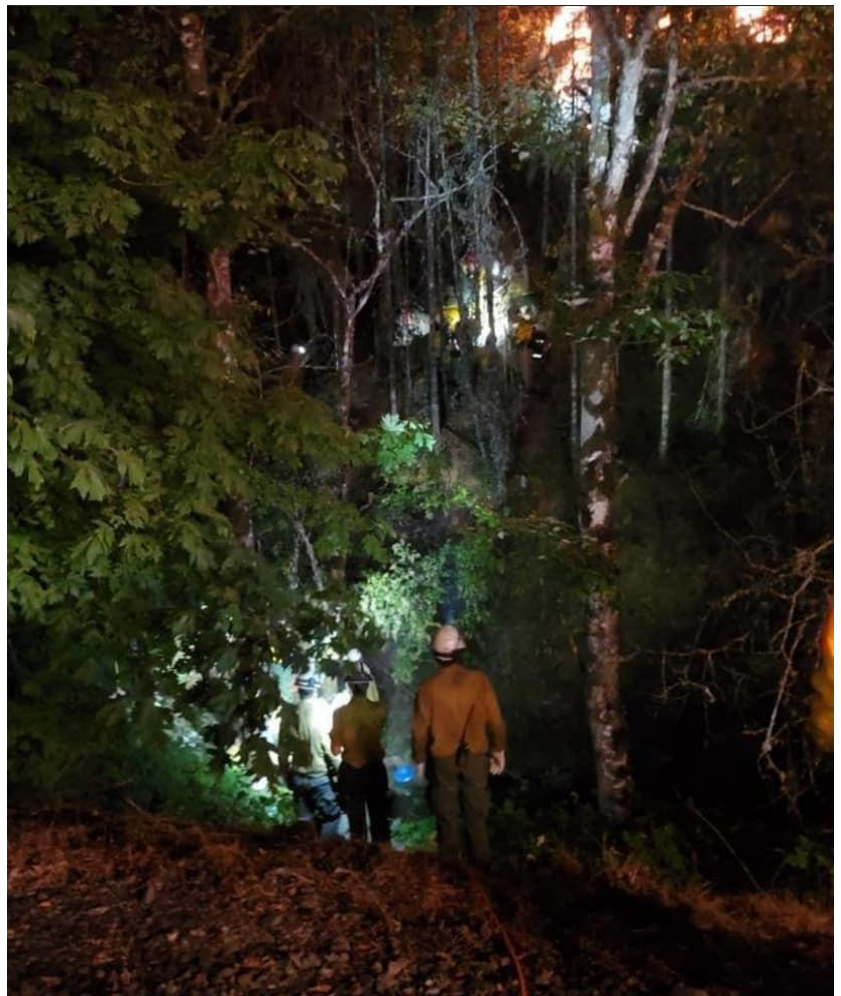
Photo taken as rescuers make their way both down and up slope 30 feet to the patients location. The fire in the foreground had been previously ignited by the hand crew during burnout operations.

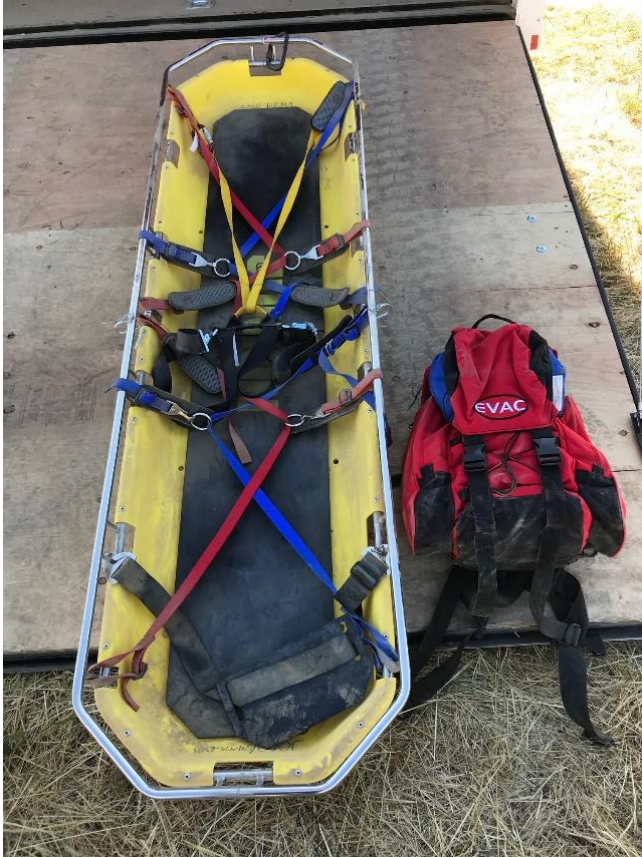
- The crew has both experience and training with backboards, but was not familiar with the strapping process on a stokes litter. This created a little confusion when strapping in the crewmember under the conditions at that time.

Photo of the stokes litter used for rescue.

What they learned: It would be valuable to expand scenario training to include some different types of rescue equipment. The strapping on a stokes litter isn't what one would consider 'user friendly'.
