**Report of the
Texas Forest Service
Accident Investigation Team
Hildreth Pool Road
Bull Dozer Accident**

**Montague County
February 9, 2006**

Final Report

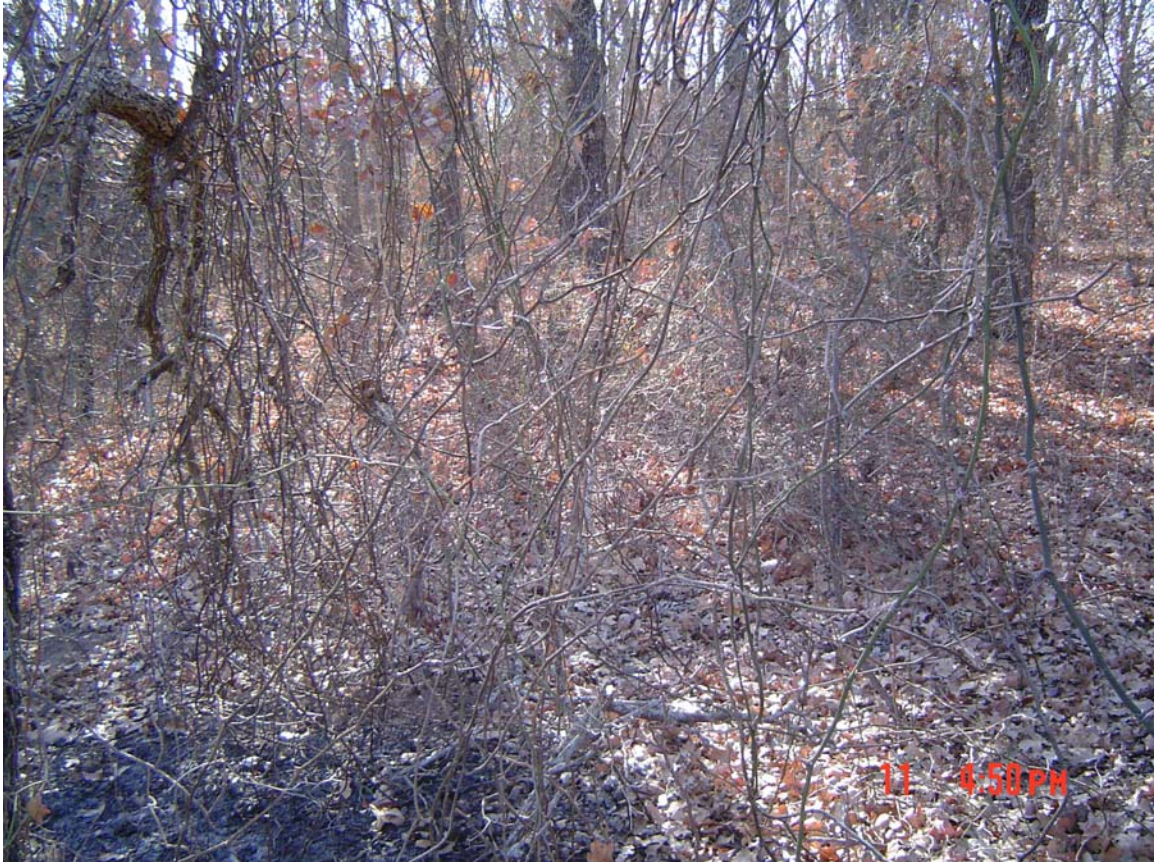
Photograph showing the thickness of the under store

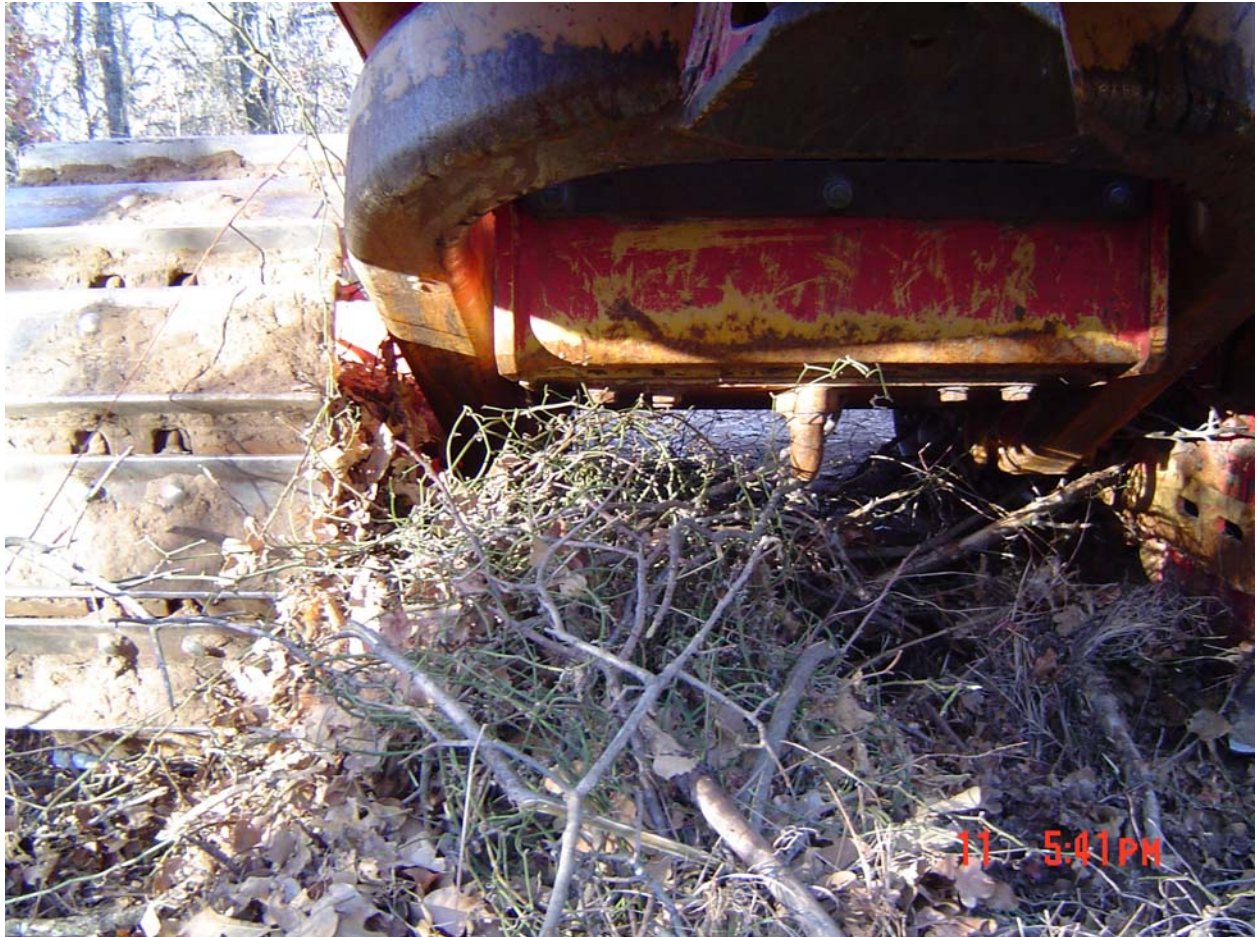
Photograph showing clearance under dozer

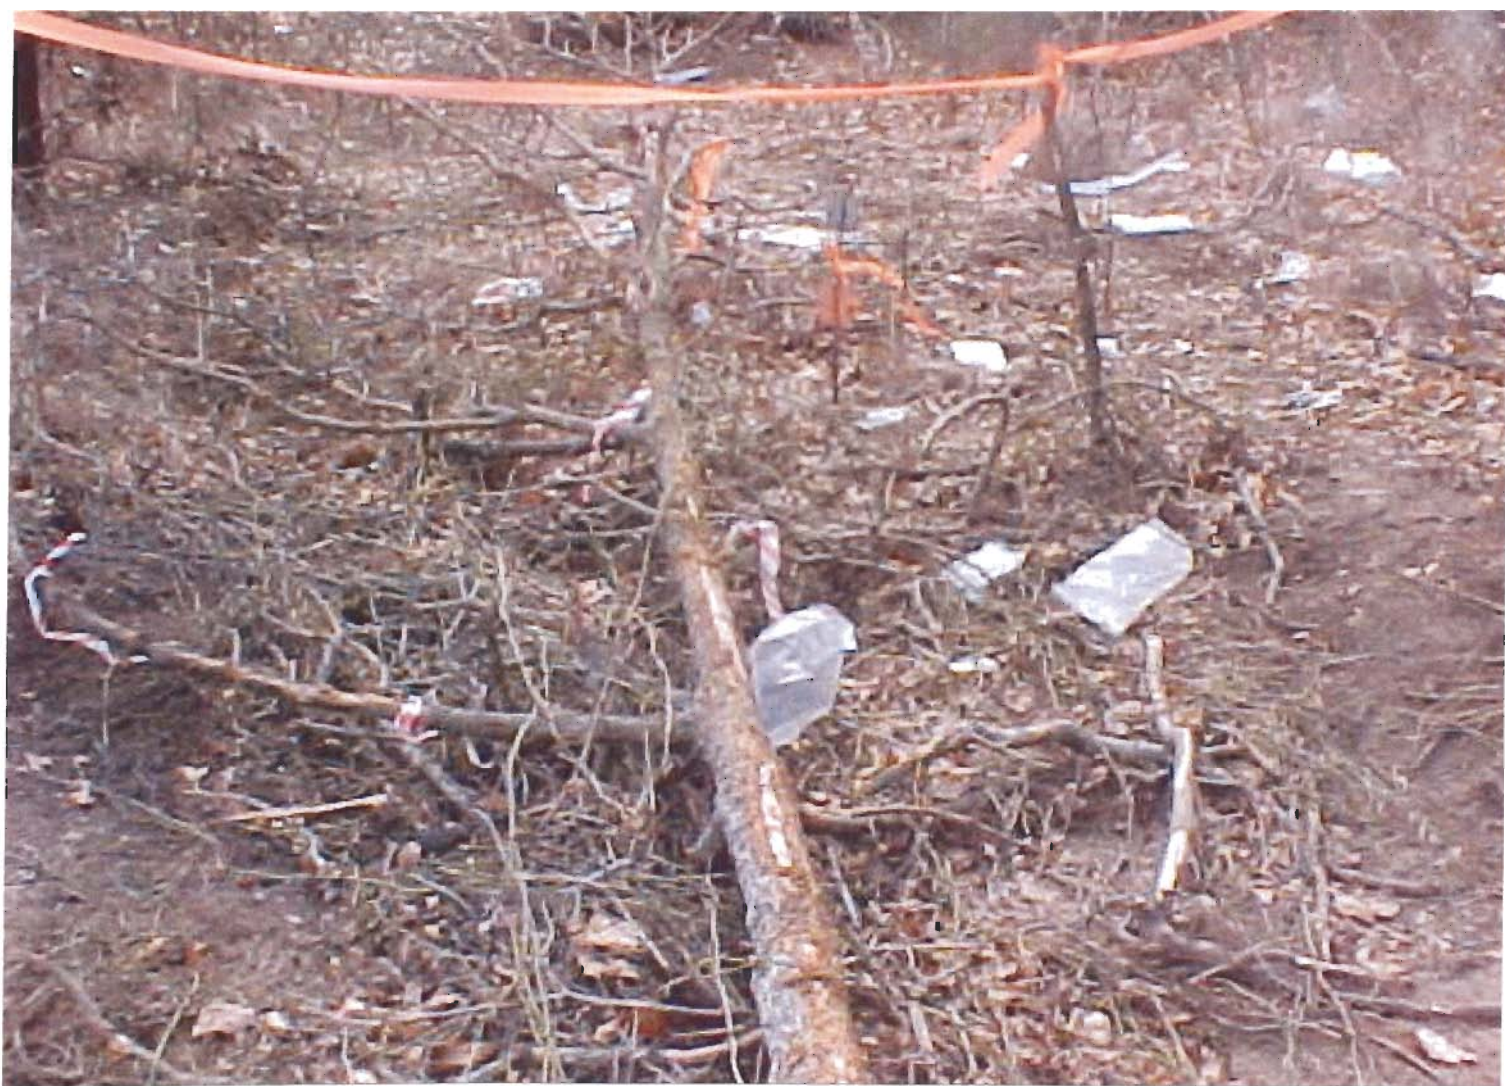
1. Location: Hildreth Pool Road	2. System Area Private Land	3. Date of Occurrence:	Month 02	Day 09	Year 2006	Case/File Number 7526619
5. Nature of Incident: Bull Dozer accident on wildfire			6. Offense:			
7. Date / Photo: 02-10-2006	8. Location of Photo: Hildreth Pool Road fire					9. Camera Type: Sony, digital camera
10. Time / Photo: 13:34 p.m.	11. Investigated by: David Cadle	12. Photographed by: David Cadle			13. Film Type: 3 inch disk	
14. Description: photo of the tree where the victim was located. Note the areas on the tree where the flagging is located, these are track marks left by the dozer					Incident Type:	
15. DOB: SSN: Race/Sex/Height/Weight:

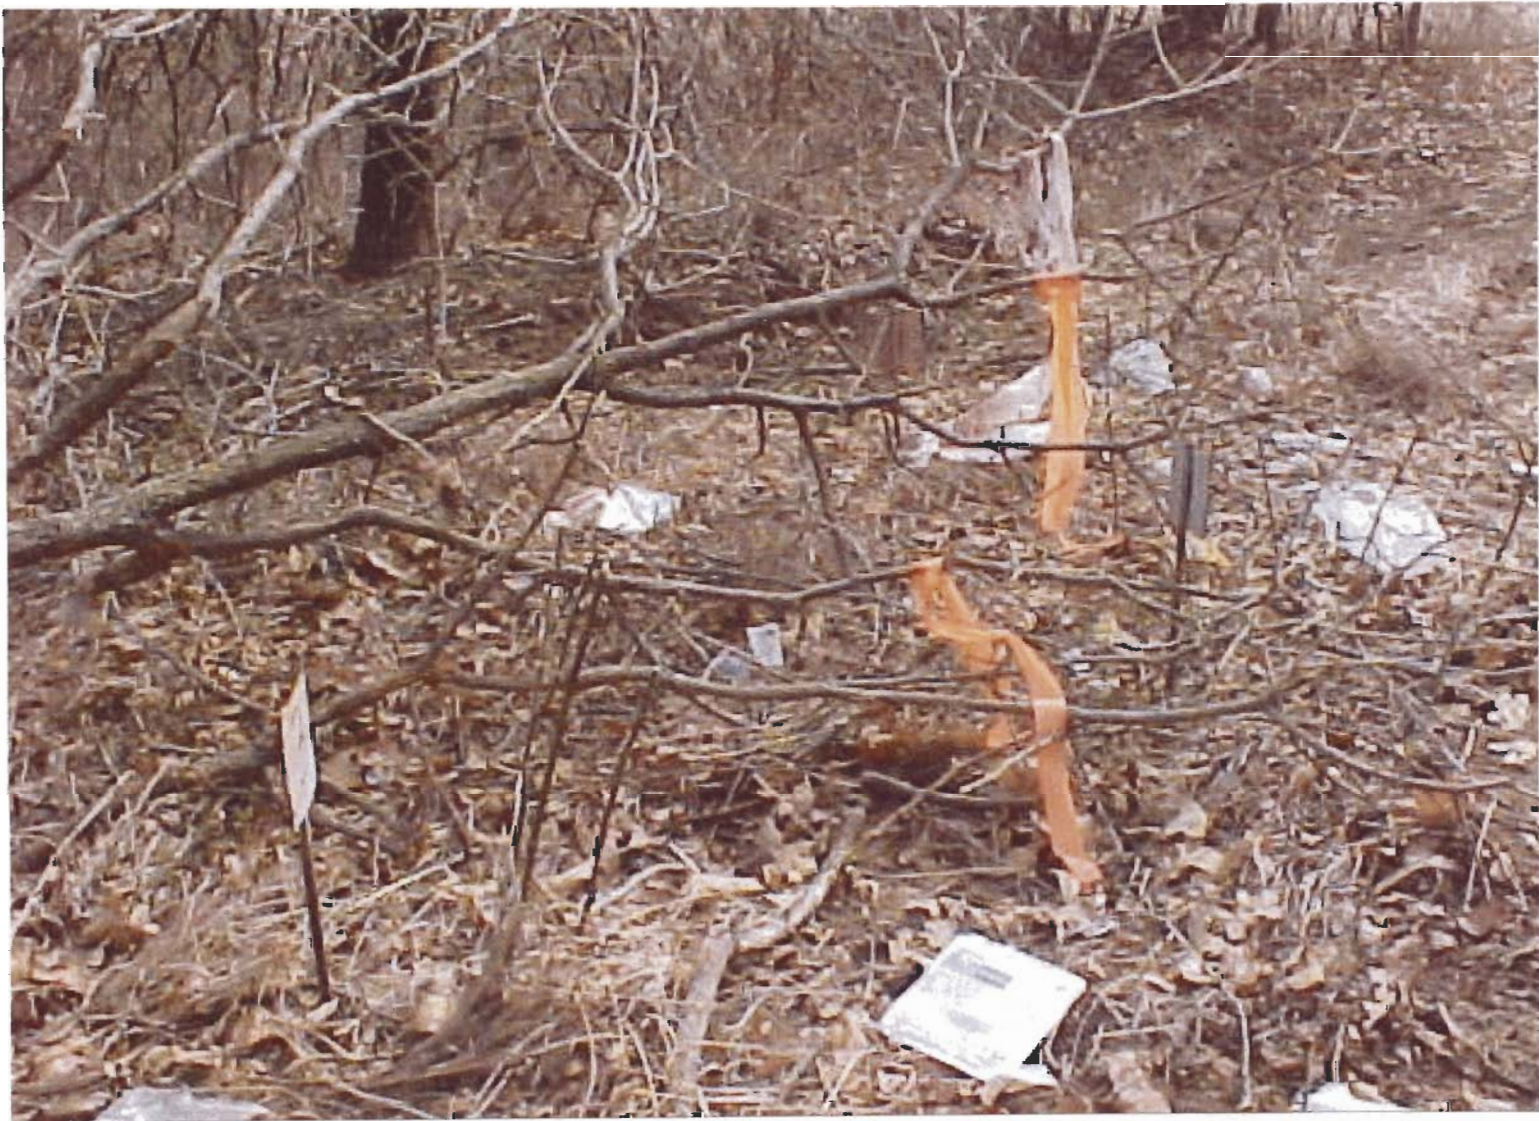
1. Location: Hildreth Pool Road	2. System Area Private Land	3. Date of Occurrence:	Month 02	Day 09	Year 2006	Case/File Number 7526619
5. Nature of Incident: Bull Dozer accident on wildfire			6. Offense:			
7. Date / Photo: 02-10-2006	8. Location of Photo: Hildreth Pool Road fire					9. Camera Type: Sony, digital camera
10. Time / Photo: 13:34 p.m.	11. Investigated by: David Cadle	12. Photographed by: David Cadle			13. Film Type: 3 inch disk	
14. Description: overall photo of where the victim was located after the accident					Incident Type:	
15. DOB: SSN: Race/Sex/Height/Weight:

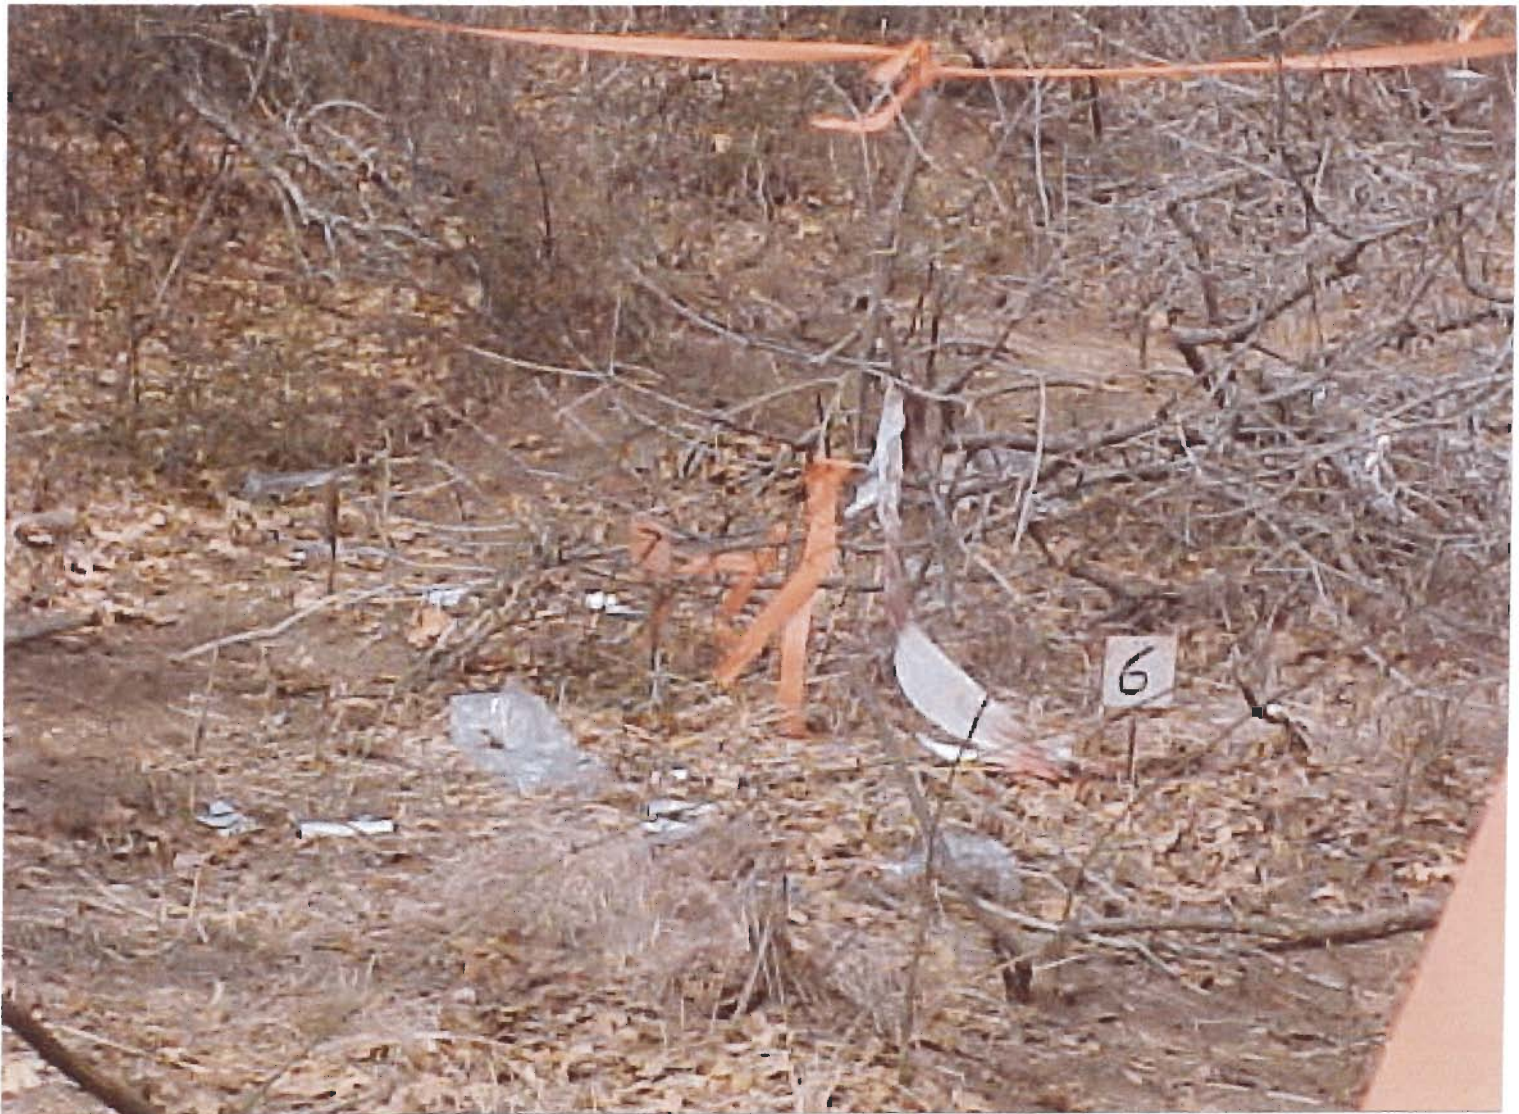
1. Location: Hildreth Pool Road	2. System Area Private Land	3. Date of Occurrence:	Month 02	Day 09	Year 2006	Case/File Number 7526619
5. Nature of Incident: Bull Dozer accident on wildfire			6. Offense:			
7. Date / Photo: 02-10-2006	8. Location of Photo: Hildreth Pool Road fire					9. Camera Type: Sony, digital camera
10. Time / Photo: 13:32 p.m.	11. Investigated by: David Cadle	12. Photographed by: David Cadle			13. Film Type: 3 inch disk	
14. Description: photo of resting place of the victim. The number 6 in the photograph represents the victims head					Incident Type:	
15. DOB: SSN: Race/Sex/Height/Weight:

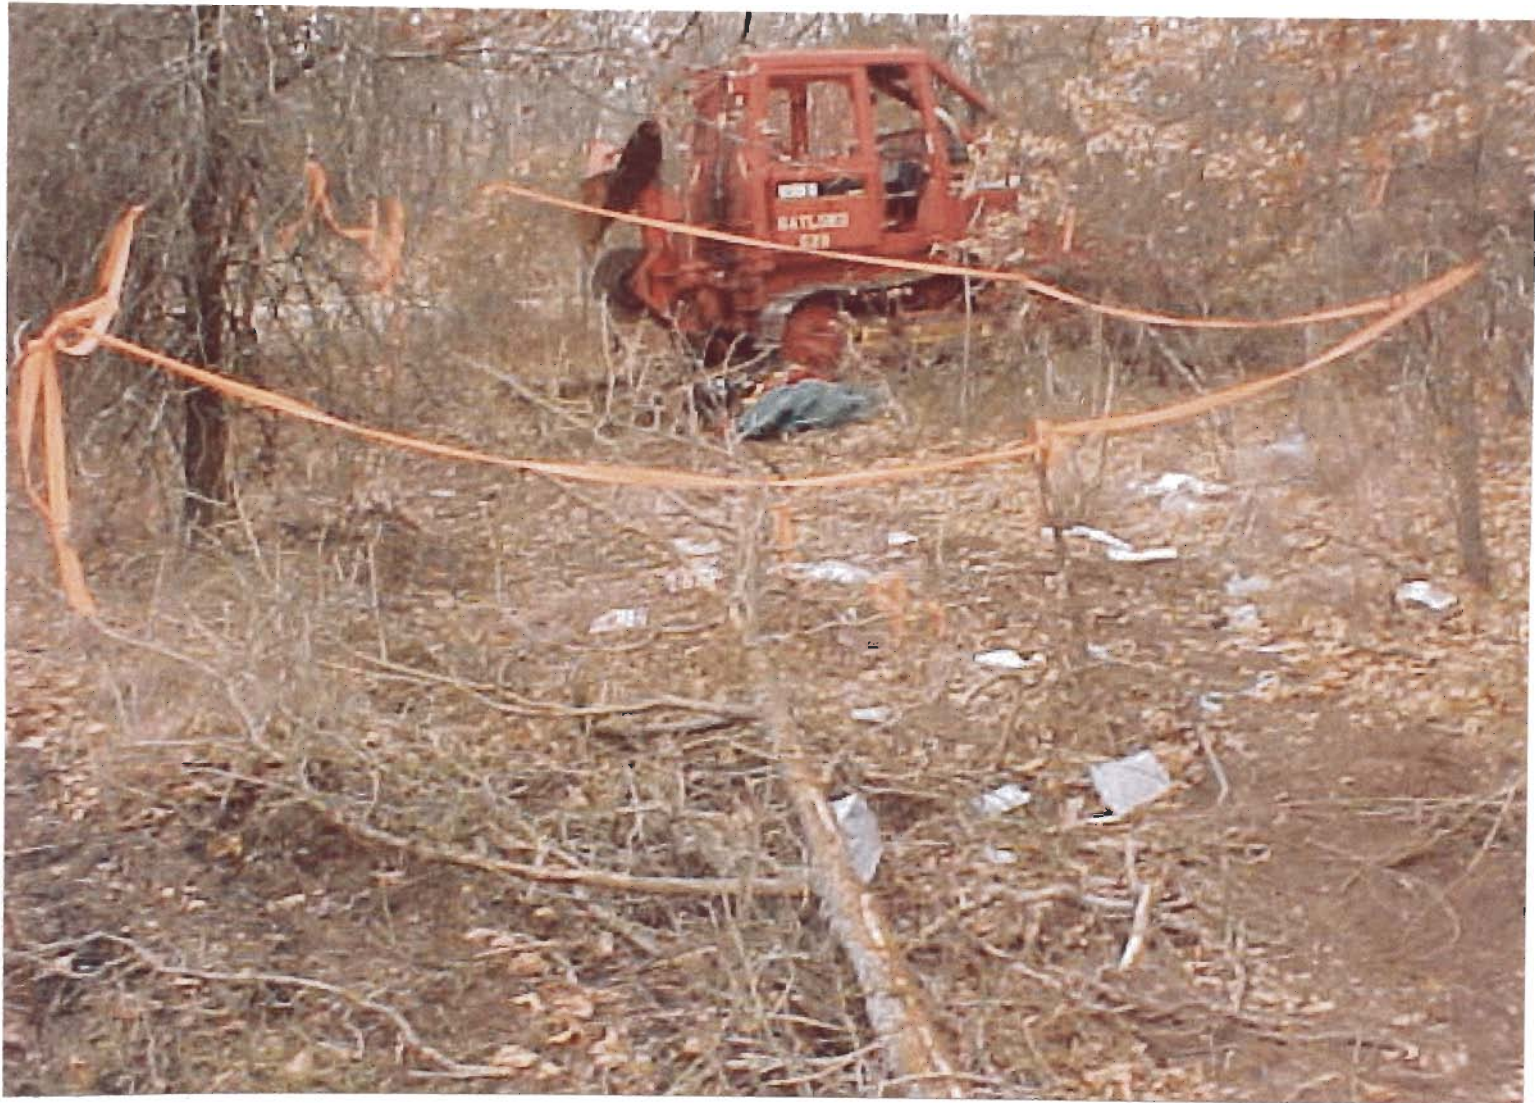
1. Location: Hildreth Pool Road	2. System Area Private Land	3. Date of Occurrence:	Month 02	Day 09	Year 2006	Case/File Number 7526619
5. Nature of Incident: Bull Dozer accident on wildfire			6. Offense:			
7. Date / Photo: 02-10-2006	8. Location of Photo: Hildreth Pool Road fire					9. Camera Type: Sony, digital camera
10. Time / Photo: 11:29 a.m.	11. Investigated by: David Cadle	12. Photographed by: David Cadle			13. Film Type: 3 inch disk	
14. Description: photo of the scene of the resting place of the victim. Note the tree in the photograph.					Incident Type:	
15. DOB: SSN: Race/Sex/Height/Weight:

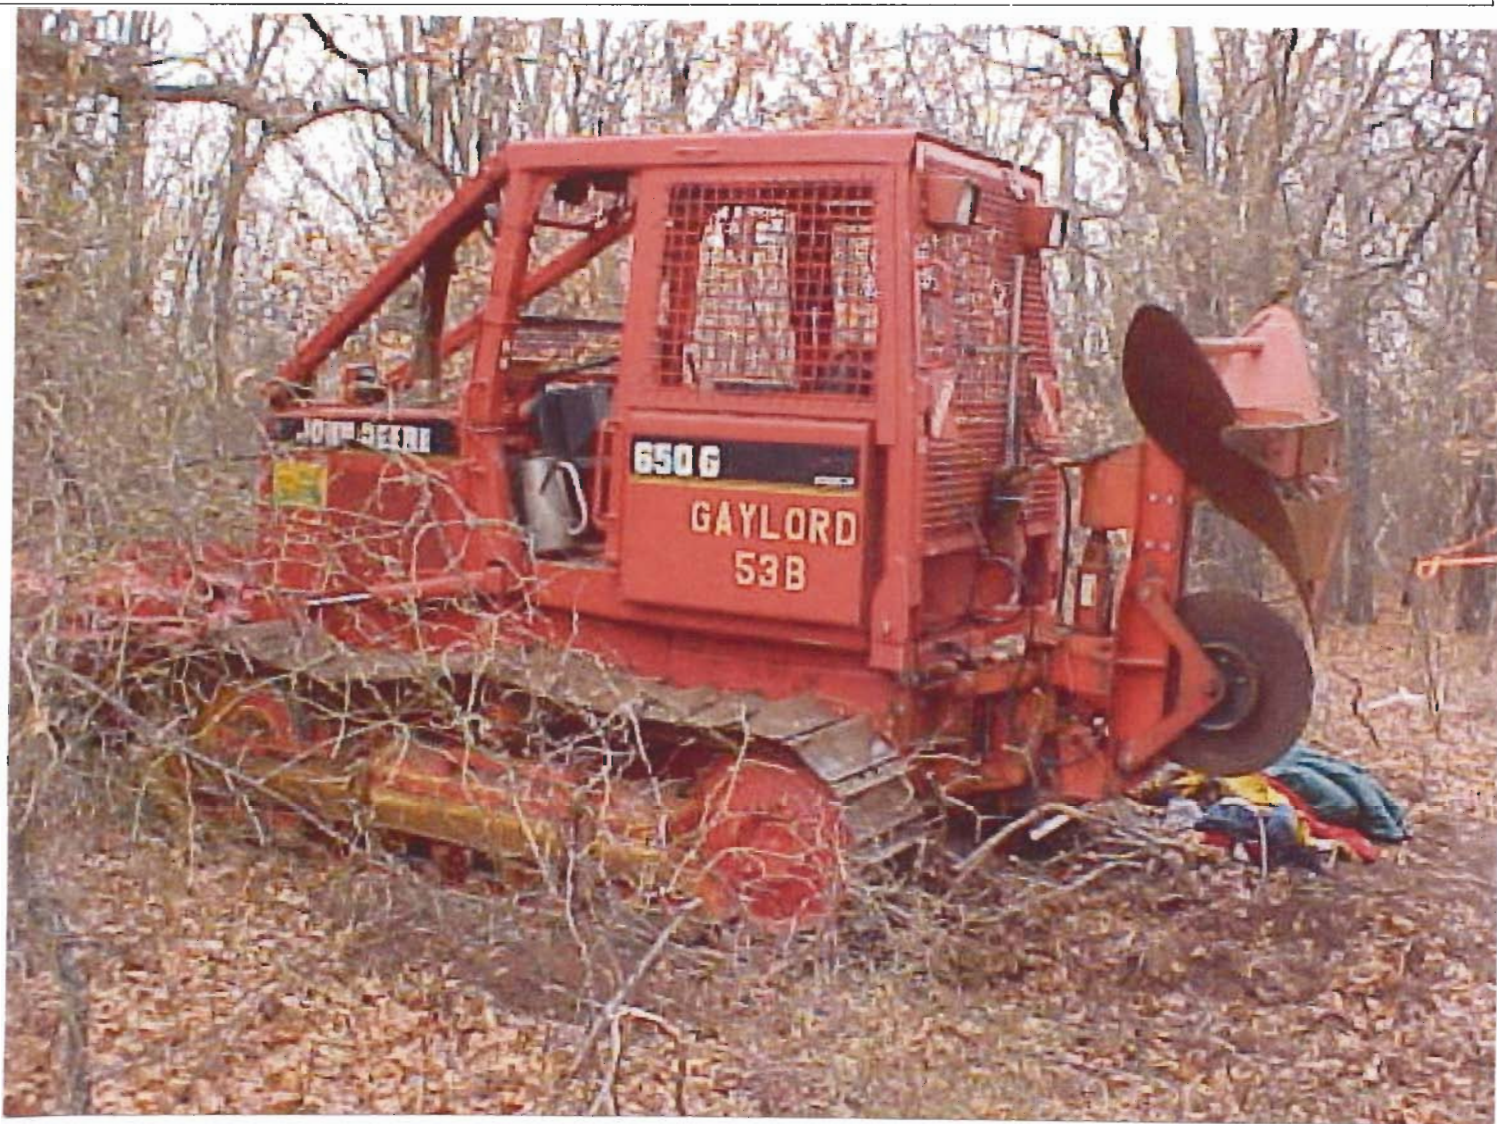
1. Location: Hildreth Pool Road	2. System Area Private Land	3. Date of Occurrence:	Month 02	Day 09	Year 2006	Case/File Number 7526619
5. Nature of Incident: Bull Dozer accident on wildfire			6. Offense:			
7. Date / Photo: 02-10-2006	8. Location of Photo: Hildreth Pool Road fire					9. Camera Type: Sony, digital camera
10. Time / Photo: 11:22 a.m.	11. Investigated by: David Cadle	12. Photographed by: David Cadle			13. Film Type: 3 inch disk	
14. Description: Overall photo of dozer					Incident Type:	
15. DOB: SSN: Race/Sex/Height/Weight:
