**USDA Forest Service  
Rocky Mountain Region**

San Juan Public Lands, Columbine Ranger District

# **Jones Creek ATV Rollover Facilitative Learning Analysis**

August 16th, 2011

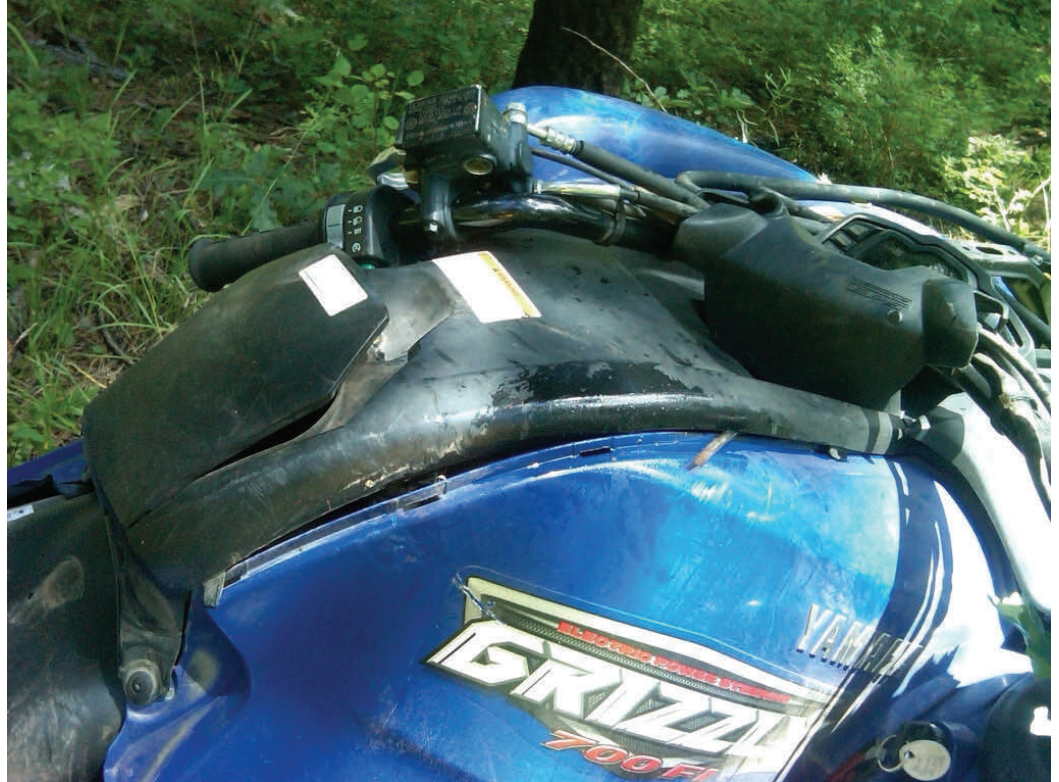
**Summary-**On Friday August 16, 2011 at approximately 1400 hours two persons were driving ATV's up the Jones Creek Trail North East of Lower Hermosa Camp Ground. They began driving through a narrow switchback along the trail when the first ATV's right front tire nudged a rock on the right side of the trail causing the ATV to slide to the left of the trail and the edge to give way. The ATV then proceeded to roll down a steep drainage approximately 80 feet. The operator was able to jump off of the ATV as it began to roll. No individuals were injured in this incident.

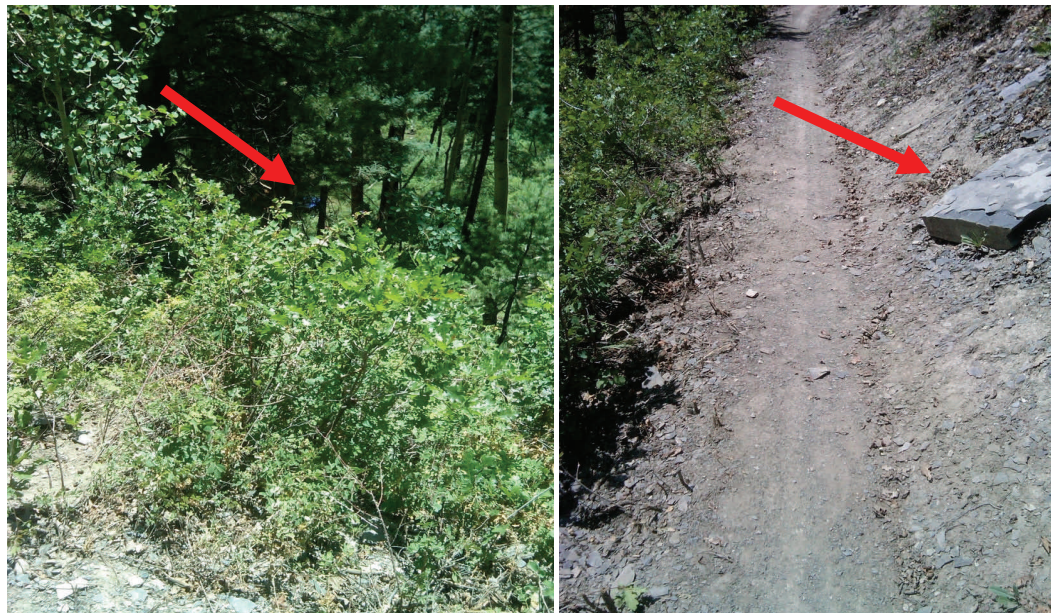
**(Looking down to the ATV in the brush and the trail at the accident site)**

**Environmental Conditions**-On this day the weather was fair, temperatures in the upper 80's, light winds out of the southwest and partly cloudy with scattered thunderstorms in the area. The location on the trail where the accident had happened had received very little if any precipitation. There was very little foot traffic on this trail, with the exception of two mountain bikers and two motor cyclist, they had seen no other individuals on this trail. The trail was made up of typical soil and dirt and was fairly easy riding. Yet at the switch back where the incident had occurred, the soil type changed to a gravel and shale rock type of material, which contributed to the ATV sliding off the trail due to its significant instability.

- 1-**Review the Trail Management Objective (TMO) for a trail that has not been utilized for operating an ATV before – the trail must be wide enough for safe ATV operation
- 2-** It is not recommended to take an ATV on a motorcycle trail.
- 3-**Operators should always know the width of the ATV they are operating.
- 4-**During planning and preparation of field work – reviewing RMA- consider and discuss the worst case scenario. An open discussion/conversation of site specific hazards can further identify potential risks.
- 5-**Evaluate terrain/trail for conditions that influence how you may have to operate the ATV.
- 6-**Not recommended to ride with wheels on uphill slope – putting the ATV off balance
- 7-**Look for an alternate way to get the job done; continuously re-evaluate all hazards.
- 8-**Ensure Notification of Dispatch as soon as possible.
