Keg Fire Rollover

**Bureau of Land Management
Utah BLM
West Desert District
Fillmore Field Office
Little Sahara Fire Station**

6/17/2012

Vehicle Rollover Investigation - June 17, 2012

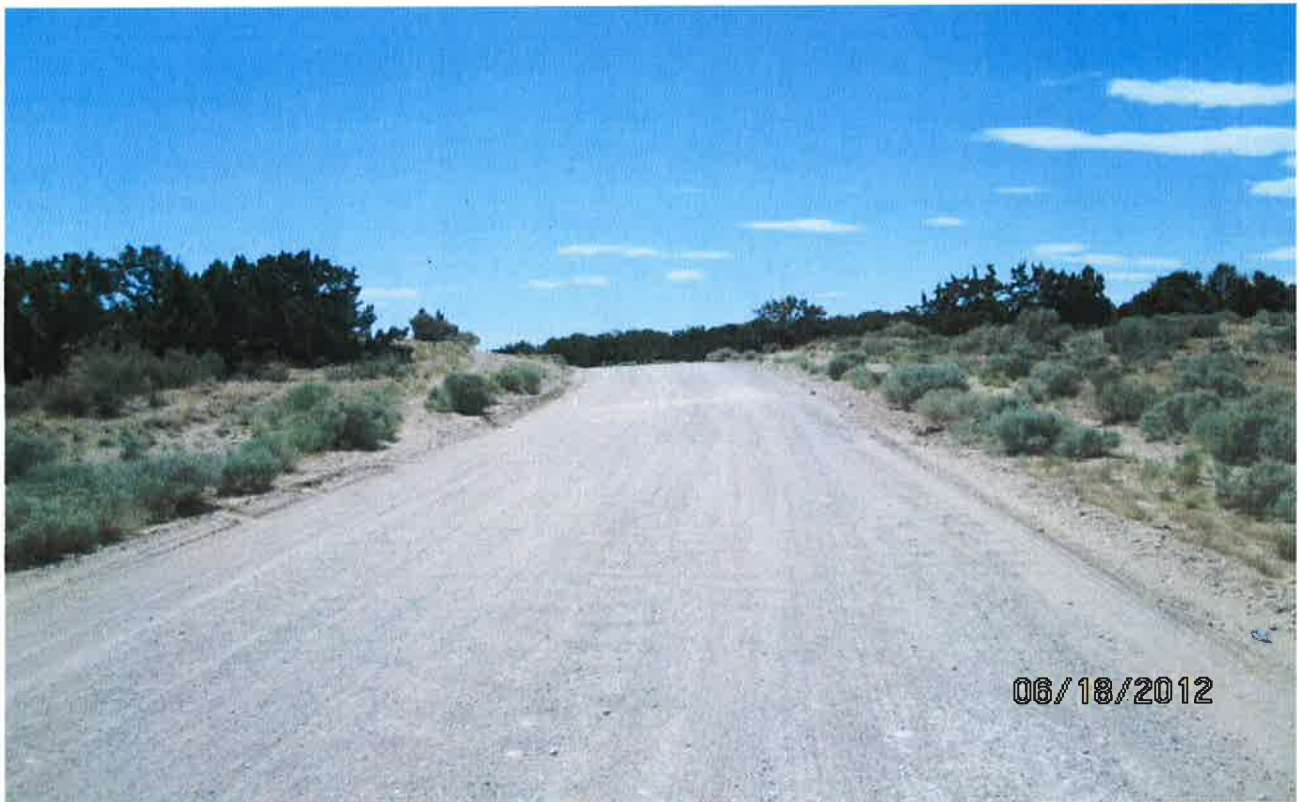
Photo #1: The blind corner on the Weiss Road, looking east in the direction of travel that Engine 5429 was traveling

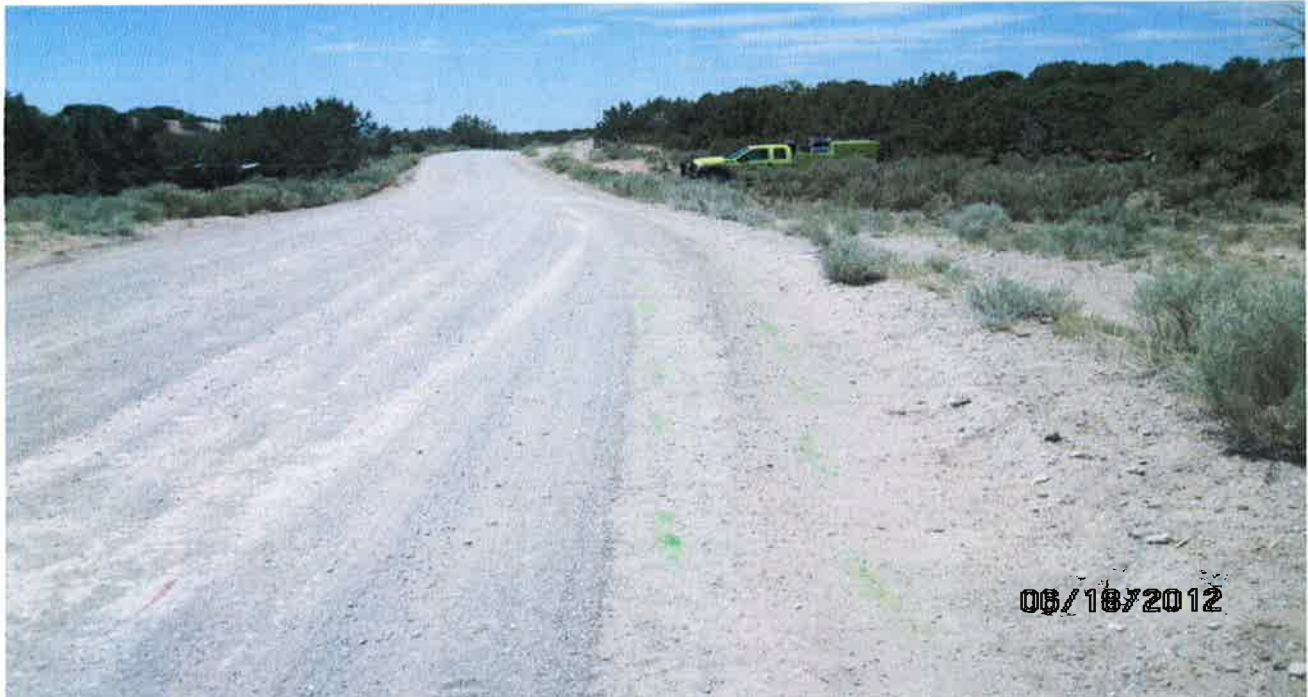
Photo #2: Photo taken from where Engine 5429 had to take evasive action, green paint represents the engine's tire tracks (right side wheels)

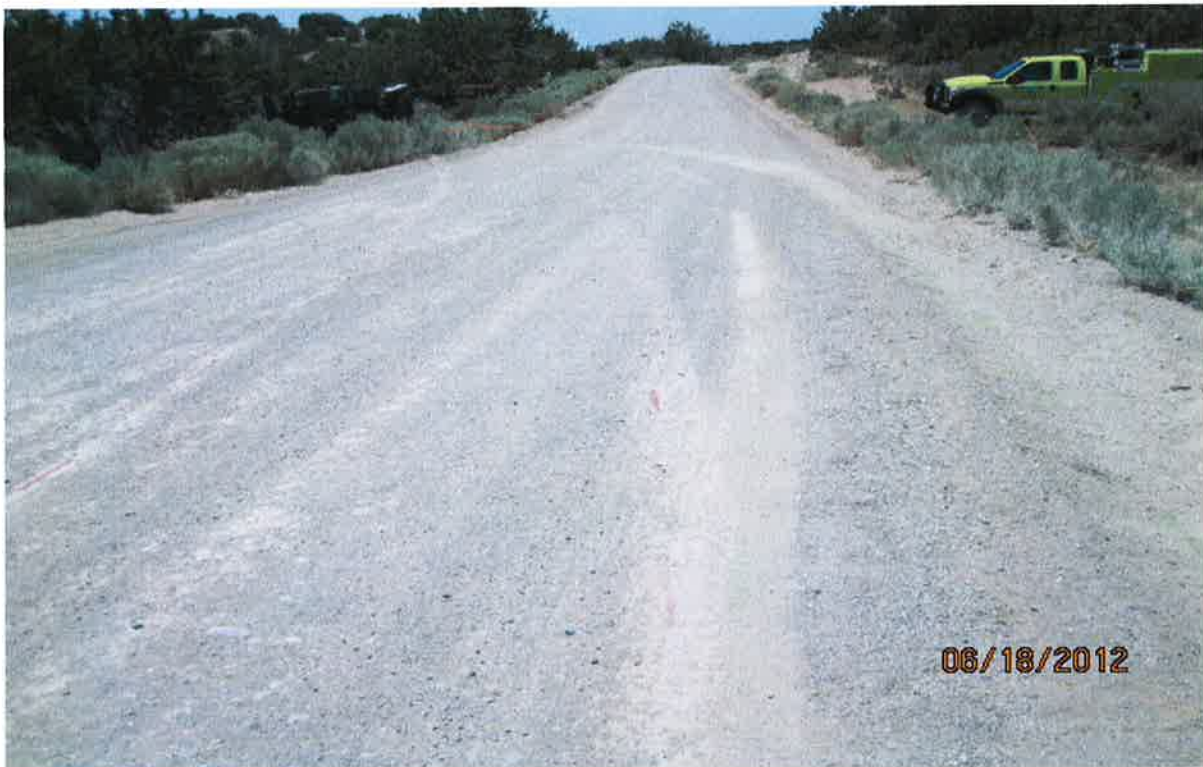
Photo #3: Where Engine 5429 began to slide sideways, notice skid marks on road surface

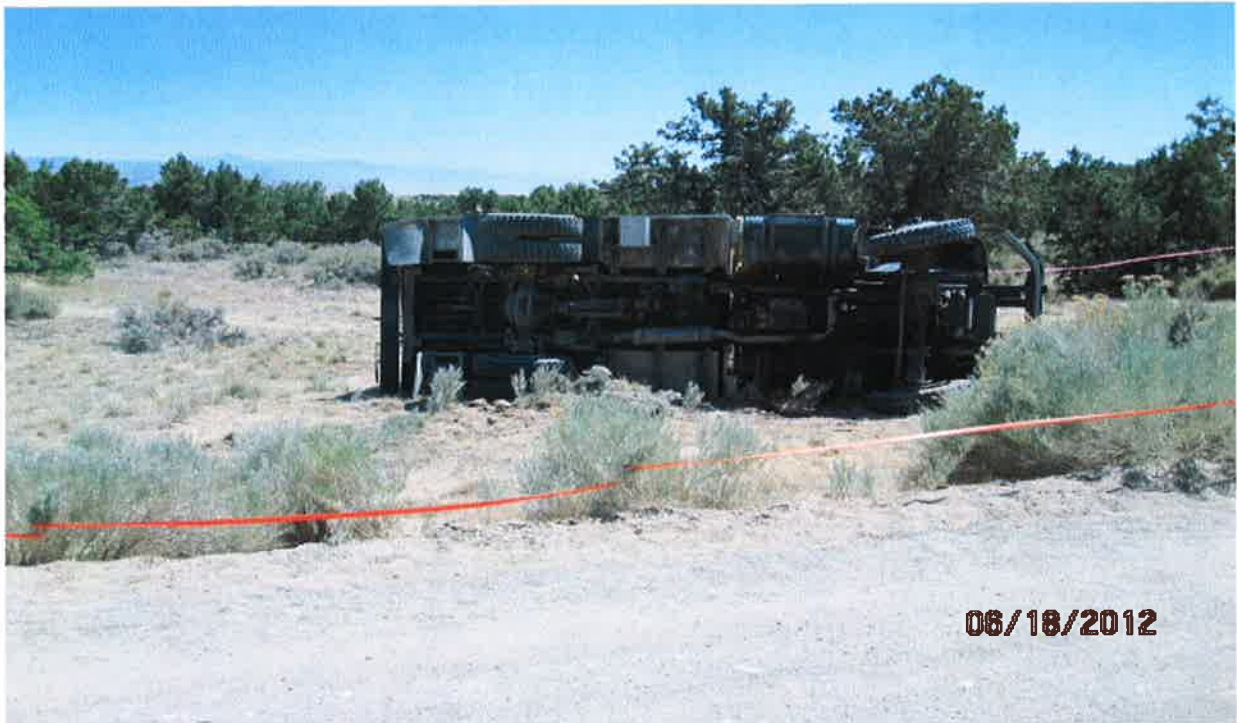
Photo #4: Where Engine 5429 came to rest, looking to the North from road

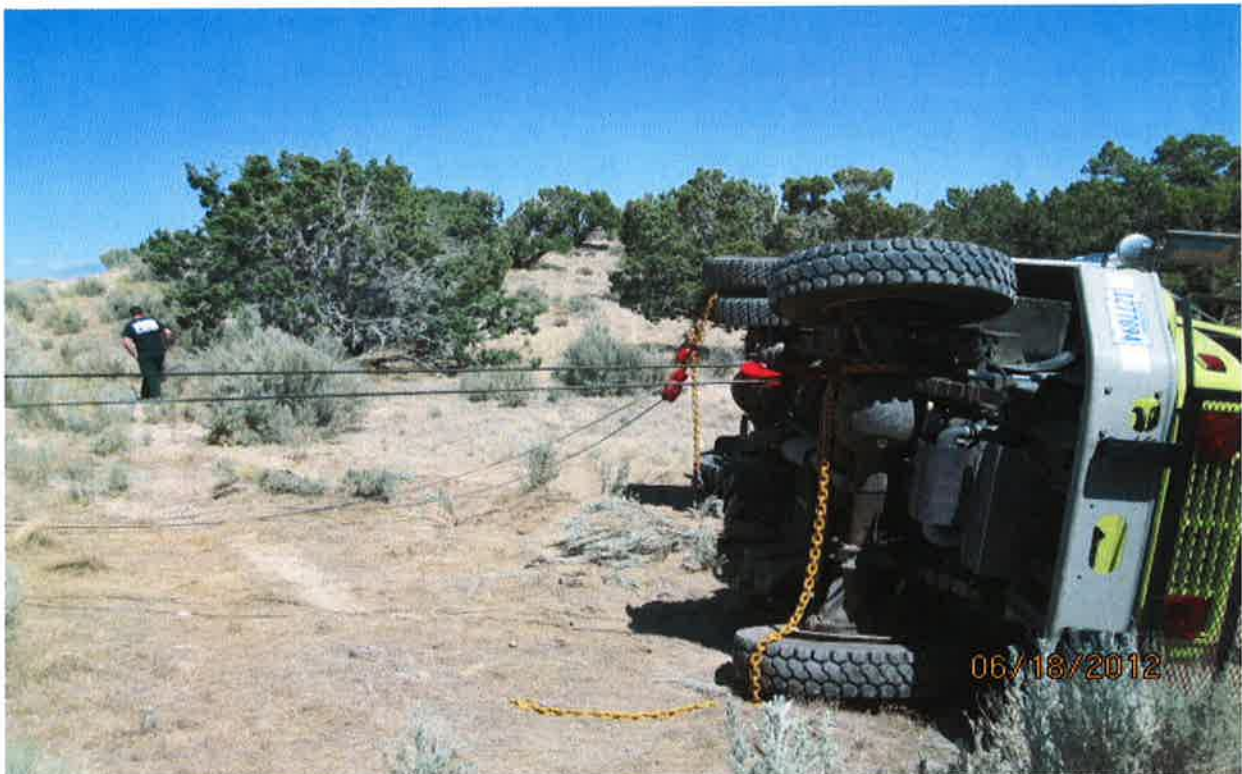
Photo #5: Engine 5429 prior to getting winched back onto its wheels; notice the wheel tracks in the grass

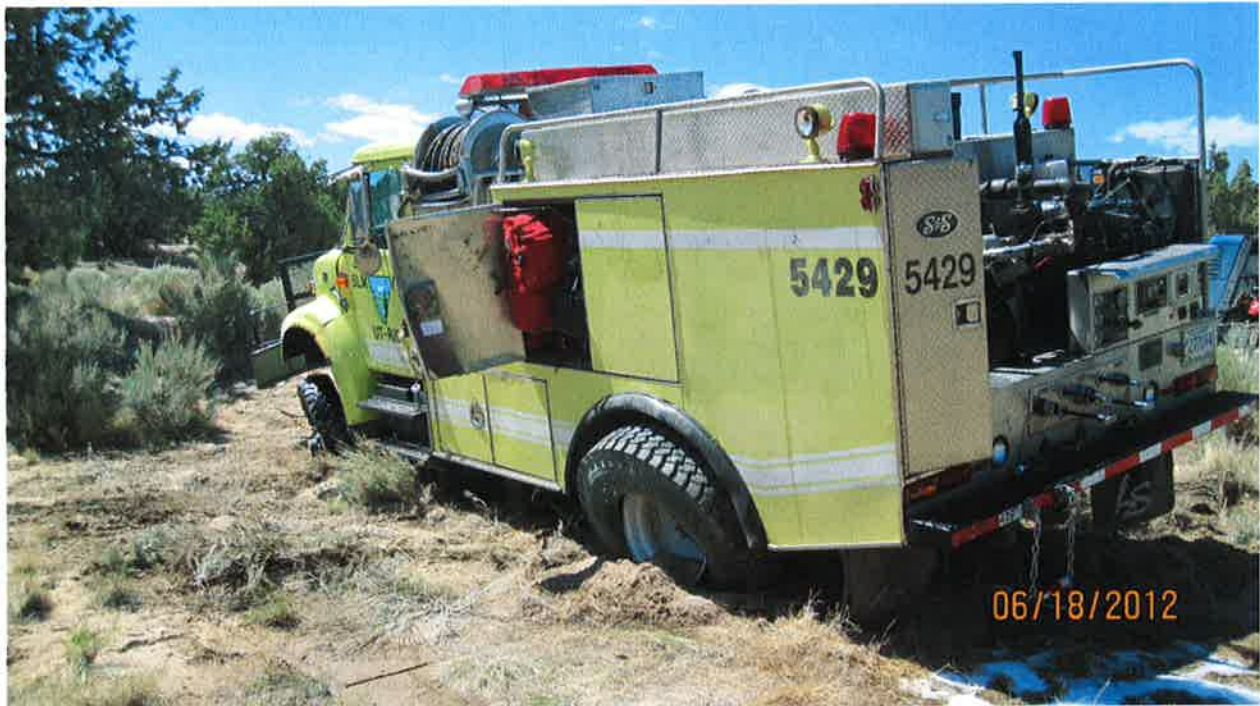
Photo #6: Engine 5429 once winched back onto its wheels, side shown is the side the truck was rolled on

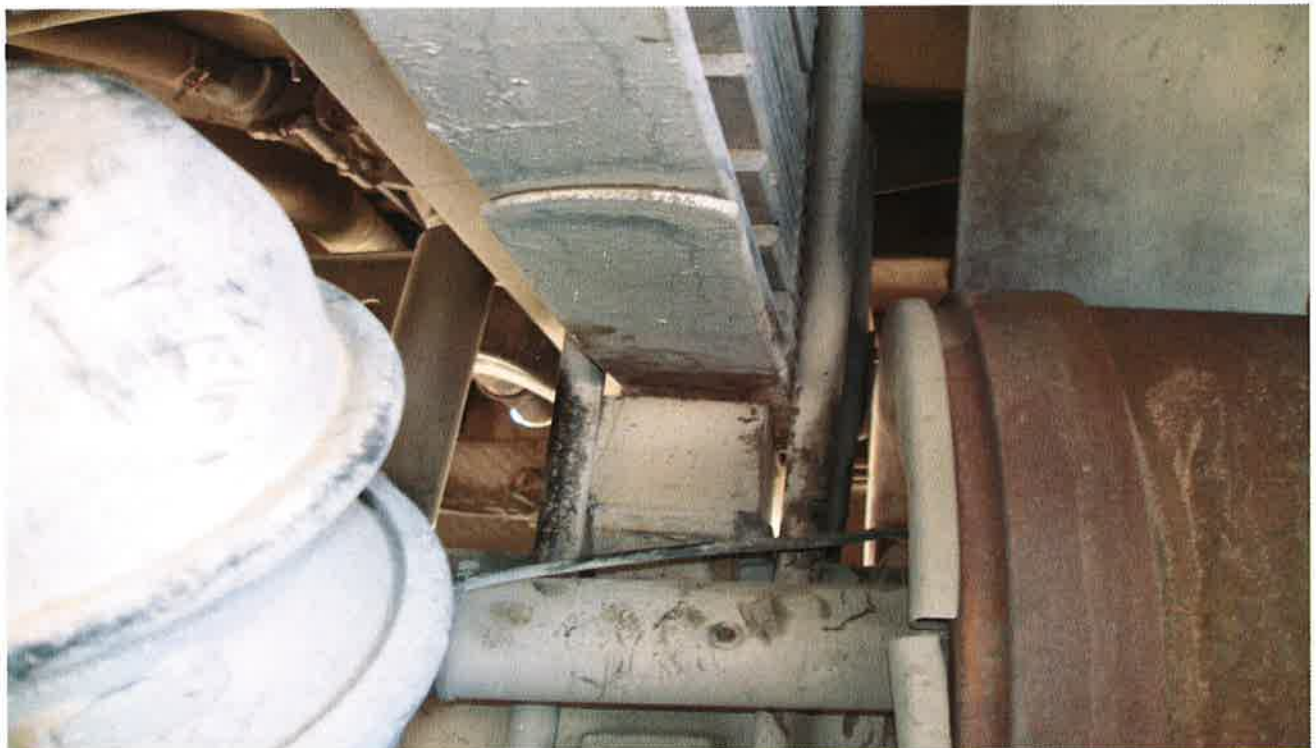
Finding #9: The left rear axle assembly had shifted prior to the accident occurring (reference photo #7). The mounting area for the alignment spring and mounting block had shifted, rust and dirt was visible where the correct axle alignment should have been.

Discussion: A diesel mechanic from the Nation Fire Equipment Program traveled to the International Dealership and inspected the fire package, baffles and pump package for damage that the chassis dealer would not have the expertise to identify and diagnose. There was not an Annual Vehicle Inspection completed for 2012 nor was there a documented apparatus safety and operational check in the Fire Engine Maintenance Procedure and Record (FEMPR) within the last week. If either one of these were completed, the axle alignment issue could have been identified and the engine could have been taken out of service until the problem was fixed.

Photo #7: Left rear axle assembly, rust and dirt are present, showing that movement was prior to accident

Recommendation: The engine crew needs to ensure that the documented apparatus safety and operational check is completed and documented in the Fire Engine Maintenance Procedure and Record (FEMPR). The engine crew should also take the time to crawl under the vehicle, look for maintenance issues, ensuring that all the mechanics of the engine are in good working order prior to daily operations. Engine crews need to ensure that the vehicle receives an Annual Vehicle Inspection and that the vehicle meets Bureau policy for vehicle safety inspections and maintenance.

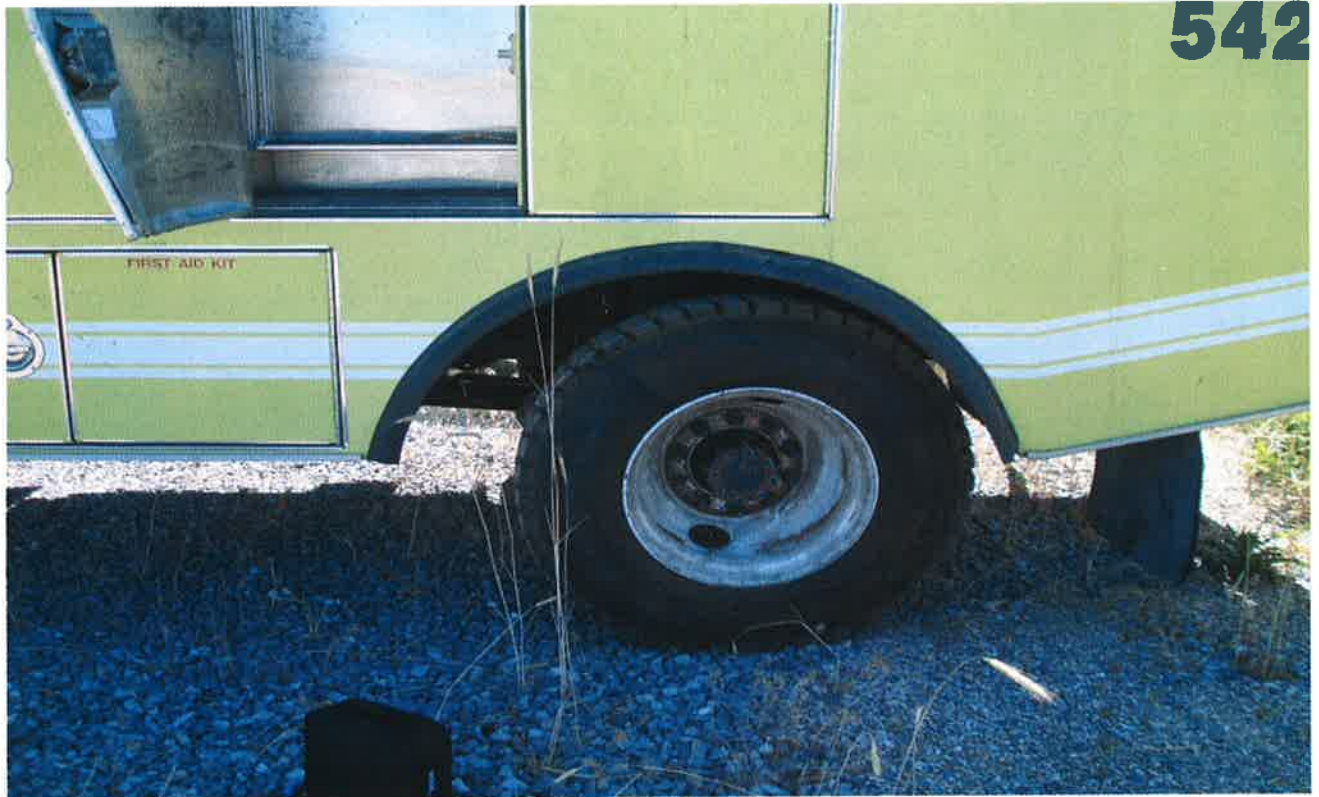
Photo #8: Shows the axle alignment due to shifted mounting block and axle alignment spring
