Kelly Creek Project

A Felling Accident

Facilitated Learning Analysis

June 4, 2018

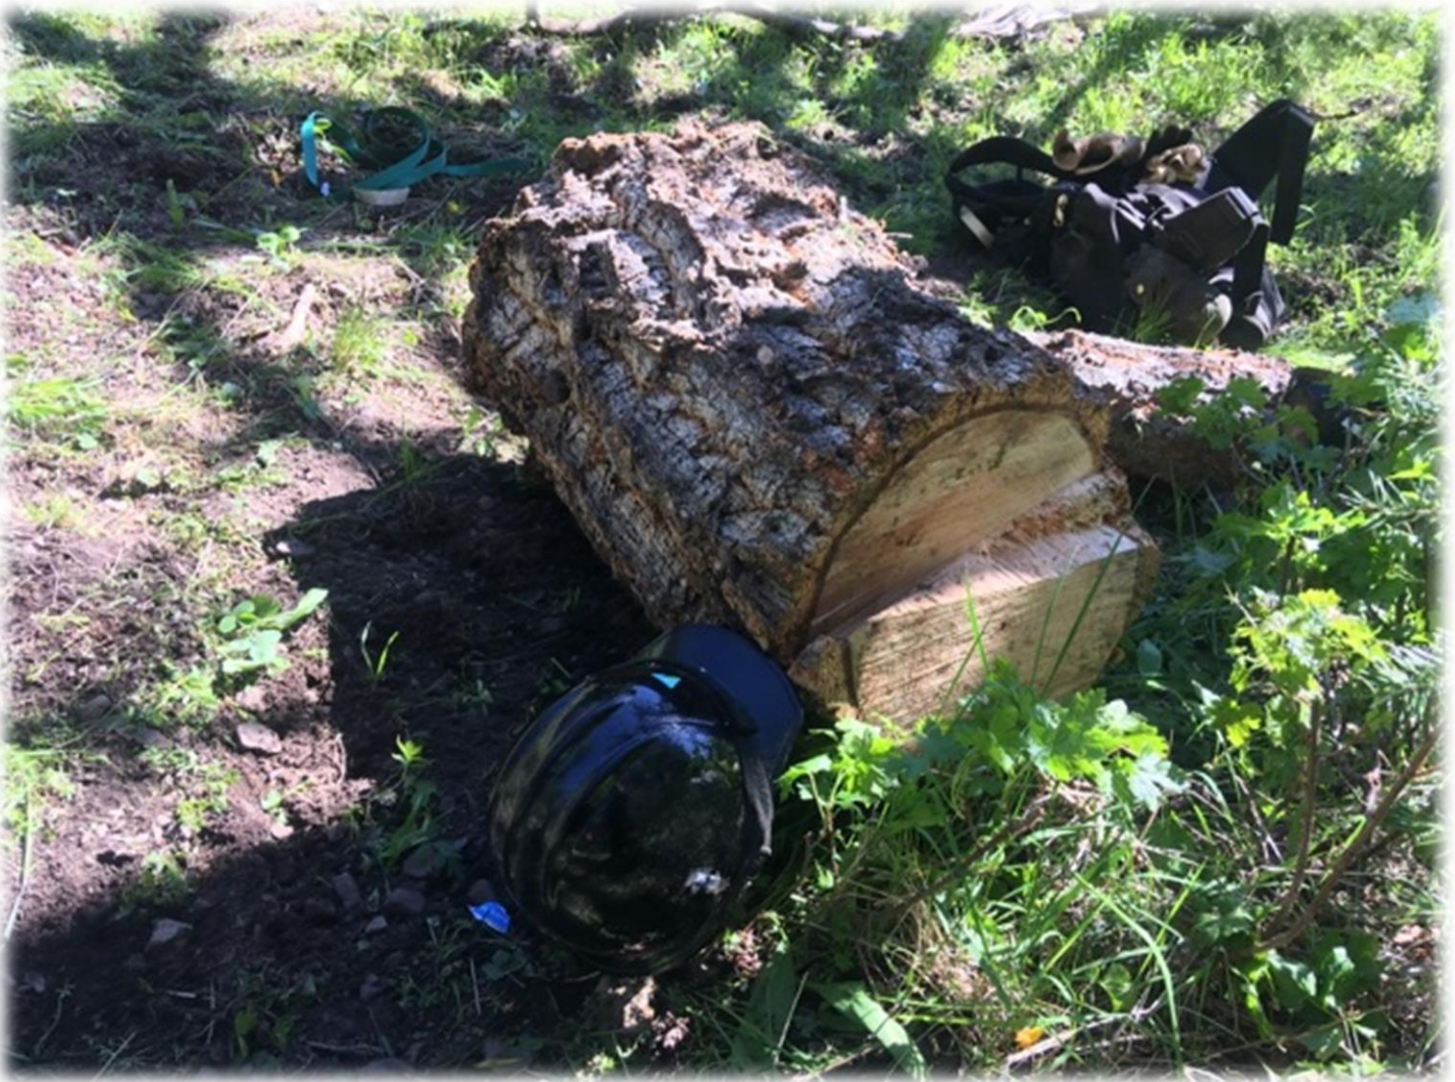
Low stumped section of felled tree

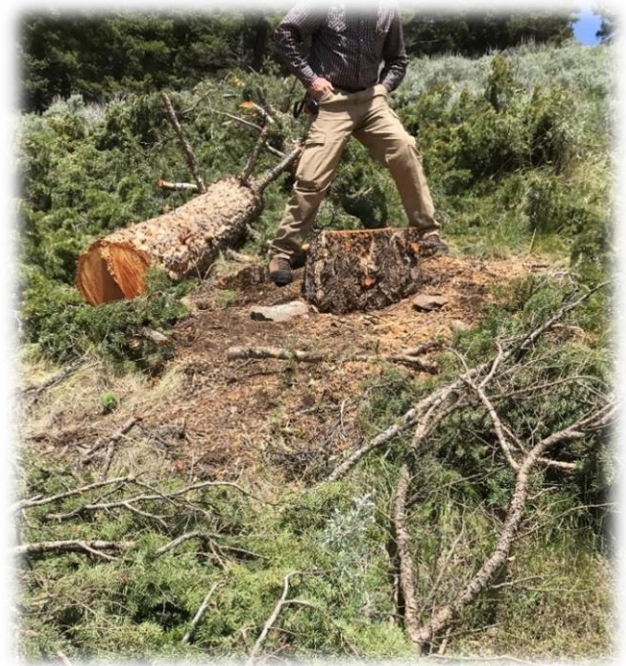
Saw team 4 felled a tree on the upper slope. This left a tall stump on the slope that needed to be low stumped. The low stumped section was green and heavy; making it difficult to manage on the moderate to steep slope. Once the low stumped section was released from the stump, it got away from Team 4 and began rolling down-slope. The team began shouting “Roller!” repeatedly while running down the slope. It looked as if the log would stop in the trees below. As the sawyer on Team 4 ran far enough downslope to see the creek at the bottom of the slope, it was apparent that the log was still traveling down slope catapulting end over end at a high rate of speed toward the creek below. Saw team 2’s swamper heard something, looked up, saw the log, and screamed “Roller!” to team 2’s sawyer. Sawyer 2 released the trigger of the chainsaw, looked up, and received a direct hit from the stump.

Felled tree

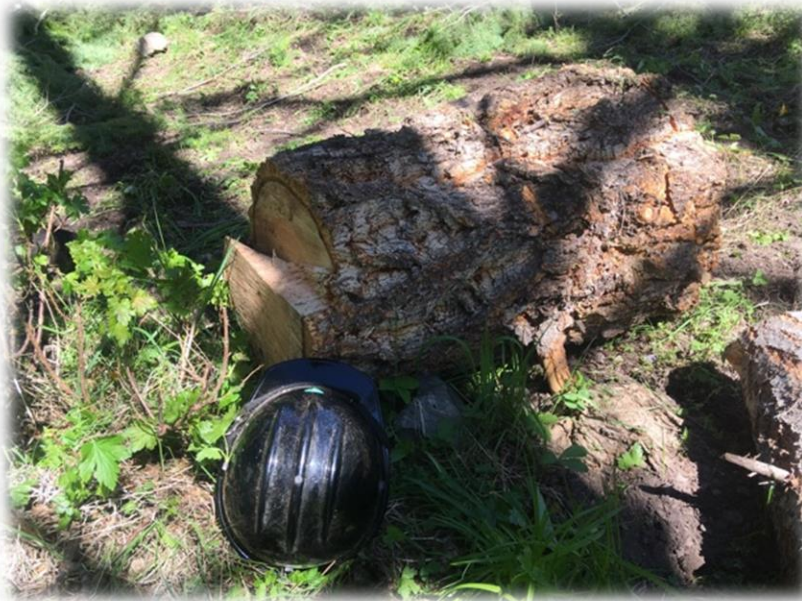
Low stumped section of tree at accident site

To note: It just so happened that the low-stumped section of a tree that had recently been felled rolled down-slope. If it hadn't released when it did, it would have remained on the slope, the saw team would have advanced down slope for their next cut, while the hazard rested above them. That scenario does not exist when working upslope, and is the reason behind the standards. This note is shared to help understand the intent behind the standard. This is not the first time this event has occurred – in government or private industry.

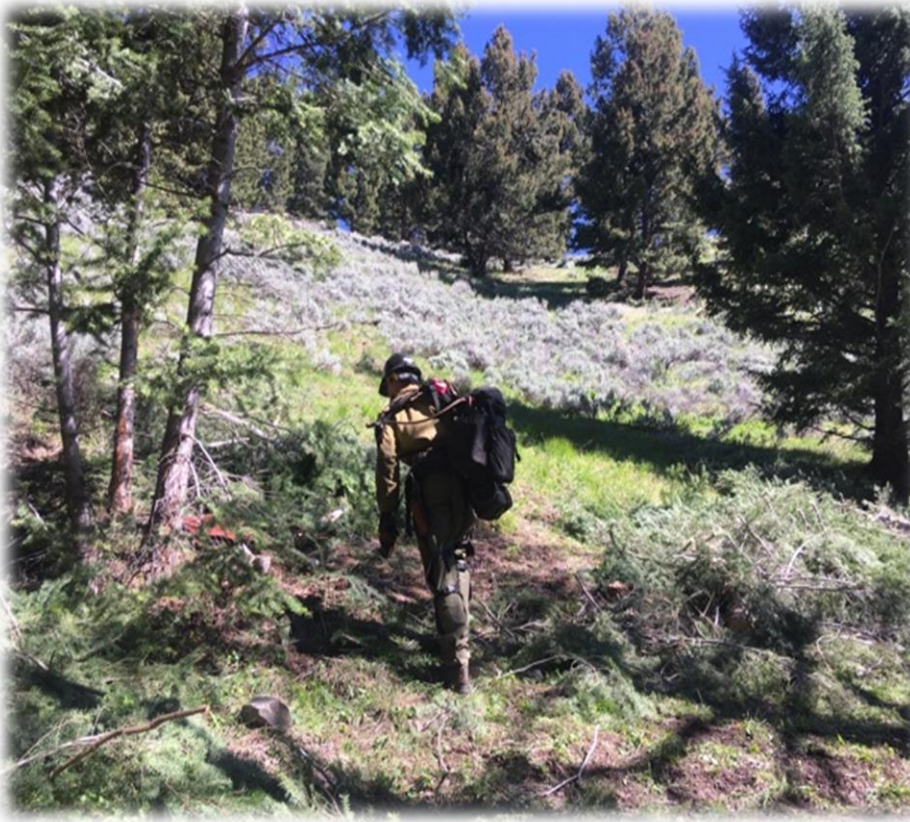
A sawyer standing at the impact site

The log made impact with the chainsaw, which was held in front of the Sawyer 2’s waist. Both the chainsaw and log were driven into the sawyer’s body. Sawyer 2 was driven violently backwards into the ground. Sawyer 2’s saw team partner witnessed the strike and immediately went to assess Sawyer 2’s condition.

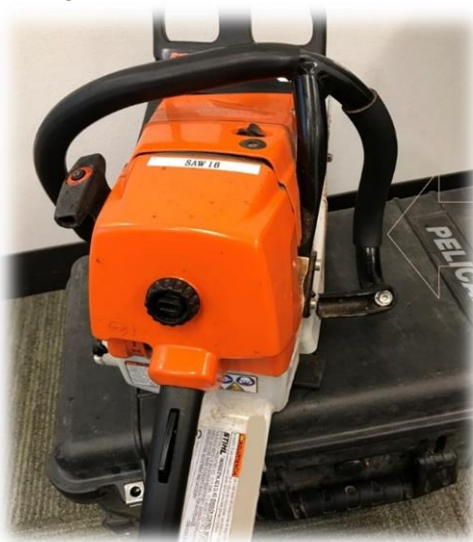
Broken front handle (see arrow)

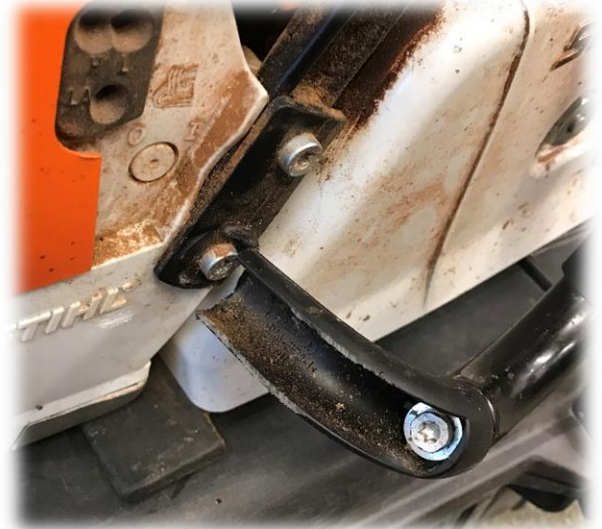
Arrow indicates where impact with the saw occurred

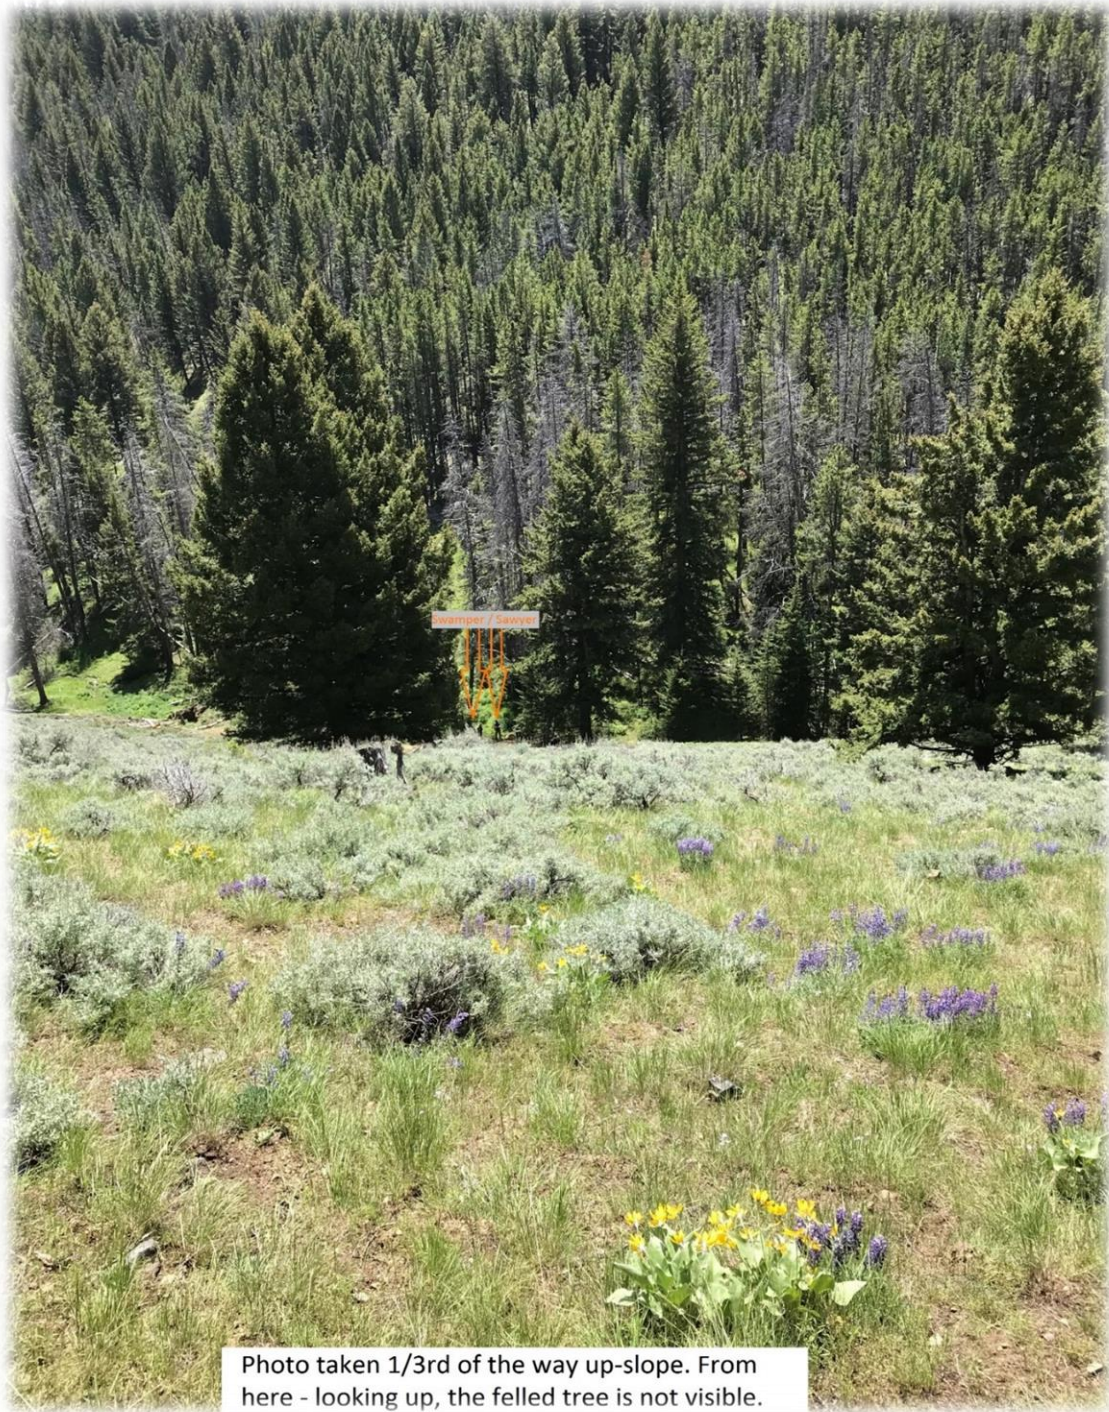
Looking down to Kelly Creek
