# **GREEN SHEET**

### **Joint Investigation Summary of a Fire Engine Rollover**

**Fire Engine Rollover  
July 1, 2004**

**Kirker Pass Fire  
CA-SCU-003601**

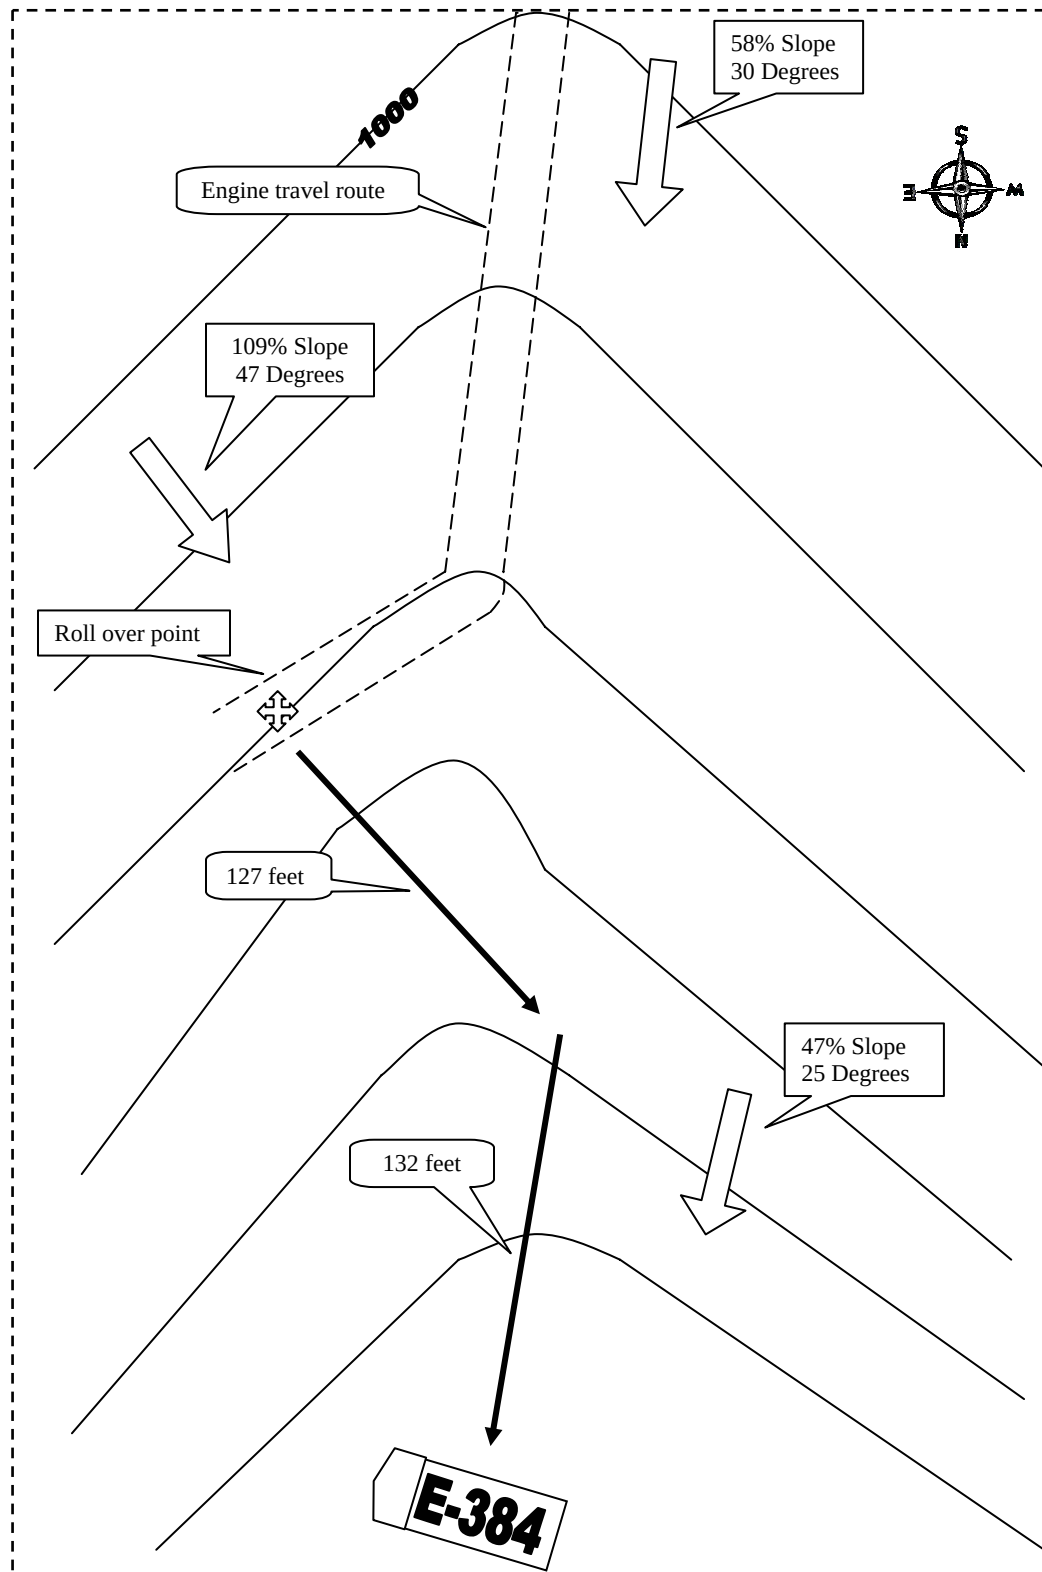
MAP 1. Descent and rollover paths of E-384.

As the engine started down the steep slope of the draw (58% or 30 degrees), gravity caused it to quickly accelerate. Initially, E-384 was traveling “under control” at an estimated speed of 5 to 10 mph. About 30 feet down the slope, the occupants felt a “jolt” and the engine seemed to “break loose”, eliminating engine compression braking, and accelerating “out of control.” Engineer 384 and witnesses estimate the engine quickly reached a speed of somewhere between 25 to 45 mph. Engineer 384 believed that service brake application would cause the engine to slide and/or roll; therefore, no brake pressure was applied at that time.

In an effort to bleed off speed, Engineer 384 turned the engine approximately 30 degrees to the right, climbing up the right side of the draw. This action placed the engine on a side slope of 109% (47 degrees). As the engine rolled to a stop, he applied the service brakes to avoid rolling backward. Within seconds, as water shifted through the tank baffles, the engine began a slow roll onto the left side, completing six revolutions over 259 feet before it came to rest on the driver’s side.
