# Lake Christine Rollover

## Accident Investigation

Bureau of Land Management  
Colorado Northwest District  
Silt, Colorado  
July 19, 2018

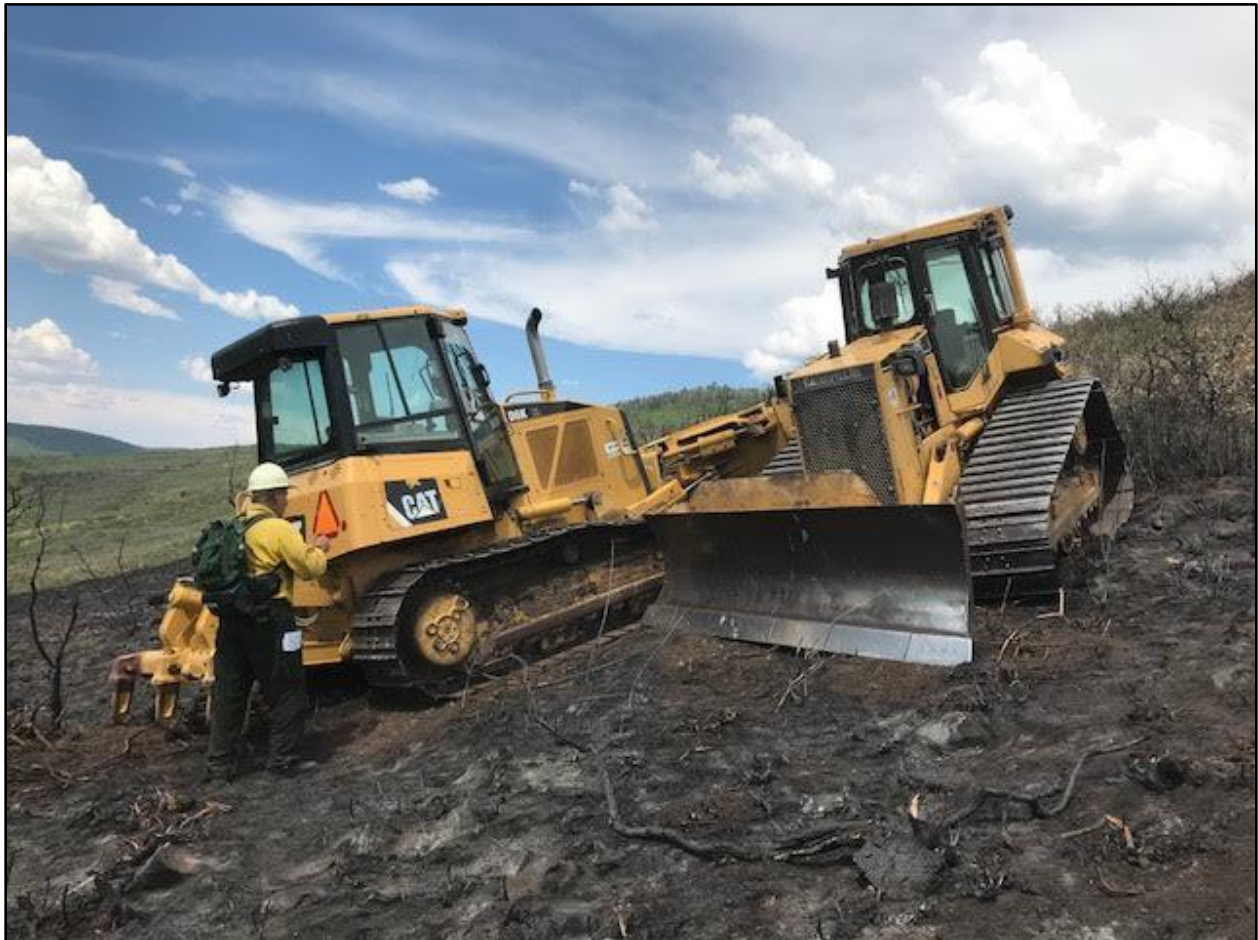
*Post rollover; Dozer 2 (left) securing Dozer 1 (right).*

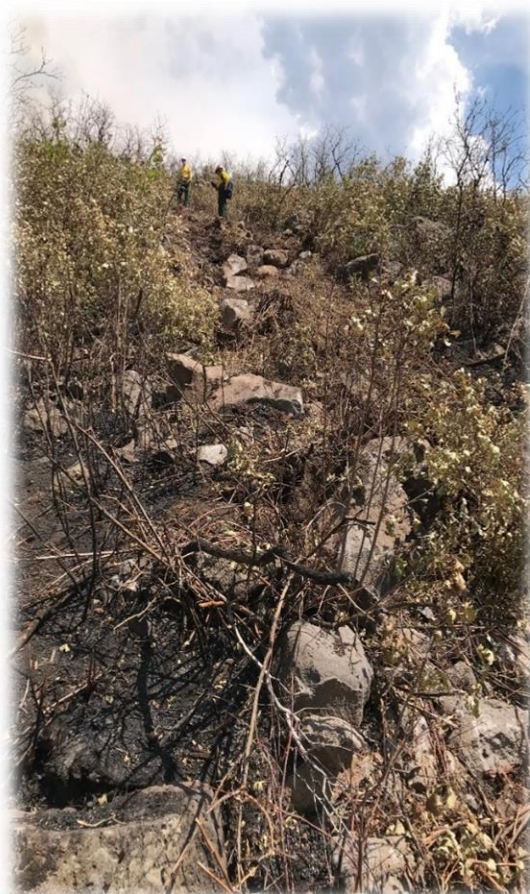
Dozer 2 tracked down the slope to the black with Dozer 1 following a distance behind on BLM administered land. Near the bottom of the descent, Dozer 1's blade dislodged a boulder causing the dozer to drive over it on the right side. This caused the left edge of the blade to strike a boulder, violently pivoting the dozer downhill to the right. The downhill momentum of the dozer caused it to roll two complete times, and in the process render the operator unconscious.

Rock dozer 1 knocked loose prior to rollover. 3/4 of rock was buried in ground. Grouser marks in rock after being unburied.

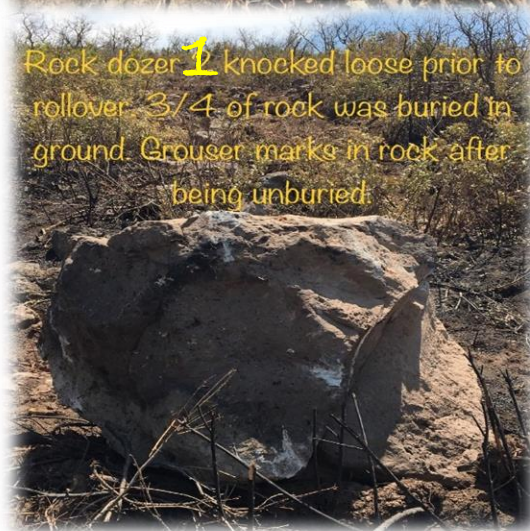
Route taken; rock dislodged.

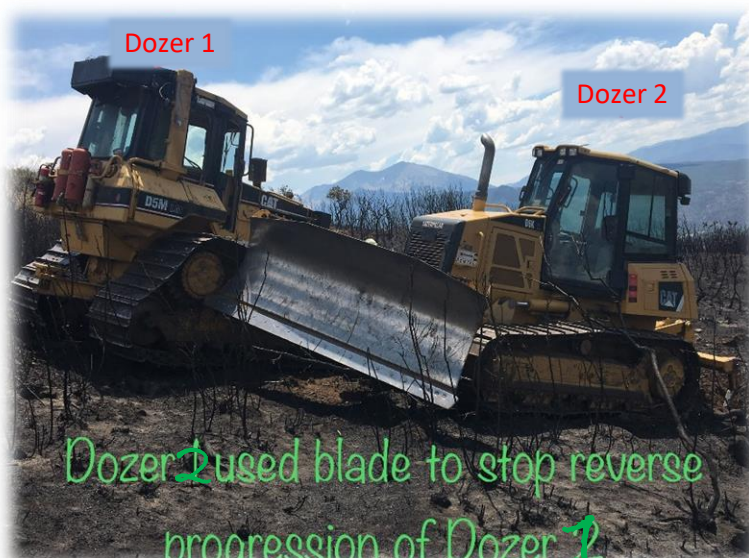
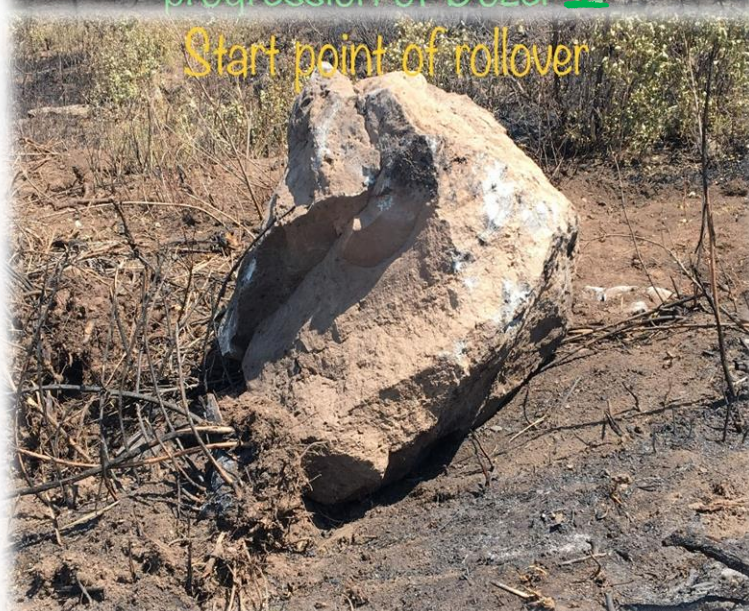
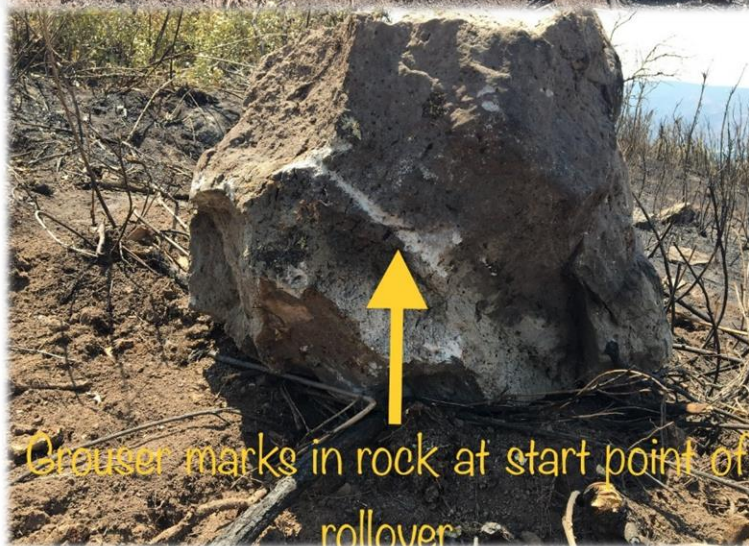
*Dozer 2 securing Dozer 1; rocks that led to the rollover.*

dozer around and used his dozer blade to stop the downhill descent of Dozer 1. After a couple of attempts, Dozer 2's operator was able to push Dozer 1 into an uphill angle and wedge his blade into the right-hand track of Dozer 1 – which effectively secured Dozer 1 in place. With the machine secured, the HEQB(t) immediately jumped onto Dozer 1 and shut it down. The operator of Dozer 1 became responsive at this time.

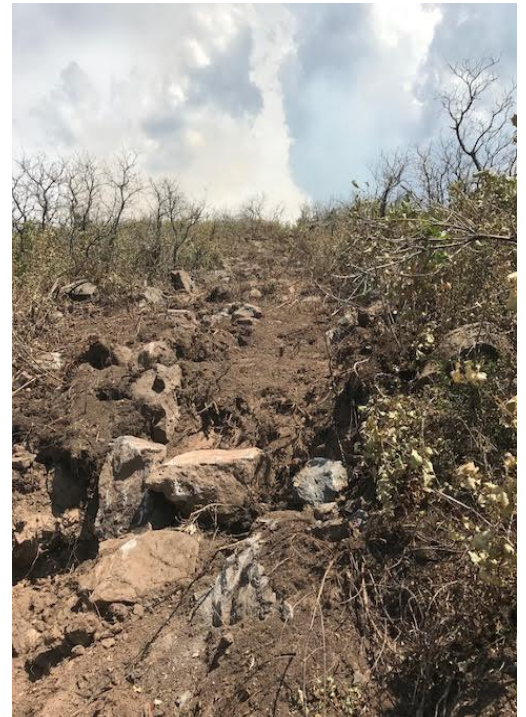
**Finding 1:** The route of travel the dozers selected was in challenging terrain.

*Discussion:* The terrain where the rollover occurred was close to a 40 percent slope with three to four foot green gambel oak and numerous large basalt rocks hidden by the brush. The dozer was travelling straight down slope at a slow rate of speed with the blade just above ground level and following another dozer. Both operators got out of their machines and looked at the proposed route of travel before going downhill. Weather and visibility did not appear to be a factor.

*Route Taken.*

*Recommendation:* Proposed routes of travel should be thoroughly scouted, walked out, and evaluated for safety before attempting. HEQB and operators should evaluate and consider all possible routes before choosing a particular path.

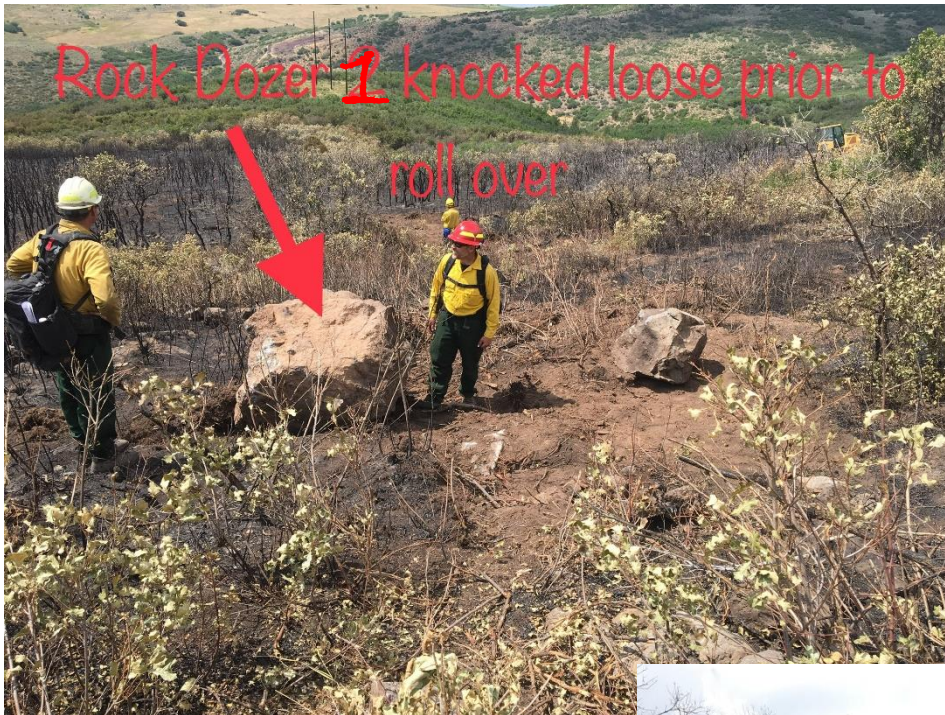
*Person next to rock for size reference*

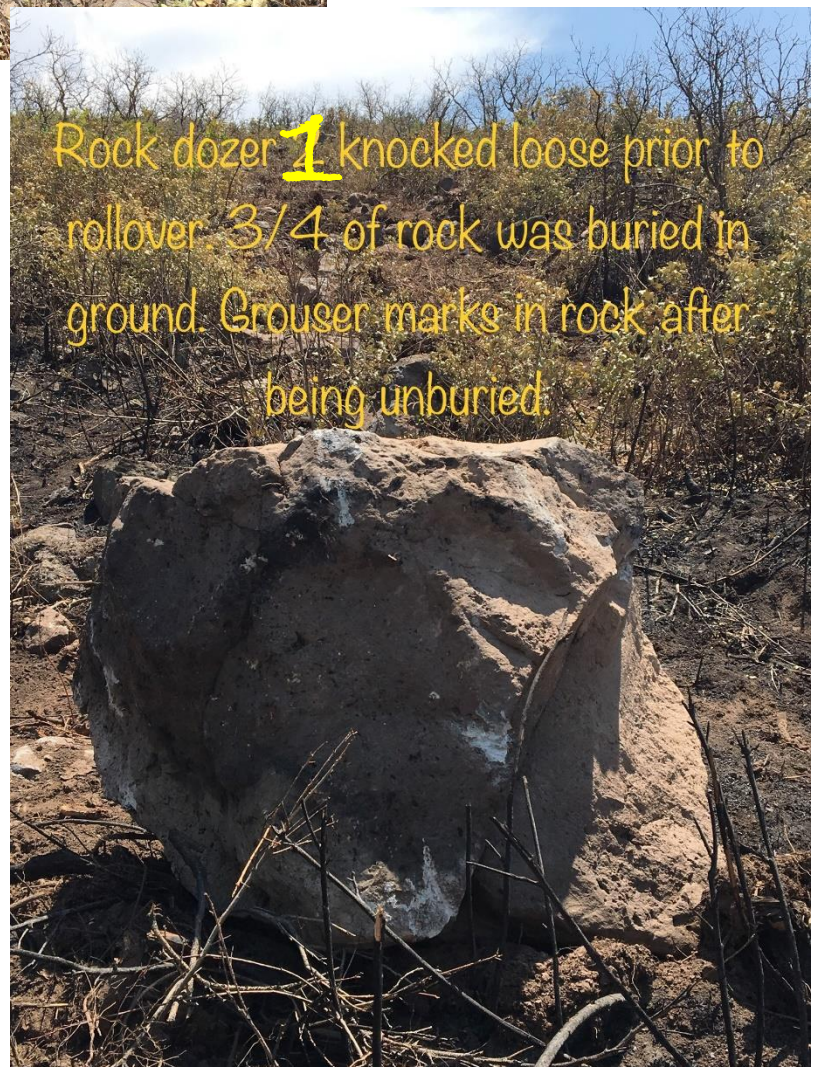
*Discussion:* The dozer was a privately owned 1996-2002 Caterpillar D5M LGP based on the serial number 3CR01415. It was not inspected at the fire prior to the rollover incident. The track width was measured at 30 inches. A low ground pressure (LGP) machine is designed for use in soft, wet terrain and to provide for less soil compaction. The dozer was equipped with a factory Rollover Protective Structure (ROPS) that was extremely effective in protecting the operator and maintaining the structural integrity of the cab. LGP machines are not uncommon in the wildland fire environment, but their capability needs to be considered when operating in steep, rocky terrain (as with all dozers). All steel tracked equipment will slip on rock. The extra surface area of track on LGP dozers can lead to more steel on rock, which increases chances of slipping.

*Grouser mark ("grousers" are devices intended to increase track – traction.)*

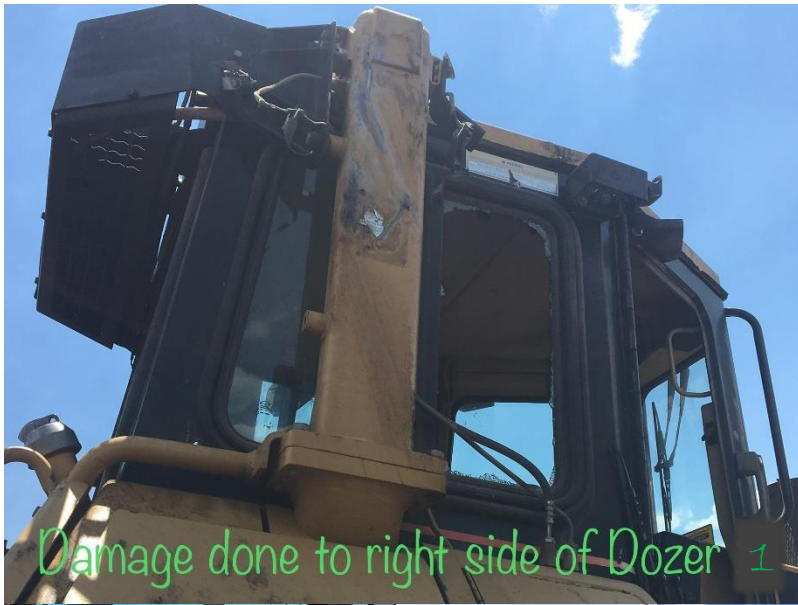
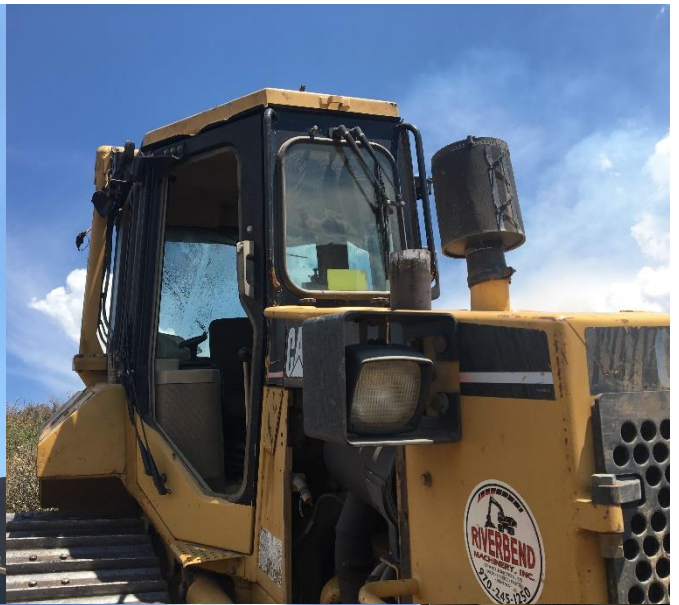
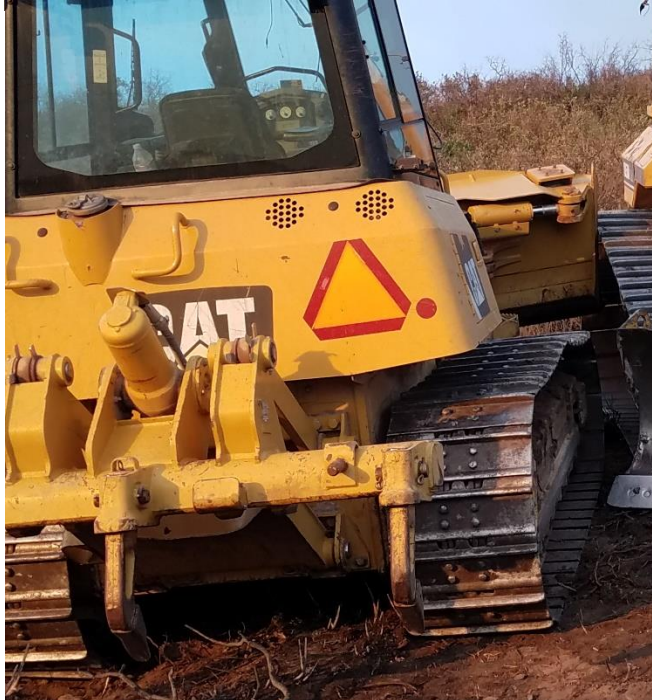
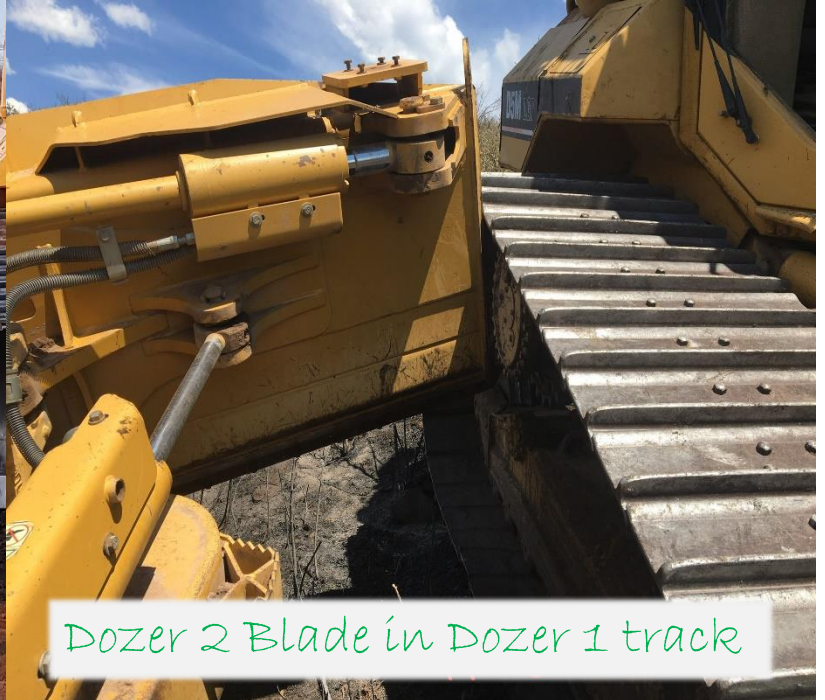
***Dozer 1 damage and Dozer 2 actions to  
secure Dozer 1.***
