Informational Summary Report of Serious CAL FIRE Injuries, Illnesses, Accidents and Near Serious Accidents

Burn Over of Two Private Bulldozers – Firefighter Near Serious Accident

September 14, 2015

Lumpkin Incident

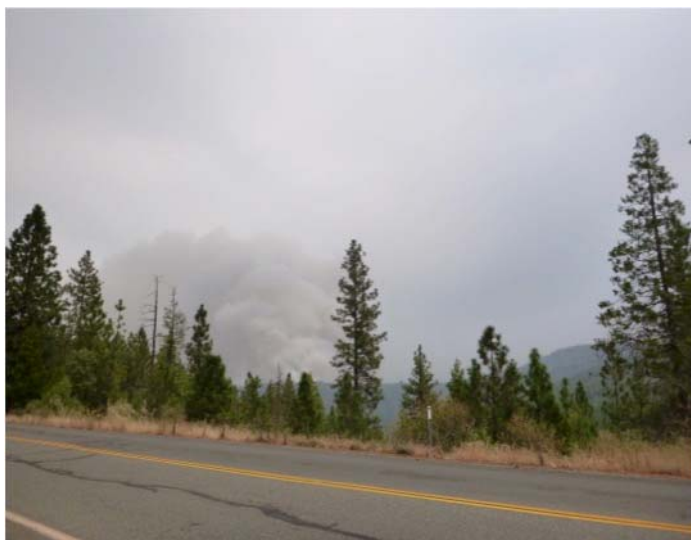
This picture was taken,
September 14, 2015, at 1204
hours, shortly after fire crosses

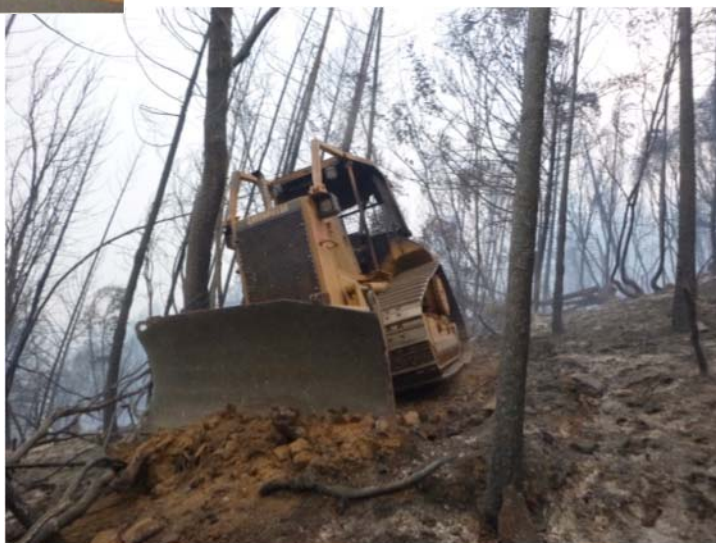
E-1 and E-6 sustained serious damage and were rendered inoperable.

This picture of E-1 was taken,
September 14, 2015, at 1653 hours.

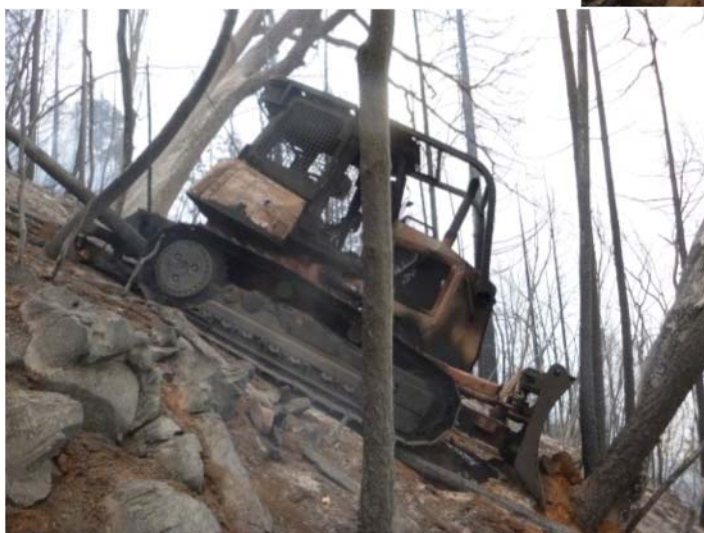
This picture of E-6 was taken,
September 14, 2015, at 1703 hours.
