REPORT OF INVESTIGATION
Personnel Injury
Jim Hawecker, Fire Apparatus Engineer

Type of Investigation: Personnel Injury
Jim Hawecker, Fire Apparatus Engineer
Morongo Fire 6/20/73
Riverside Ranger Unit

Investigation by: Russell F. Bockhop
State Forest Ranger I

Date of Report: September 14, 1973

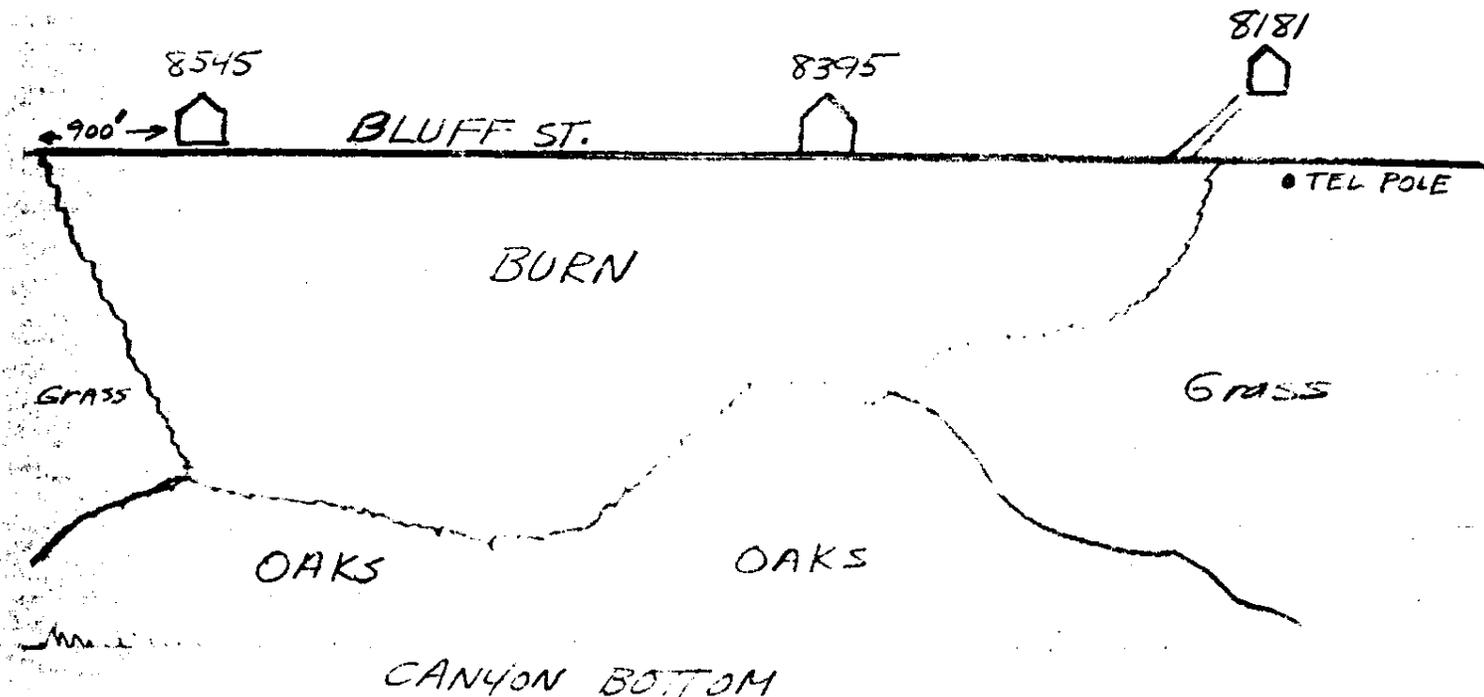
ORIGINAL PROBLEM
6-20-73 1350 HOURS

The fire started on the west side of Banning Canyon and burned in basically the pattern shown above. At this time, action was taken to control the north and south spread of the fire on the side of the bluff. In addition to the main fire, dozens of spot fires were being set on the Banning bench.

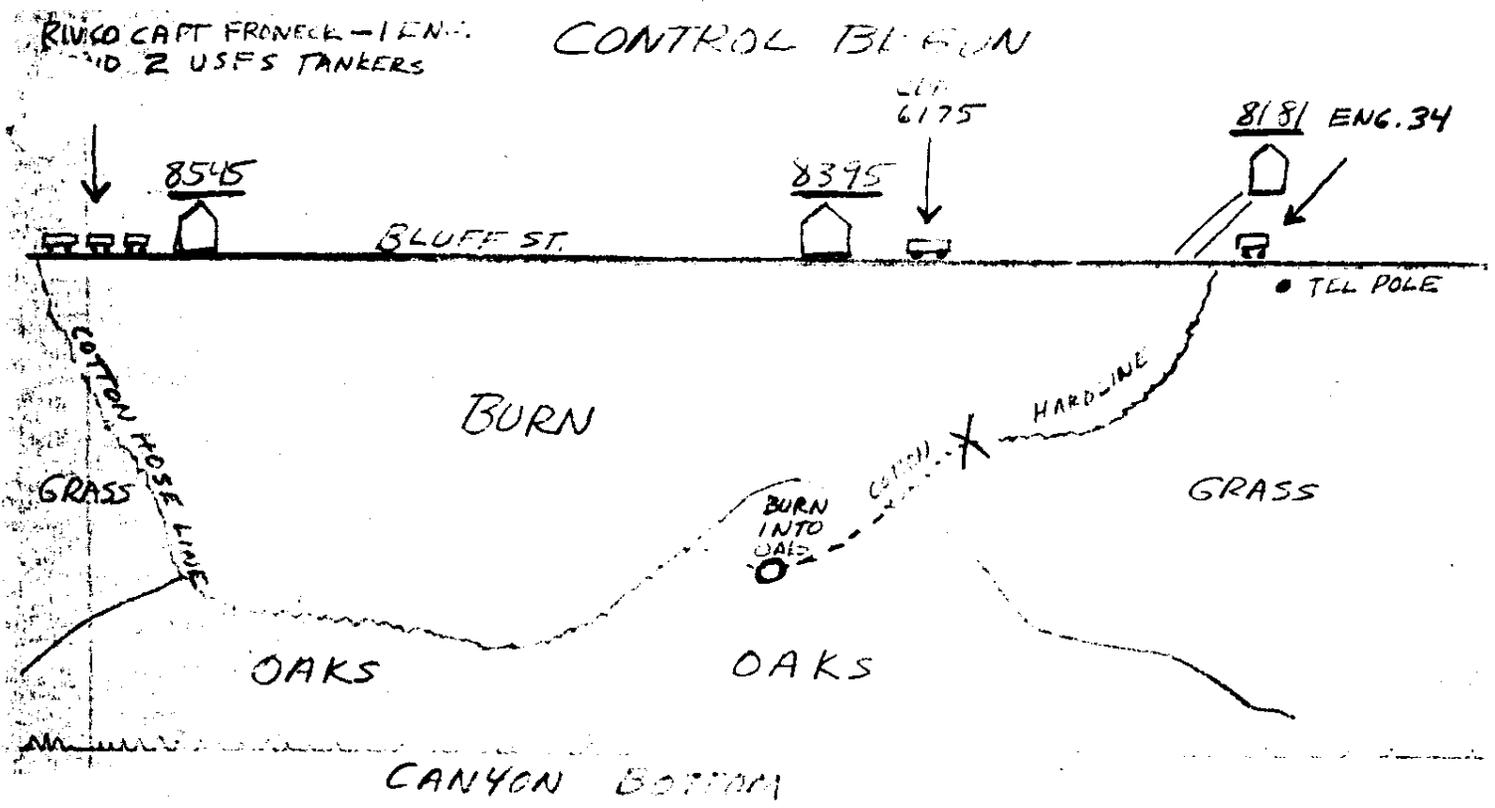
South End - 1 Riverside County engine and 2 U.S.F.S. tankers laid a hoseline over the side and later fired out a section to tie the fire into the bottom of the canyon on the South side.

North End - With the wind calm, 200 ft. of 1" hardline was used to control the fire to point X. Then 200' of 1 inch cotton was added to the hardline but not fully extended to point O.

At this time FF Kimbey was starting a 1-1/2" hoseline straight down the side from 6175.

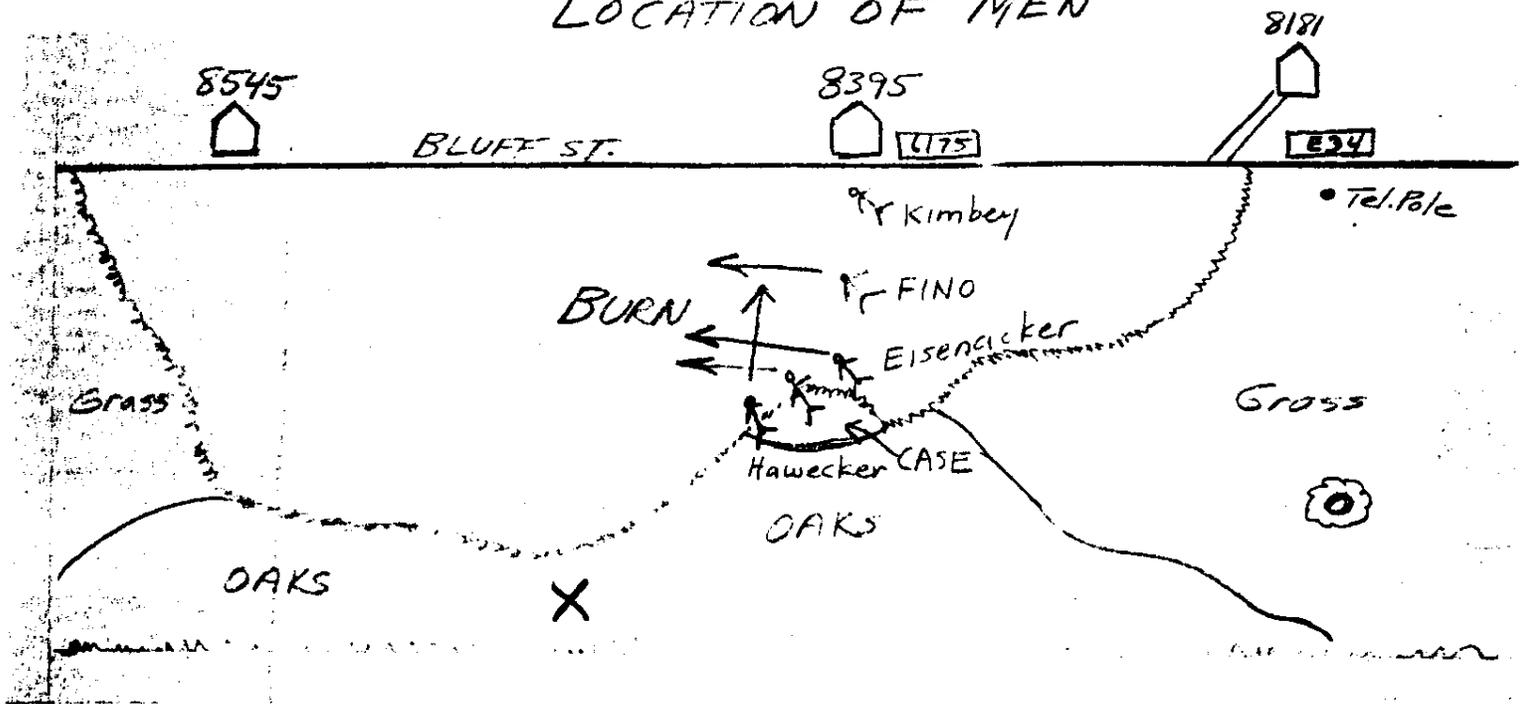
TIME APPROX 1402
FIRST INDICATION
OF PROBLEM AND
LOCATION OF MEN

1. Crew heard crackling sound at X.
2. Spot fire started at O. (Later burned into main fire.)
3. Wind came up strong.
4. Crew began moving out.

1. Firefighters Fino and Case and Volunteer Eisenacker went in a southerly direction (sidehill).
2. Engineer Hawecker went westerly uphill and was burned approximately 50 ft. below Bluff Street.
