MORTON INCIDENT SUMMARY SHEET

Informational Summary of San Bernardino County Fire Department
Near Miss Incident and Vehicle Accident

Morton Fire Incident
99 Incident-Vehicle Rollover

August 9, 2010
Morton Fire

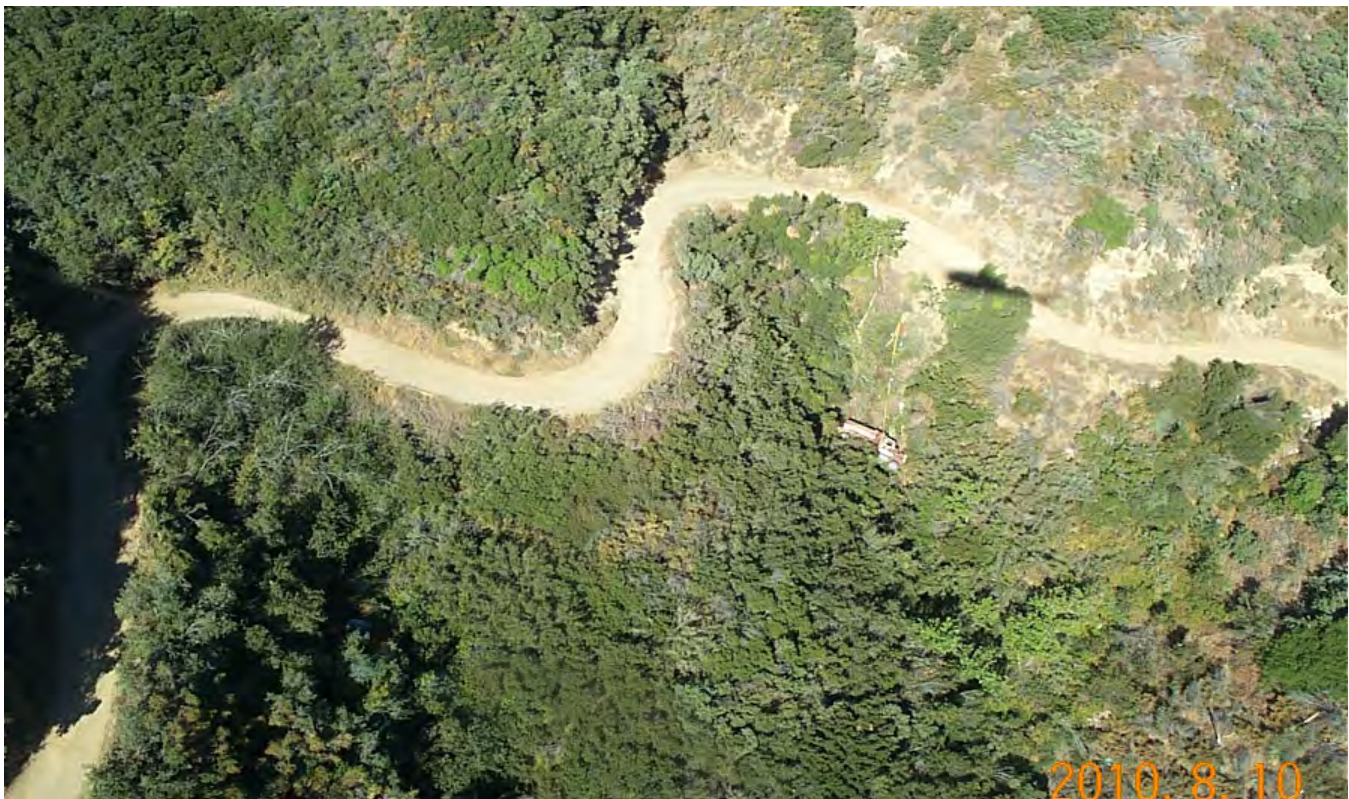
Aerial photo of Forest Service Road 1 N 12
and Water Tender 99 approximately 65 feet below roadway.
Note the path of disturbed vegetation due to the lateral roll of WT99.

Both Paid Call Firefighters sustained minor injuries and were transported to Arrowhead Regional Medical Center (ARMC) for evaluation. Both firefighter's were evaluated and released from ARMC. Water Tender 99 sustained substantial damage and has been removed from service.

The physical condition of Forest Service Road 1 N 12 and visibility were both good. The driver operator was trained within agency standards and had a number of years of experience driving WT99. Both firefighters were following agency policy with the use of seatbelts and full PPE. However, vehicle positioning on the roadway was far to the right. Incorrect road positioning, failure to correctly judge vehicle clearance needs and a soft shoulder resulted in the rollover. Water Tender 99 was examined by a qualified agency mechanic and was found to meet DOT operational tolerances. Medical response was fast and appropriate for the injuries sustained.
