Facilitated Learning Analysis

(Motor Fire CA-SNF-2119)

Date/Time: August 28, 2011 2330 hrs.

Location: Division P on the Motor Wildfire, Stanislaus NF portion of the fire. In a side drainage off of Ned's Gulch.

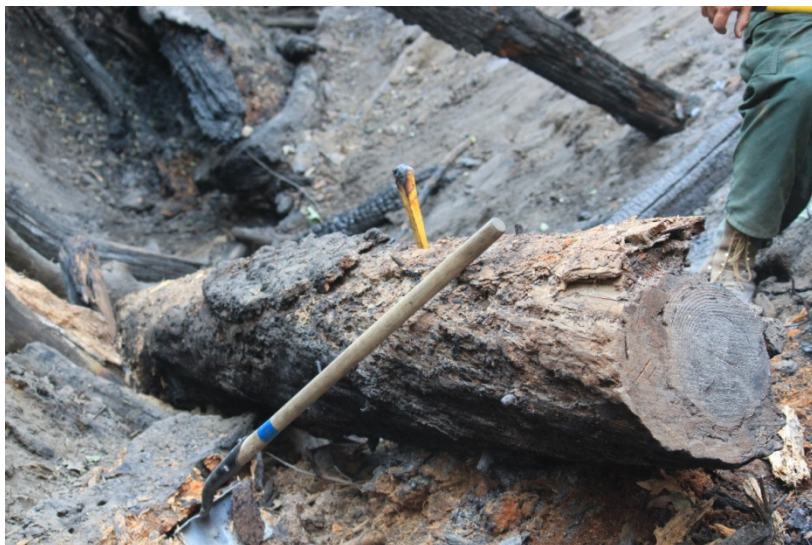
While engaging the fire with fireline construction the first two saw teams cut their way past the log but did not cut it. The third saw team while waiting for the 2 saws to get ahead decided to put in a partial buck of a downed white fir log approximately 30-40 ft long, he put in a partial buck that left a section 15 feet long left to be finished up when the lower saw teams had cleared the area below. The section was measured onsite with diameters on the small and large

Figure 1. Log section that rolled over firefighters.

end being 15" and 17". The weight was estimated between 900-1000 lbs. After cutting the log another firefighter (Squad Boss) who was working with the saw teams stepped on the partially cut log to make walking easier due the very steep slope (85% measured with clinometer on scene) this action caused the log to break loose and roll down hill towards saw teams 1 and 2 who were cutting below. The squad boss seeing what was happening made a split second decision to try to grab around the log and make an attempt to stop or at least slow the log down before it hit his fellow crewmembers. During this the squad boss was pulled over the log and was rolled over at least twice from his recollection. The log continued down the

- When working at night or in an area where an individual cannot see what is supporting a log that has been partially bucked and combined with what degree the log is in decay crew members other than the sawyers will not work below or around such logs until the log can be safely secured. (When the cut was stopped the log gave no sign of rolling, the remaining wood was broken when the log was stepped on by an individual who was not a part of the saw team.) In the future logs that have the potential to roll when bucked should be secured before starting the bucking cut.

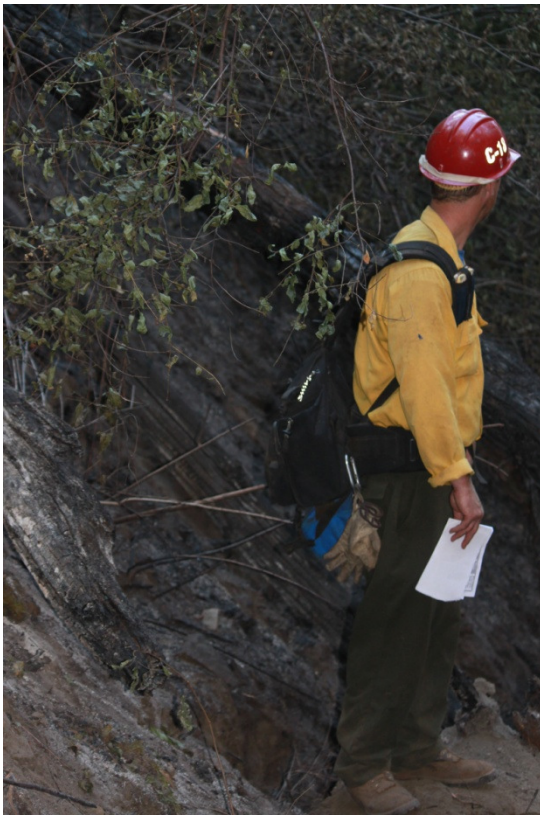
Figure 2. This photo shows the slope of the terrain the crew was working on. (85%)

- **Steep Terrain:** This incident occurred on a slope that measured 85%. Once a solid object starts in motion the likelihood of it being stopped is very slim. Any activities that could place firefighters in this situation need to be evaluated very carefully and all the options must be discussed before placing firefighters in these situations.

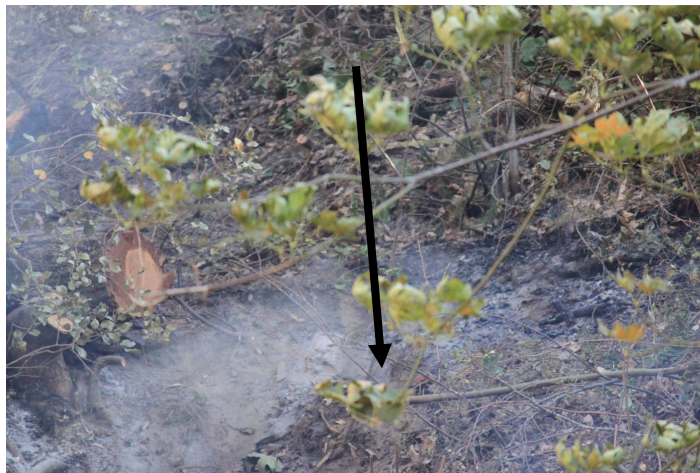
Figure 3 Photo shows the original position of the log before it rolled. Arrow points to the direction the log rolled.
