GREEN SHEET

Informational Summary of Serious CAL FIRE Injuries, Illnesses, Accidents & Near-Miss Incidents

Pine Fire Wildland Fire Entrapment & Burn-Over One Victim – Moderate to Major Burn Injuries One CAL FIRE Dozer with Moderate Damage

**September 12, 2007
Pine Fire**

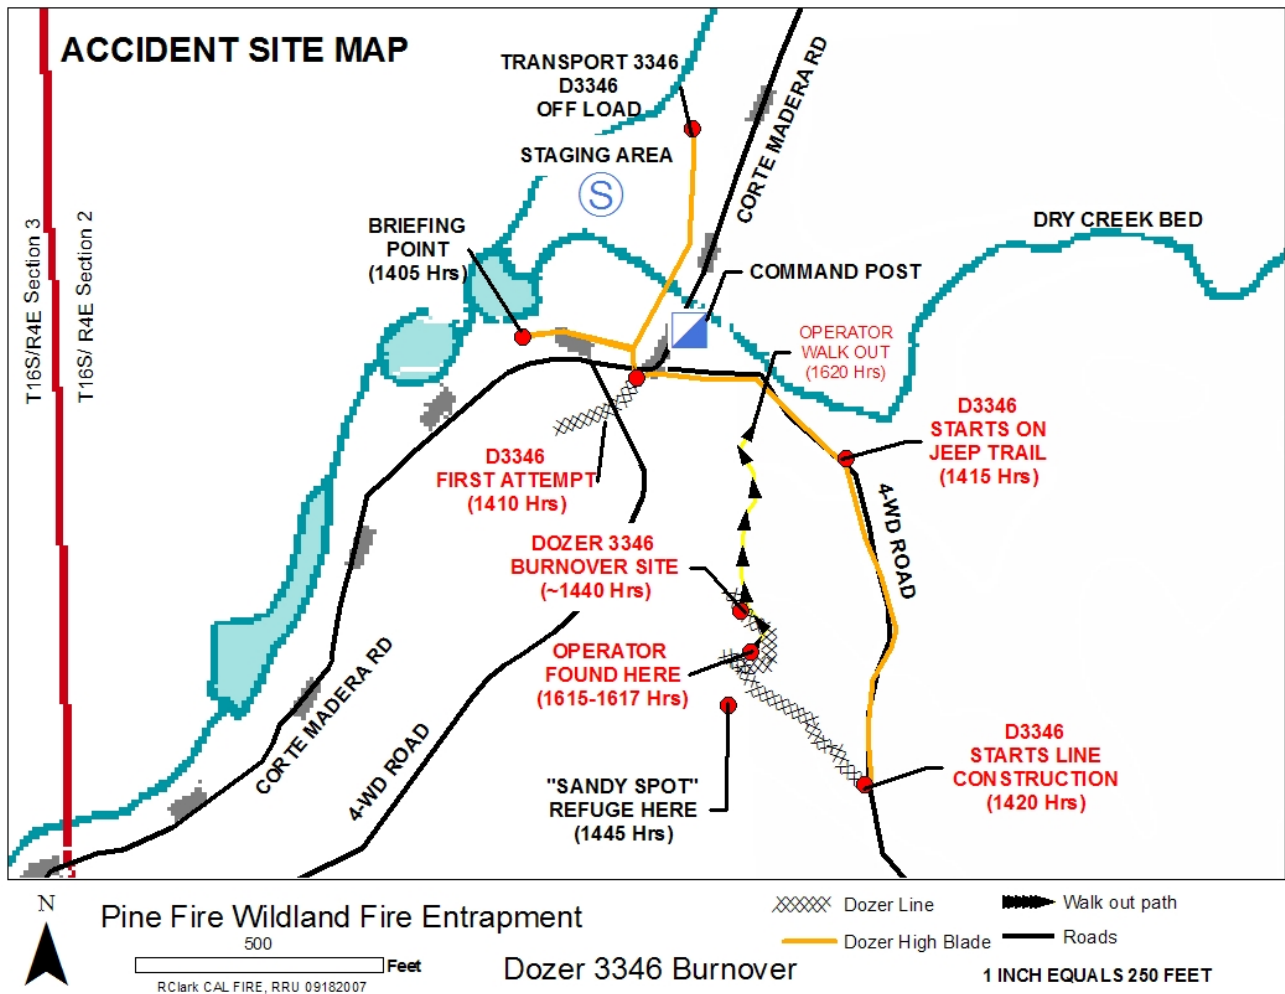
The accident site was on State Responsibility Area lands within the Direct Protection Area of the United States Forest Service. The latitude of the accident site is 32° 48.25'N and the longitude is 116° 32.84W or otherwise identified as the SW ¼ Section 2, T16S, R4E, SBBM.

Lookout

Communications

Escape Routes

Safety Zones
