Prospect Rock ATV Rollover FLA

All Terrain Vehicle Accident Facilitated Learning Analysis

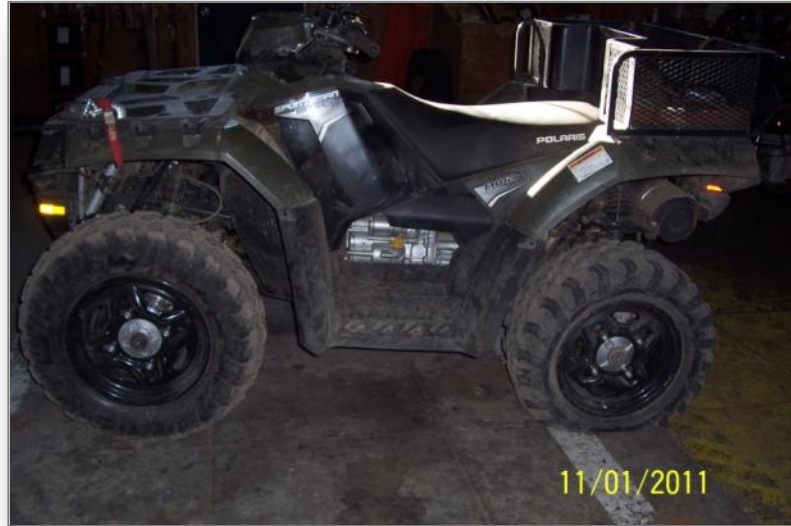
A condition leading to this accident appears to be the extreme slope of the hill and the speed needed to ascend successfully. Upon striking a rock, the front end of the ATV lost traction and became airborne, with the subsequent momentum flipping it backwards into a rollover. The reported under-inflation of a rear tire may also have been a factor as well. This event illustrates how, in a split second, a situation can occur which thankfully did not have devastating consequences. Due to training and experience the rider jumped off in time to avoid a more serious injury.

Flat left rear tire on ATV

- Every vehicle requires pre-ride/drive examination, including tire pressure checks if it appears to be inadequate.
- Look for alternate ways to get the job done; continuously re-evaluate all hazards.
- Ensure notification of Dispatch as soon as possible so upward notifications are made in a timely and consistent manner.
- A medical doctor should be consulted on questions of a patient's ability to drive a motor vehicle immediately after treatment for a vehicle-caused injury.

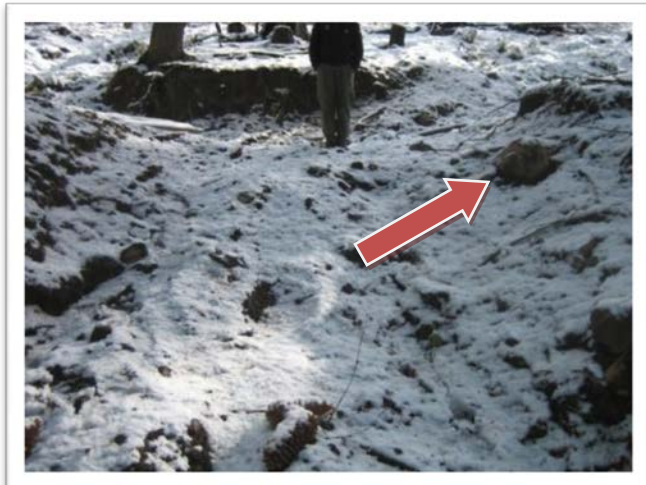
Down slope view of skid trail

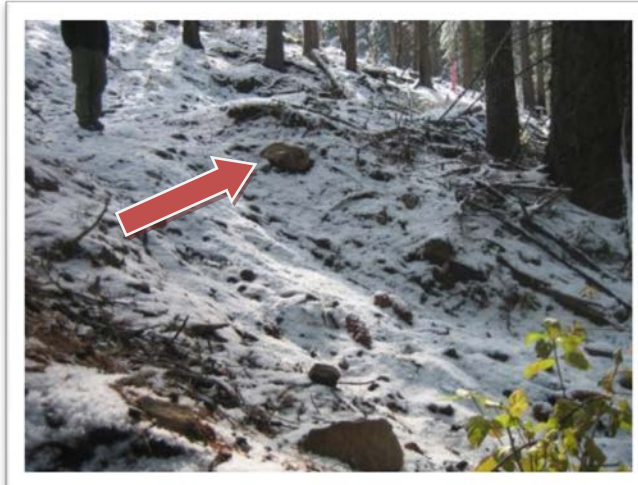
Upslope of skid trail with crew member standing at top for perspective. Rock shown that ATV struck.

While patrolling a control line on an ATV, an employee rode up a fairly steep hill, estimated at 40% slope. Just before reaching the top the ATV hit a rock and flipped over backwards, possibly because of improper weight distribution, speed, the possible under-inflation of one tire, or a combination of some or all of these factors.

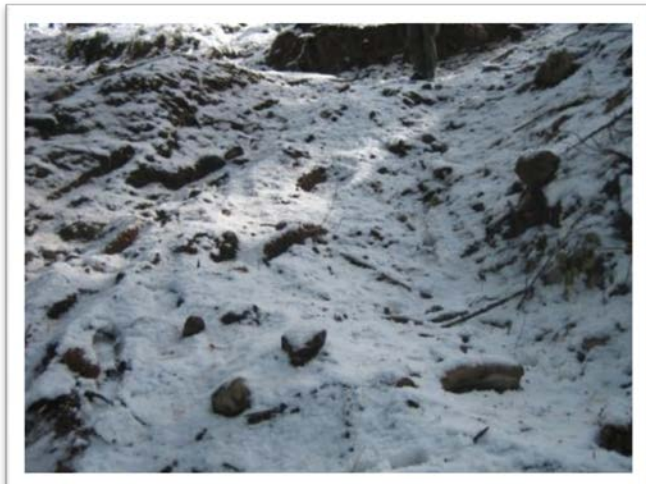
Lateral aspect of slope where ATV overturned, with crew member standing for perspective.

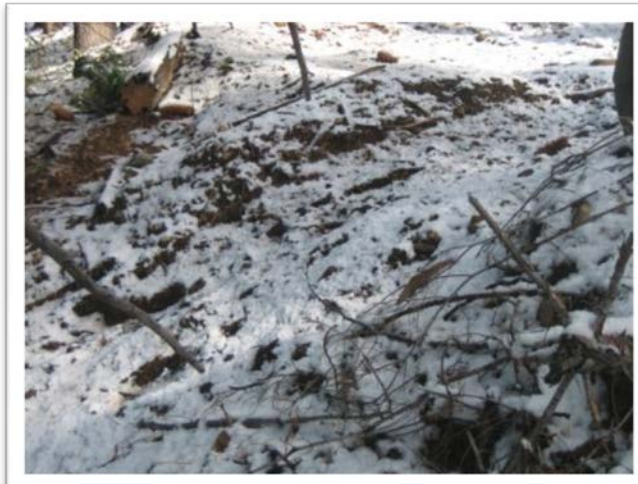
More lateral views of slope where ATV overturned, with crew member standing for perspective
