# Rapid Lesson Sharing

**Event Type:** Tree Strike Injury;  
Medevac Problems

**Date:** July 22, 2015

**Location:** Holnakatna Fire #539;  
Galena Zone; Alaska

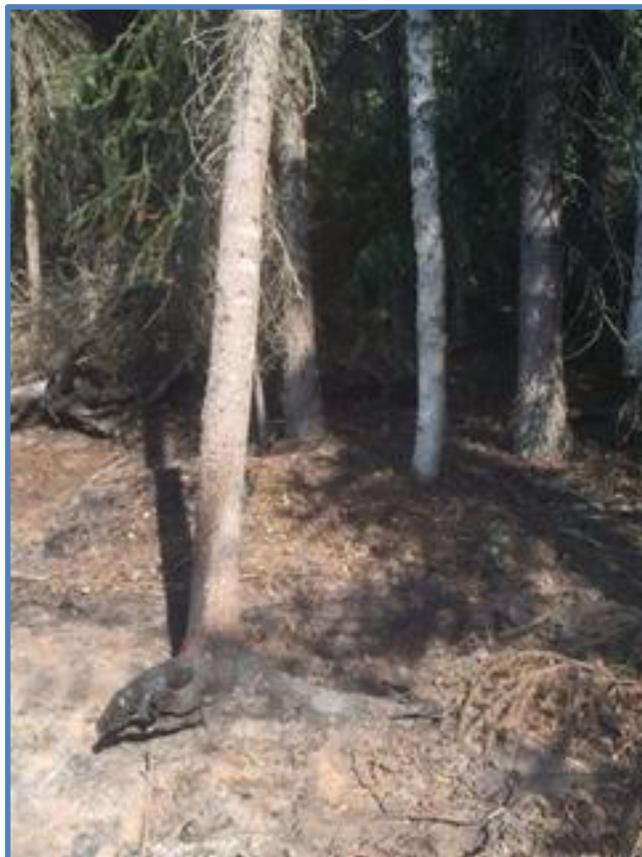
*Photo shows the shallow root base on a white spruce that was easily consumed when the ground fire passed through this stand. (This is not the tree that was involved in this tree-strike injury incident.)*

Due to their shallow root base, it is not uncommon for the root systems to be completely consumed after ground fire passes through a white spruce stand. Many of these trees will fall without warning—or with the slightest wind. Identifying and felling these trees is a good practice to ensure these areas are safe for mop-up.
