# Rapid Lesson Sharing

**Event Type:** SEAT Strikes Powerline

**Date:** July 28, 2016

**Location:** Northern Idaho

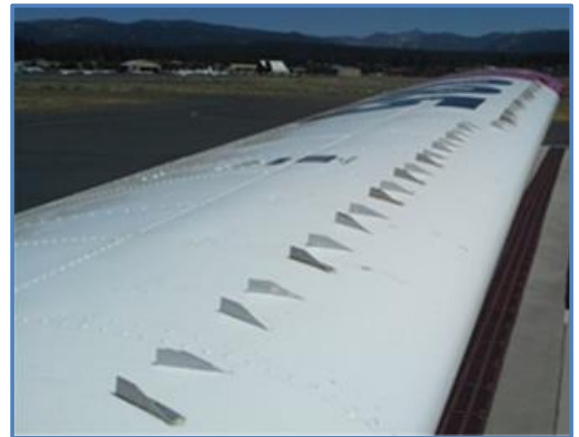
While conducting fire suppression operations, a Single Engine Air Tanker (SEAT) struck a powerline while on final approach for a drop. The pilot was unaware of the strike at the time it occurred. Following the successful drop, the pilot looked out at his left wing and realized that numerous (21) vortex generators (see photo on right) were missing. He informed the Air Attack Group Supervisor (ATGS) and it was recommended that he go to Lewiston, Idaho. However, the Pilot decided that he would return to base at McCall, Idaho.

*Replaced vortex generators along the aircraft's left wing. The powerline strike took out 21 of these.*

The Pilot flew back over the drop area and confirmed that the known powerline was still intact. He did not locate the poles from the line that had been struck. As he was heading back to the dip location, he looked out at his left wing and realized that numerous vortex generators were missing. The vortex generators are glued on the wing and have been known to come off in flight, but normally only under extreme cold or hot weather conditions. Normal flight is not affected by missing vortex generators. Their purpose is to add stability, lift, and performance during dipping and dropping maneuvers. All controls of the aircraft were functioning normally.

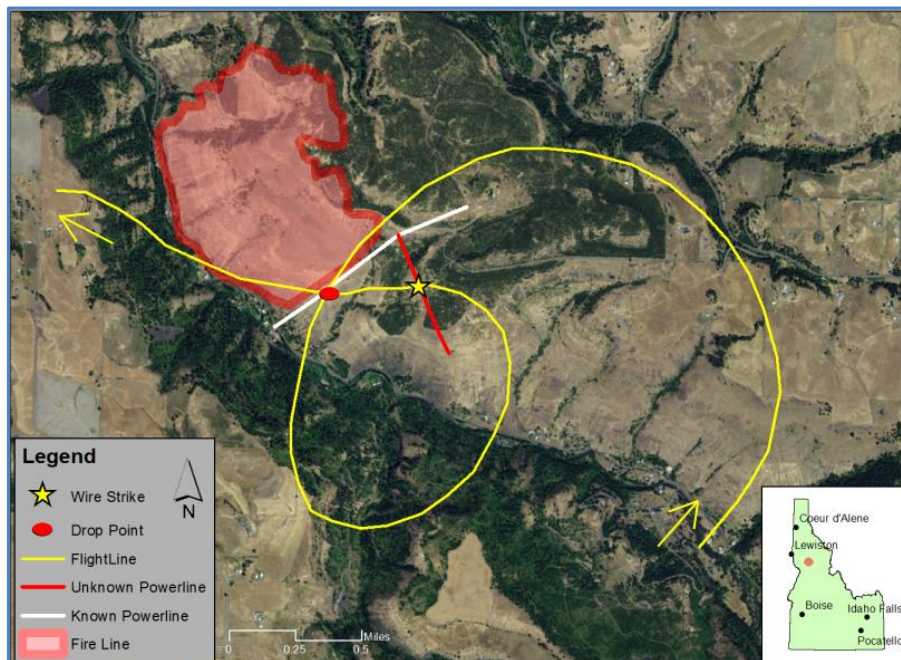
**Flight path and location of powerlines in relation to drop.**

At this point, the ATGS, who was circling overhead, instructed the Lead Plane to give the SEAT a target and let him work his own approach. The SEAT came back around in a fairly tight circle which created a different final approach than had previously been used. This new approach of the flight line brought the SEAT over a powerline that had not been identified prior to the

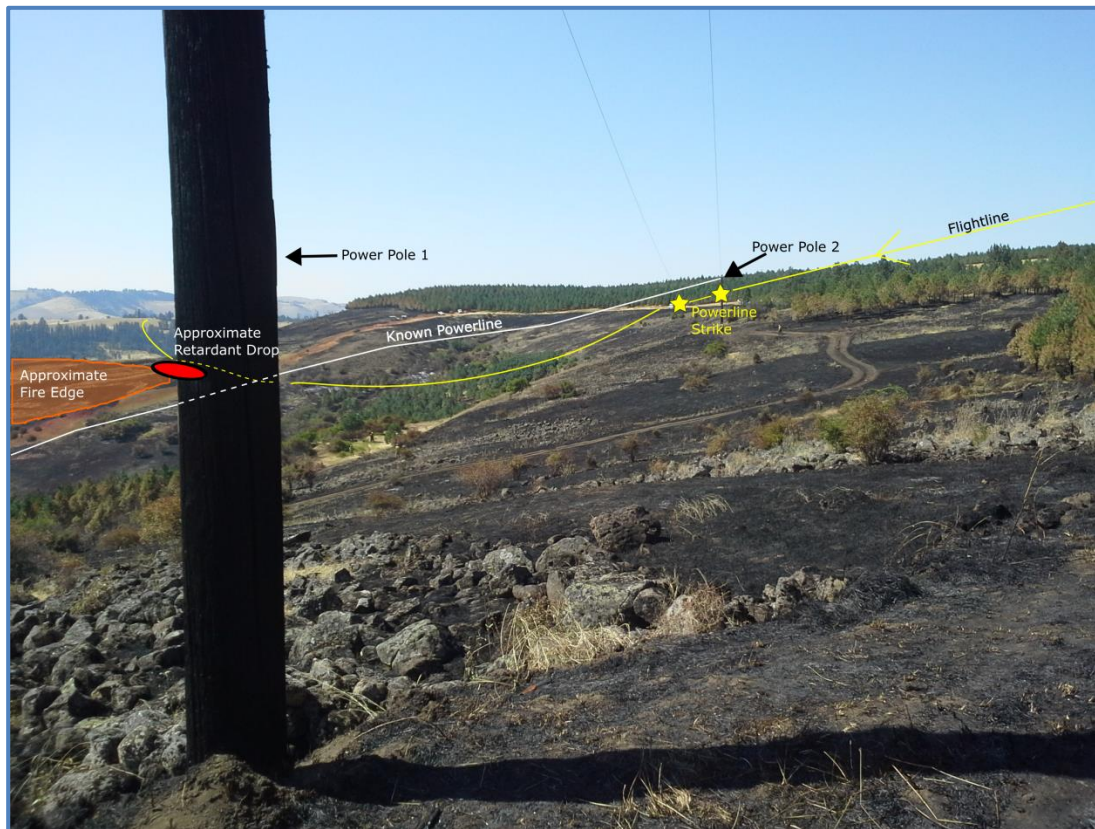
The SEAT's flight path was between Power Pole 1 and Power Pole 2, approximately 225 feet from Pole 2.

The distance between poles is 670 feet.

Note how the lines are visible against the sky—but *not* against the darker colors of the terrain, which is how it would have appeared to the SEAT Pilot.

The area in the foreground burned after the strike occurred.

The angle of the bank caused the nose and the right wing of the plane to create a blind spot, obscuring Power Pole 2 from view. The angle of the sun and the dark color of the powerlines would have made them basically invisible against the backdrop of the terrain. The Pilot was unaware of the strike at the time it occurred with the only indication being a brief sound that was not part of the “normal” sounds experienced in the aircraft. The flight was bumpy due to turbulent air that is normal on hot summer days in canyon country. Following the successful drop, the Pilot informed ATGS that he might have hit something.

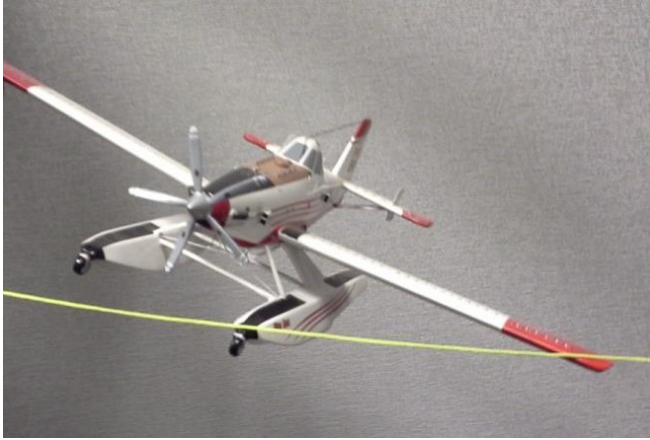
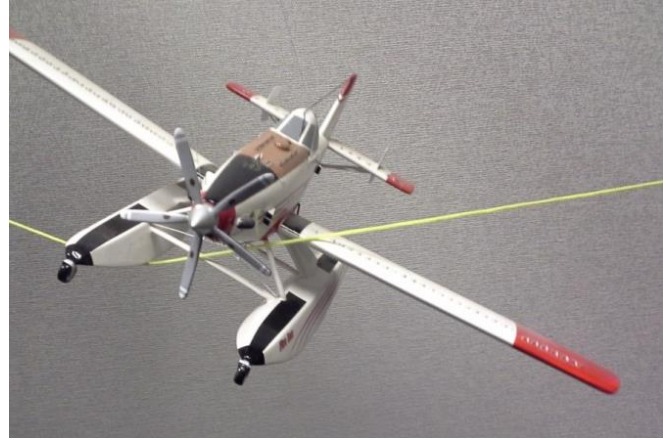
### ***A Recreation of What Happened***

*Approximation of initial contact with powerline is represented in left photo. Photo on right shows the approximate location of the powerlines as the slack was taken up and the lines snapped. This illustration is based on marks on the plane, the angle of the flight path from the plane's GPS, and from information gathered at the scene.*

A dry run at a higher altitude on the first approach from this new angle could have avoided this strike. It is surmised that the wire was initially contacted in the last two feet of the wing as the SEAT was banking into final approach for the drop. The line was then drawn inboard as the Pilot came out of his turn and the tension of the wires increased, all of which happened in fractions of a second.

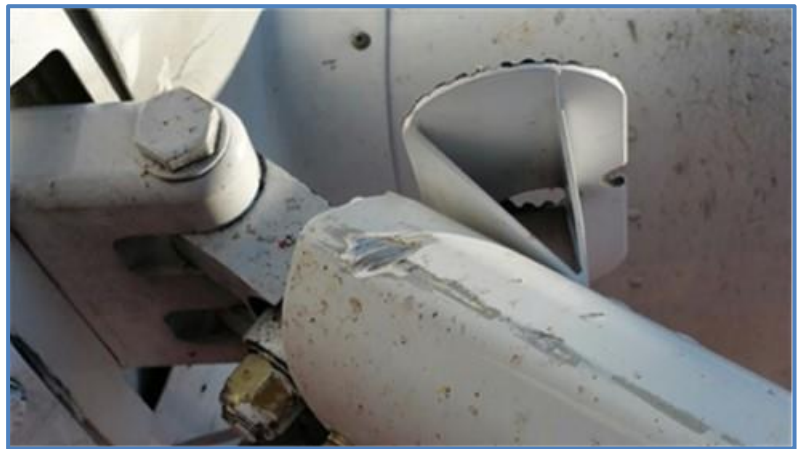
The line that was struck was a distribution line consisting of two #6 gauge wires with black rubber coating. The span where the impact occurred was 670 feet between poles. The wire was torn from the cross-arms of both poles before breaking, allowing the slack line from poles 1,900 feet apart to be taken up as the wire moved up the wing and between the pontoons of the plane. The heaviest point of friction and damage to the aircraft was located at the top of the pontoon strut near the fuselage.

***Strut damage from the wire strike with repaired step.***

Airspeed at the time of impact was estimated at 135 mph as the Pilot began his descent toward the target area. The aircraft had a full load of water on board (approximately 5,800 pounds). Upon safely returning to McCall, the plane was inspected by both company FAA-certified mechanics and the U.S. Department of Interior's Office of Aviation Services (OAS) inspectors. Light repairs were made and the aircraft was returned to service.

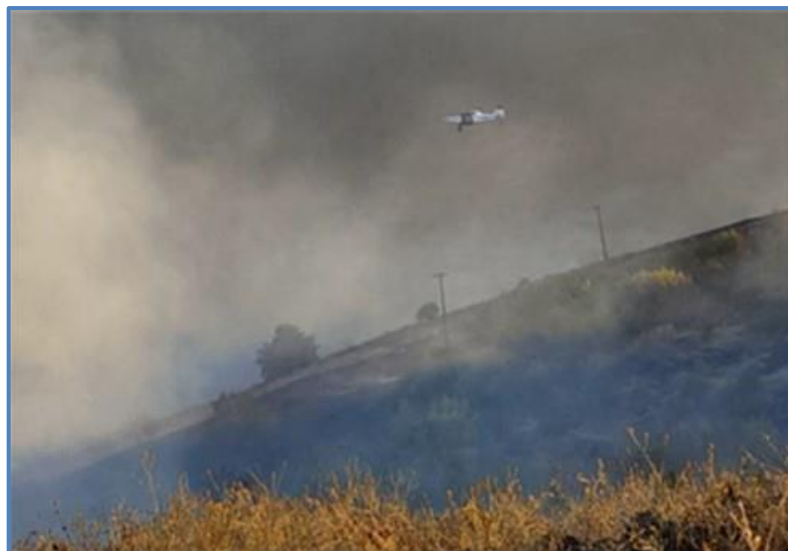
*A SEAT on approach from the opposite direction above the known powerline.*
