Facilitated Learning Analysis Runaway Fire Engine on the Mountain!

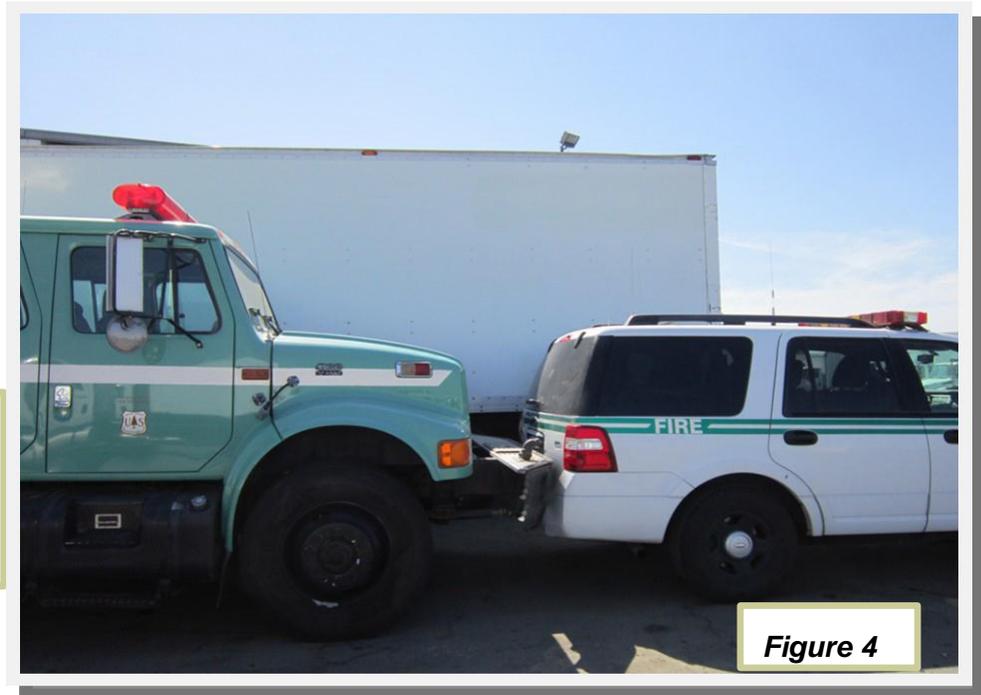
Figure 4

After passing the logging truck and creating a safe distance from it further down the mountain, the STEN began to slow his vehicle allowing the engine to creep up to it until contact was made he began to apply his brakes gently. The STEN remembers feeling a jolt and hearing what sounded like the fiberglass of his vehicle shearing apart. He recalls it took about 5 seconds to bring the engine to a stop on the right shoulder (Figure 3). Impact with the Ford Expedition was estimated at 63 mph. Figures 4-5 show what it would have looked like when both vehicles made contact with each other.
