Grassy Mountain Complex Contractor Fatality
Rome, Oregon
August 10, 2013
Serious Accident Investigation

Grassy Mountain Complex Contractor Fatality

Serious Accident Investigation

Factual Report

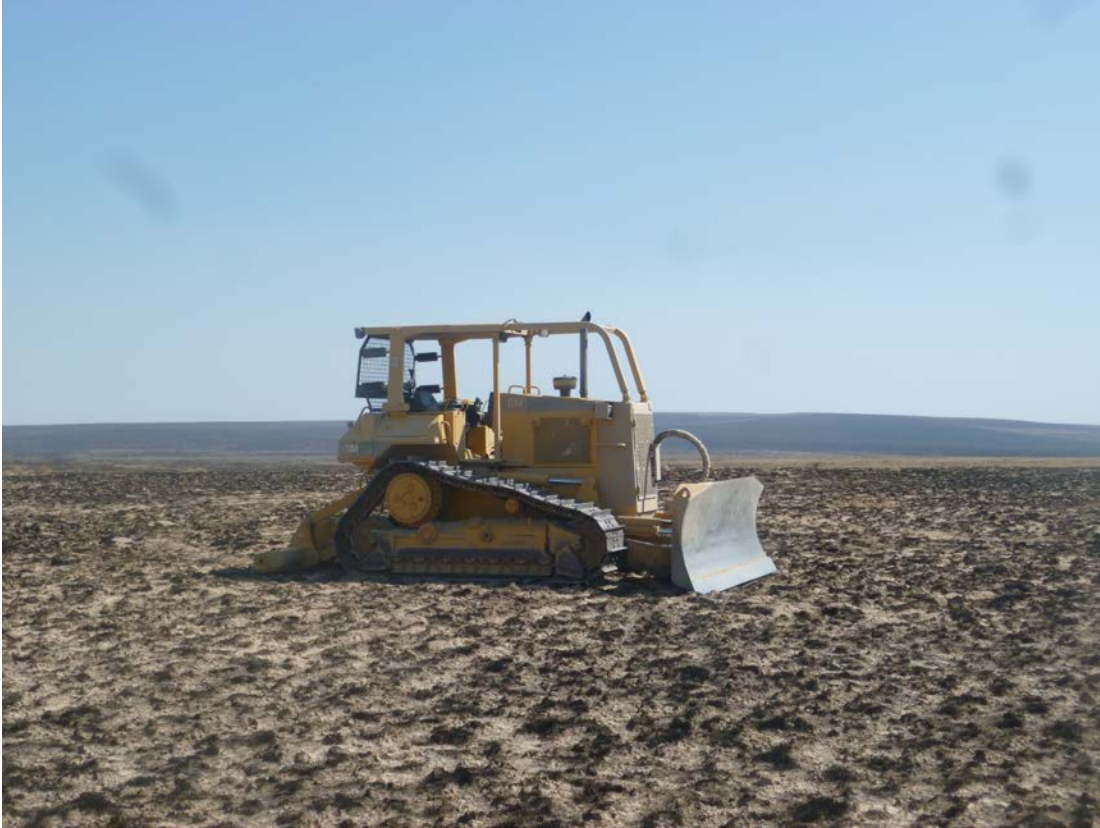
E-19, Brian McKinney Company Type 2 Dozer

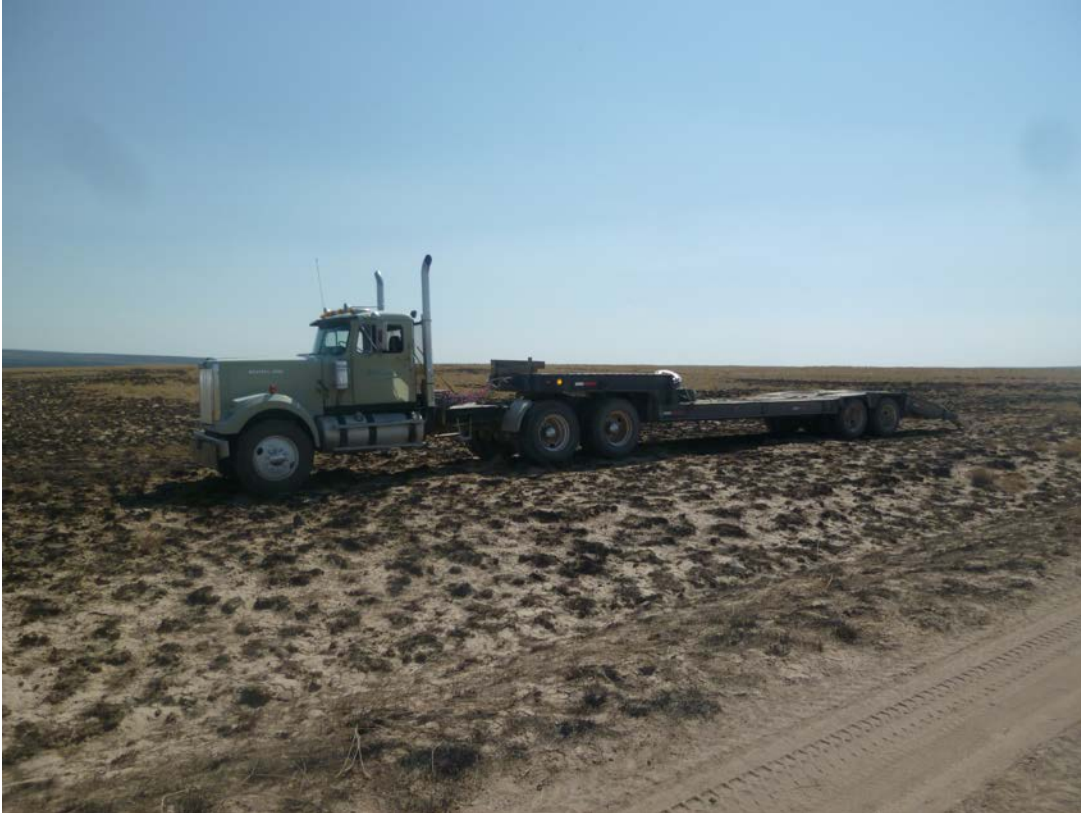
E-19, Transport for Brian McKinney Company Type 2 Dozer

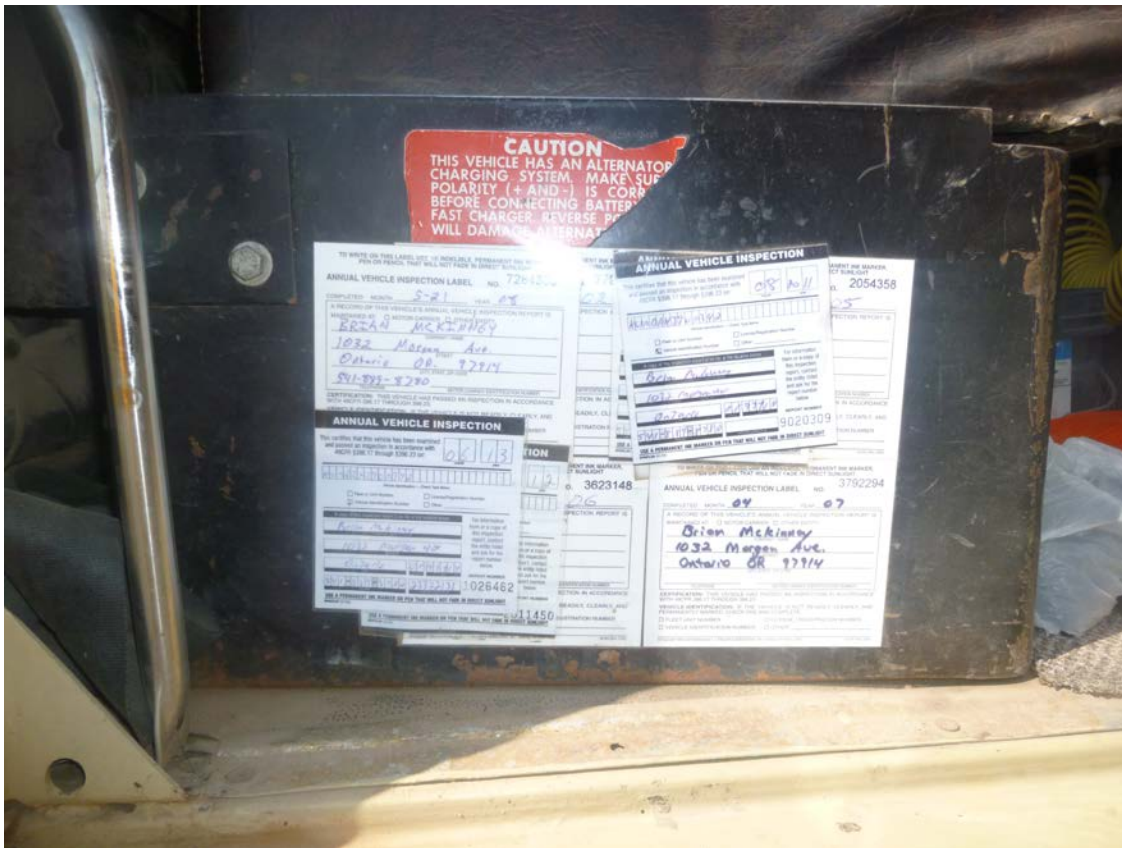
DOT Inspection Sticker for Brian McKinney Company Transport
