Rapid Lesson Sharing

Event Type: Crew Transport Burn

Date: August 6, 2022

Location: The SRF Lightning Complex
Six Rivers National Forest, California

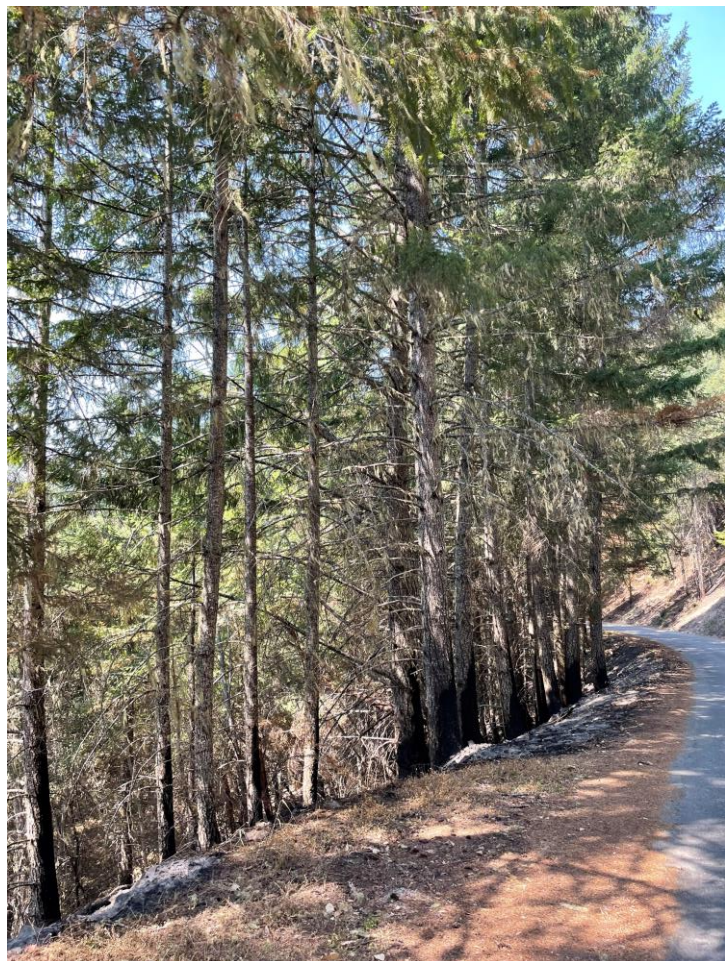
Looking towards where firing was being conducted along the road.

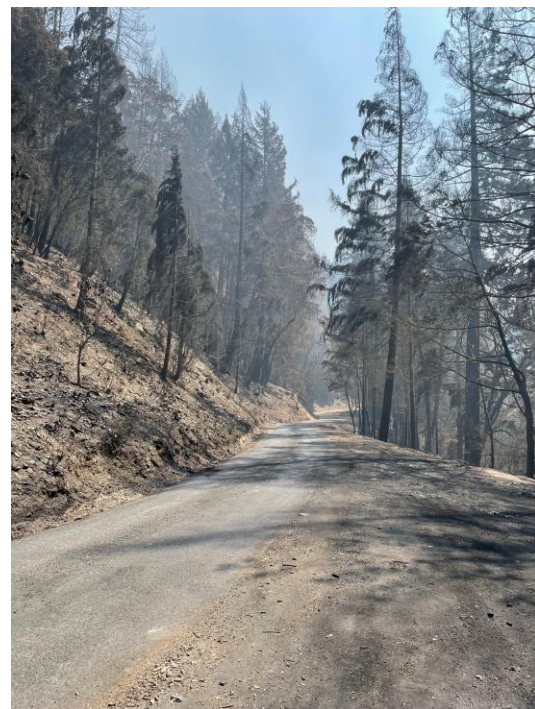
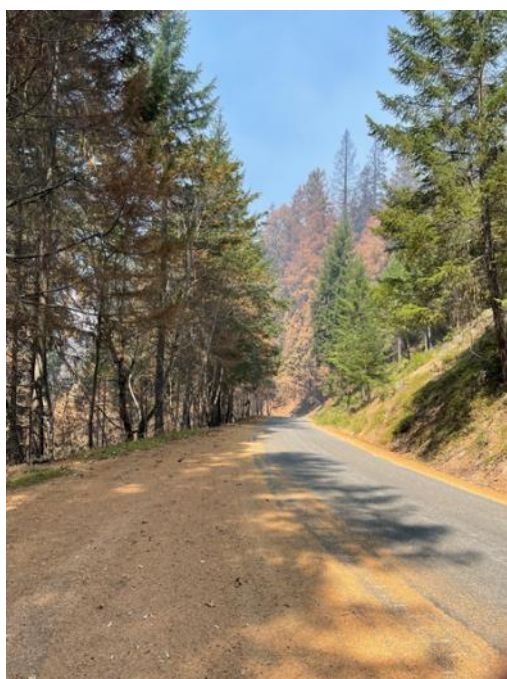
The buggies were overtaken while parked on the road shortly after 1800 about half way between the east-west boundary of the high intensity section (0.25mi section of road).

Left photo: transition from low severity in foreground to high severity in background.
Above photo: Looking from where crew carriers were parked in area of high intensity run uphill.

- A. Apparatus Placement – *“You need to have safety zones for your vehicles as well as for your crew. It is worth investing some time into the decision on where to park before hiking away and going to work. I look for cold black as much as I can, but you also have to consider egress, terrain, snags, and other hazards”*. C-2 CRWB.

Stage drivers at vehicles, *“keep vehicles closer to crew”* or *“post lookouts at buggies or park buggies in black.”* C-3 Squad Bosses.

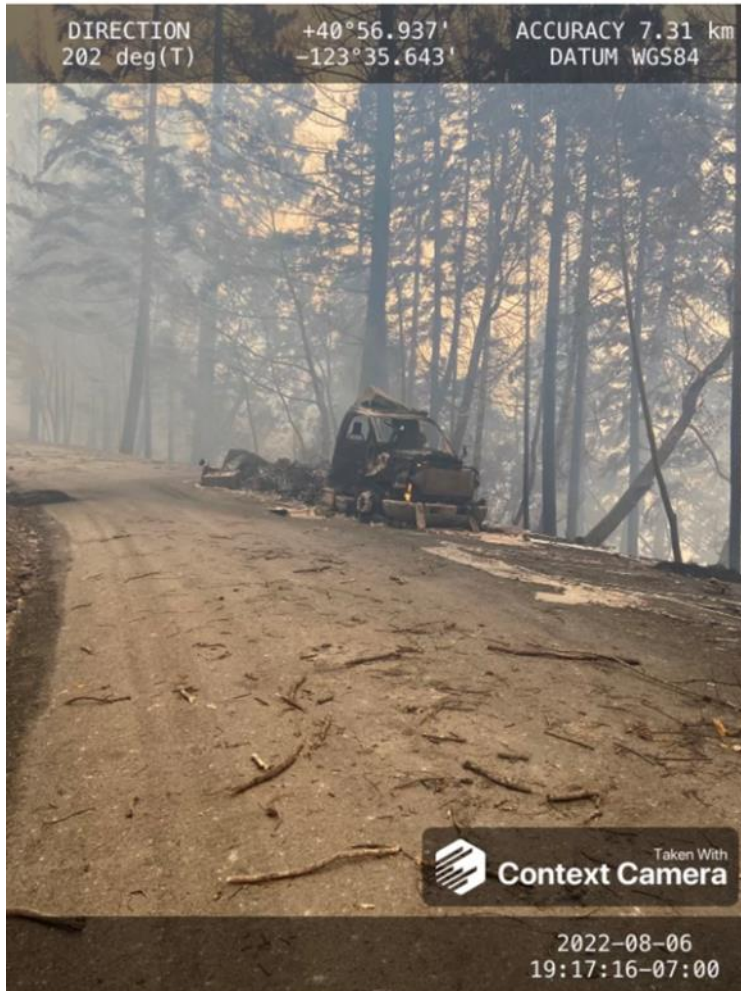
From the IR perimeter on 08/05/2022 at 2308 to the time the buggies burned about 19 hours later, the fire had spread approximately 18 chains, and had been flanking through surface and ground fuels. At the point at which it transitioned into a high intensity crown fire, it burned approximately 0.25mi linear distance along the road with high severity fire effects. To the east and west of the high severity patch, the flanking fire resulted in low-moderate fire severity.

Above: Condition of crew carrier hours after the burn occurred. The other crew carrier is out of sight down the hill.

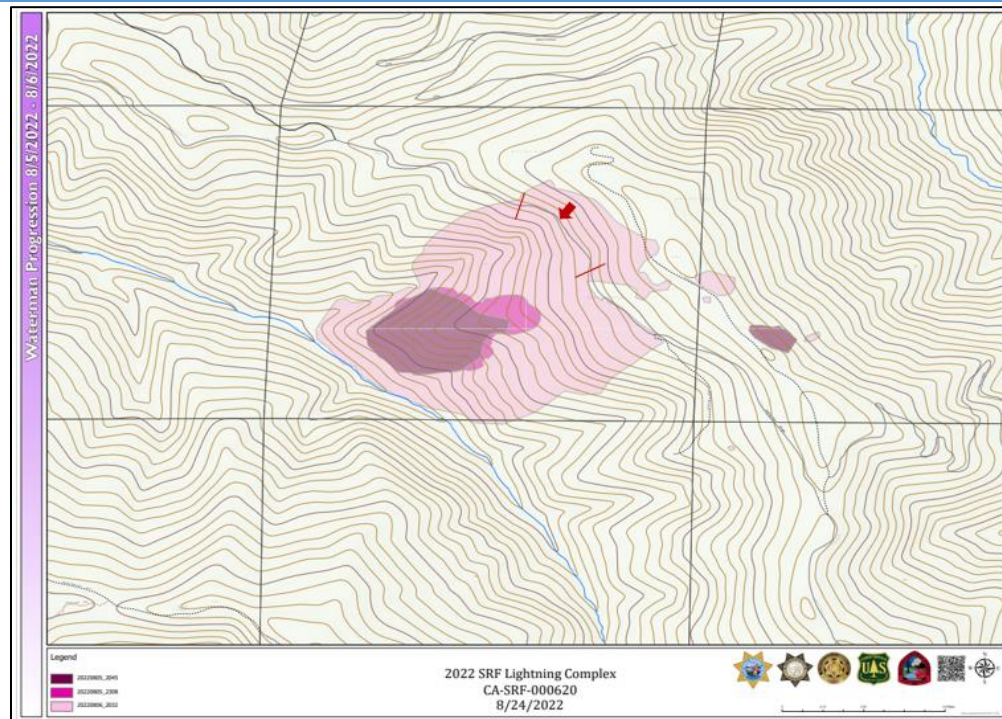
Top image: Oriented north- red arrow location of crew carriers. Red lines indicate area of high intensity uphill run. Not visible in the smoky conditions during the fire, but visible on the contour map was how narrow the sub-drainage is at the creek bottom relative to the width at the road.

Bottom image: Looking northeast - yellow pin indicates location of crew carriers on Waterman Ridge Rd.

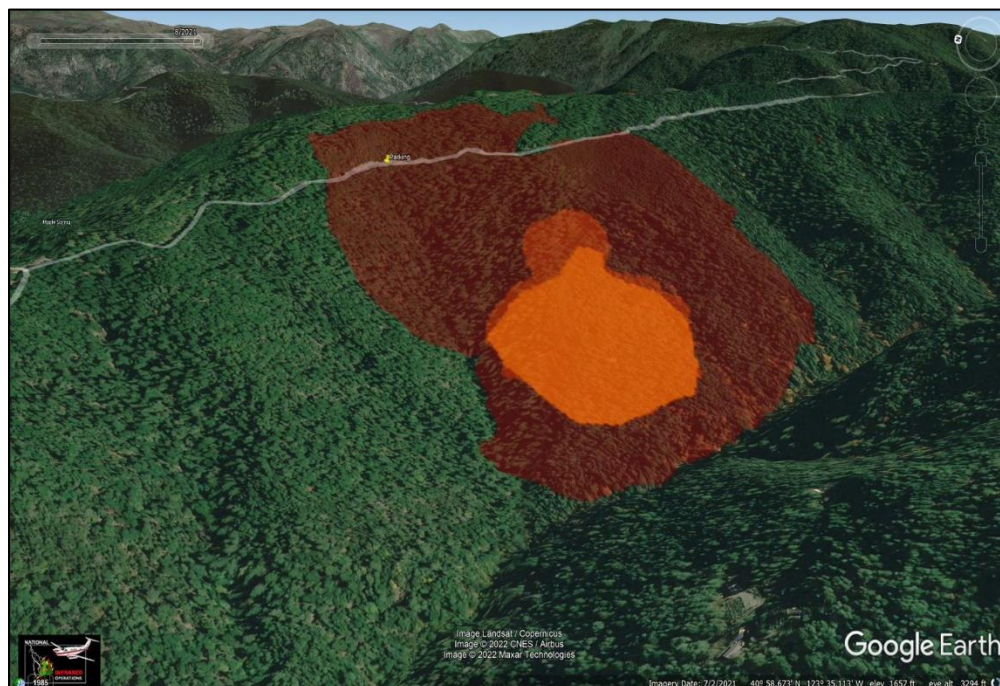
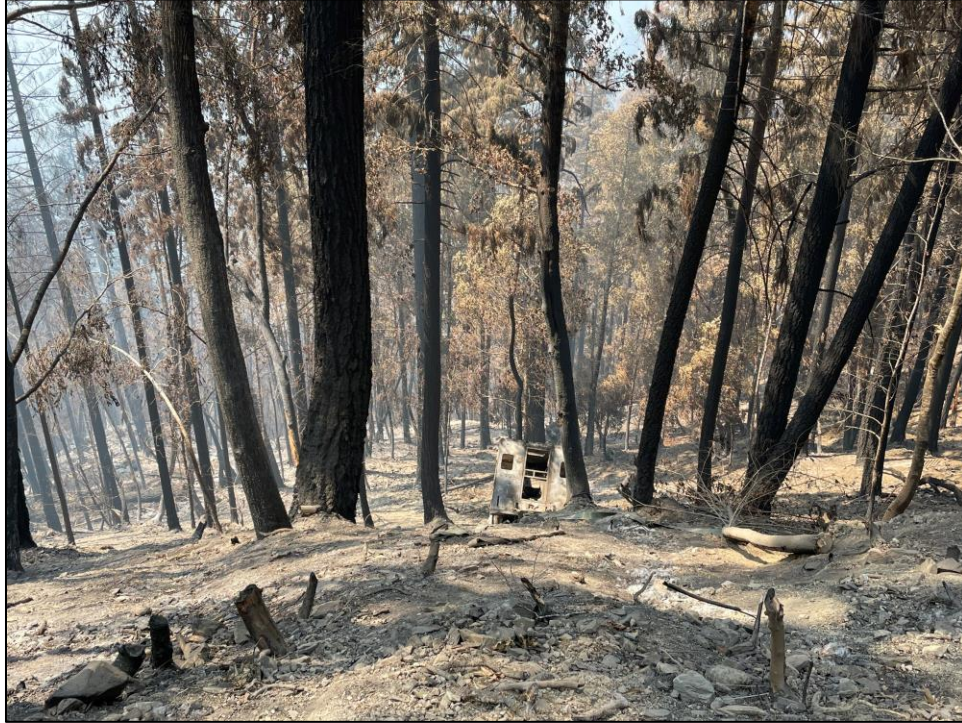
Top image: Crew carrier downhill from parking area.
Bottom image: Crew carrier being yarded up by two Type 1 wreckers simultaneously.
