## Slaughter Fire Accident Report

The Slaughter Gulch Fire located roughly 3 miles northeast of Silt, Colorado resulted in a Burning Mountains Fire Protection District (BMFPD) Engine burn over. Moderate damage occurred to the engine. No firefighter injuries occurred.

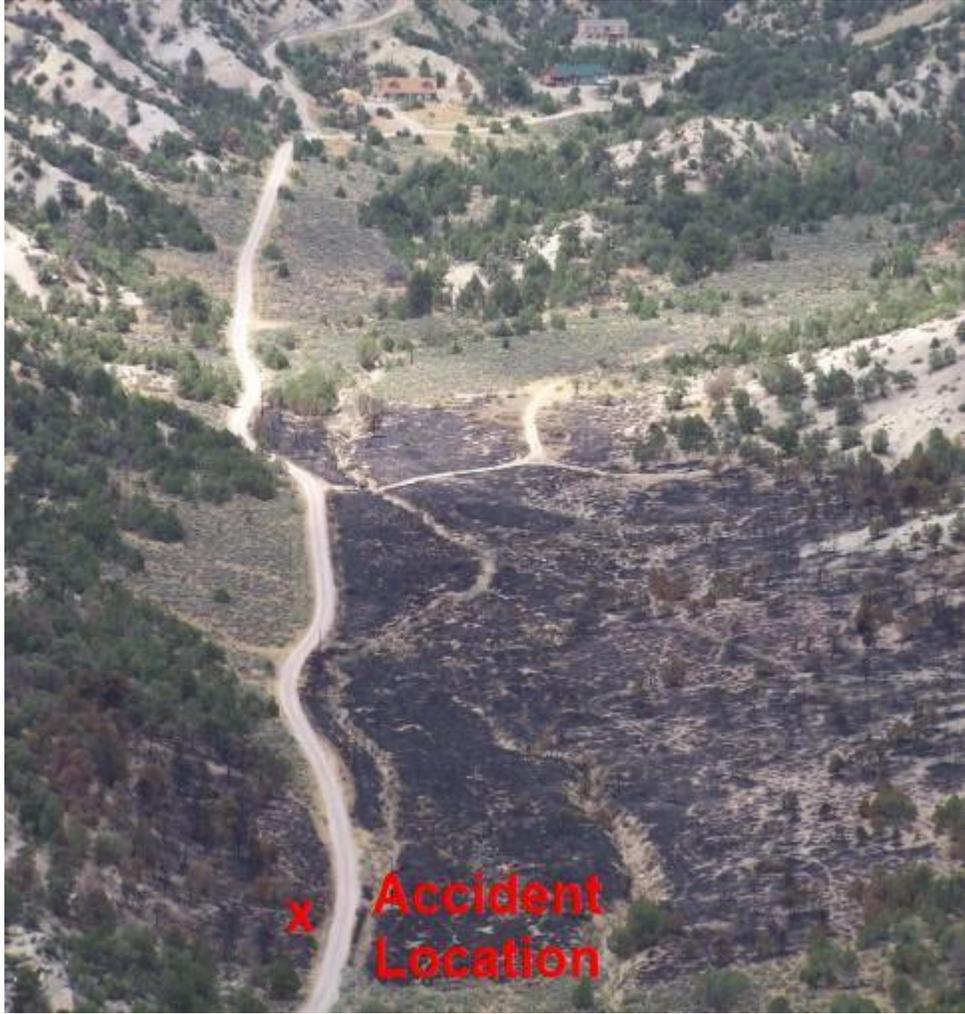
Photo of the fire with accident site identified.  
(note the structures above the fire)

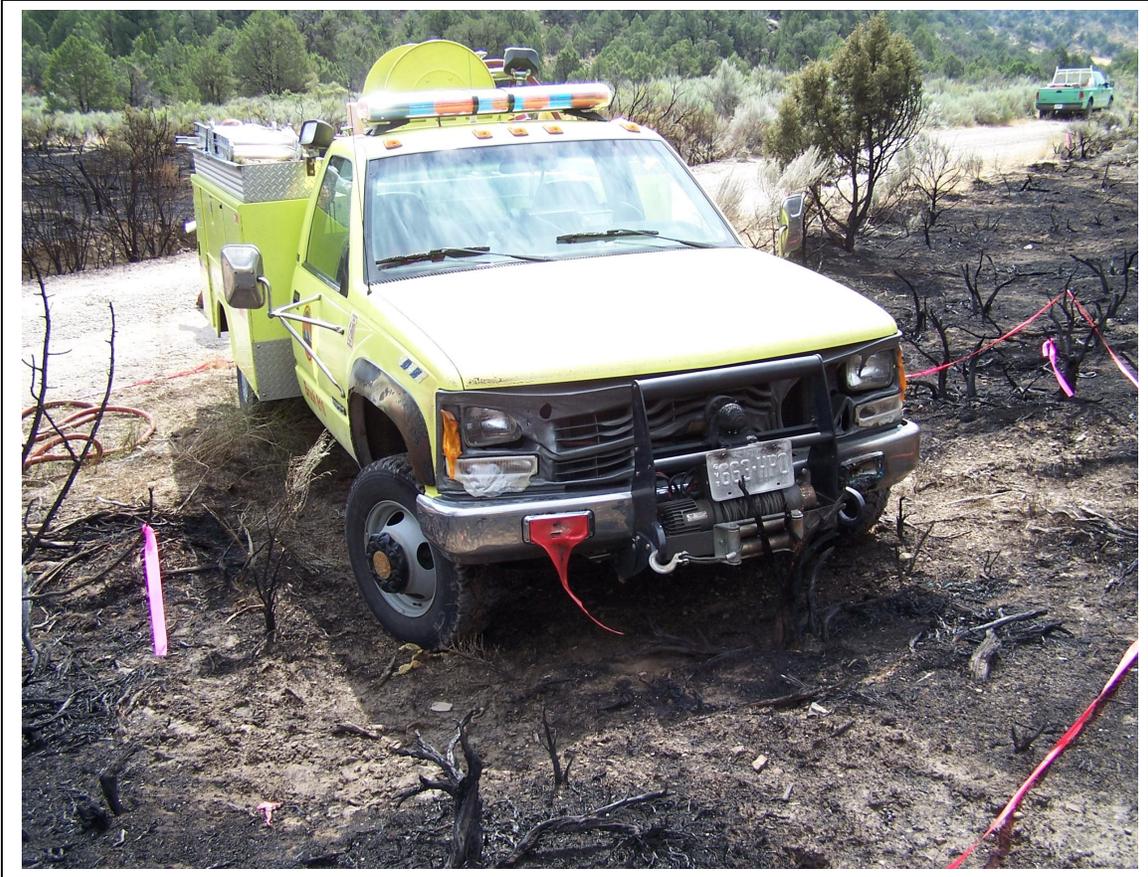
BMFPD Brush Truck 810 a 250 Gallon Type 6 engine was told by their Captain to pull off the single lane dirt Slaughter Gulch Road and wait for BLM engines. Brush Engine 810 pulled off the road into the sagebrush and cheat grass as shown in the picture. The fire was moving 5 to 10 chains per/hr. with 4' flame lengths on the opposite side of the road moving down canyon and away from the road. BLM Engine 605 with a chase vehicle pulled in front of Brush 810, their chase vehicle was behind Brush 810. The vehicles were located 30 yards from the right flank of the fire, with solid black further up the road.

The radiant heat ignited the vegetation on the SW side (across) the road where Brush 810 was parked resulting in the damage shown in the photo. The engine crews were not able to return in time to protect Brush 810 due to 15' flame lengths combined with intense heat. Five minutes later a heavy down pour from the thunder cell that caused the high winds dosed the fire slowing additional fire spread. No injuries were sustained by the engine crews. Engine damaged was estimated at 7,000.00 dollars by review team.

Brush 810 pulled off the road in light flashy fuels with unburned fuels between them and the fire. Parking in a direction/location to expedite a safe retreat to a safety zone must always be considered prior to leaving engines parked.

The main fire approached from across the road causing personnel to evacuate the scene.

Engine 605 should have started their initial wet line operations 30 yards up the road with a solid black anchor point adjacent to their engine. Additionally 605 should have advised Brush 810 to relocate their engine into a better position for tactical applications and escape.
